Sub: Fire Accident in High Rise Commercial Carlton Towers,  
Airport Road, Bangalore on 23-02-2010 – constitution  
of a technical committee to investigate the cause of fire,  
work done and lapses.

**FIRE ACCIDENT IN HIGH RISE COMMERCIAL BUILDING  
(Carlton Tower)  
ON 23-02-2010**

**INVESTIGATION REPORT OF THE COMMITTEE, CONSTITUTED BY  
THE DGP, FIRE & EMERGENCY SERVICES, IN OFFICE ORDER  
NO.GBC(3)37/2010 DATED 02-03-2010**

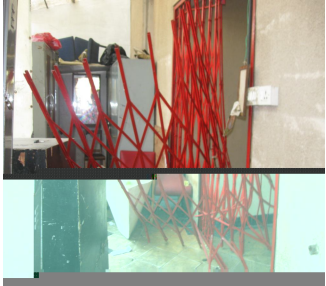
Details	As per the NOC issued on 3-4-1993 and CC issued on 27-7-1999	Observations / lapses as noticed during the inspection of the site and building on 3-3-2010
No. of staircases	3 staircases in Part-1 (affected by the fire) and 2 staircases in Part-2.	<p>Even though 3 staircases, one at the centre and one each on both the flanks (southern &amp; northern sides) (Total 3) have been provided, the Management have provided collapsible gates at ground floor level and locked the exit path of 2 staircases on both the flanks. Further the Fire check doors provided at each staircase landing to prevent the possible travel of smoke and fire both horizontally and vertically to the staircase area have been locked. Apart from these the common passage between the staircases at 2<sup>nd</sup>, 3<sup>rd</sup> &amp; 4<sup>th</sup> floor level have been modified and blocked with additional constructions/ alterations and shutters. This has totally prevented the occupants of upper floors from moving horizontally from smoke filled areas to smoke free areas and out of the building. Added to these, the doors of each staircase, leading to the terrace, were also locked, restricting the possible escape of the occupants of the upper floors to the terrace.</p> <p><b><u>Objective evidence</u></b></p>

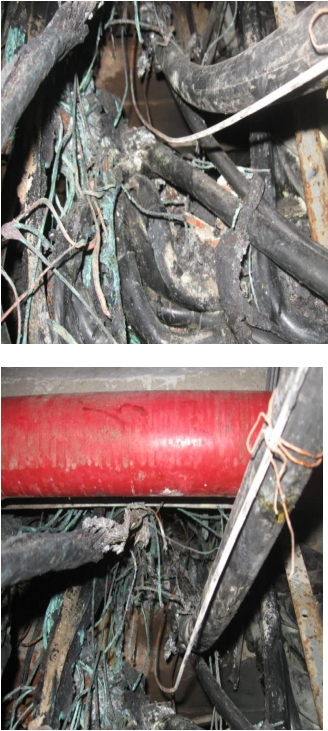
Details	As per the NOC issued on 3-4-1993 and CC issued on 27-7-1999	Observations / lapses as noticed during the inspection of the site and building on 3-3-2010
Service ducts	All the service ducts are to be enclosed by walls of 2 hour fire resistance capability with inspection panel doors of 2 hour fire resistance capability of each landing. Further all the ducts are to be sealed at every alternative floor level with non-combustible materials of 2 hours fire resistance capability. Compliance of this was confirmed while issuing clearance certificate by the department.	<p>At the time of clearance compliance of these requirements have been confirmed. But later, along with the original cabling, few new ones were added in an unprofessional manner. Some of these were of small diameter wires joined with ordinary insulation tapes. To lay these additional cables for different applications by the different occupants the sealing at every alternative floor level have been removed and not refixed. This has allowed the dense smoke to travel upward in the beginning, thereafter horizontally resulting in mushrooming of the smoke.</p> <p><b><u>Objective evidence</u></b></p>

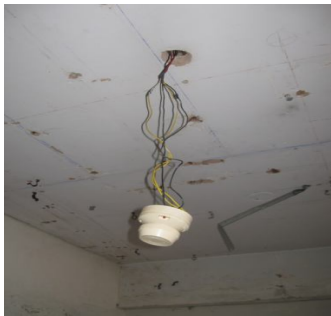
Details	As per the NOC issued on 3-4-1993 and CC issued on 27-7-1999	Observations / lapses as noticed during the inspection of the site and building on 3-3-2010
Fire Detection System	Installation of smoke detectors to cover all the floors from ground floor to 7 <sup>th</sup> floor with its control point at ground level was recommended and was found complied with while issuing the clearance certificate.	<p>The detection system, provided in the building, has not been maintained and at few places has been either covered with false ceiling or removed.</p> <p><b><u>Objective evidence</u></b></p>

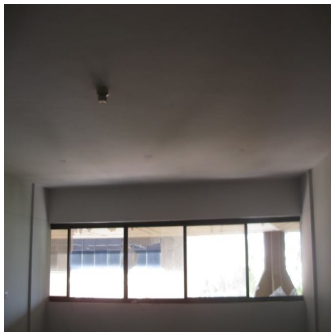
Sprinkler system	Installation of automatic sprinkler system in the basement parking area and shopping area at ground and 1 <sup>st</sup> floor level of the building was recommended and was found complied with while issuing the clearance certificate.	<p>Even though the sprinkler system with 378 sprinkler heads have been installed with required quantity of water and pump &amp; these systems were tested at the time of issue of clearance to the building, the system installed at ground and 1<sup>st</sup> floor level were found removed. Further the system installed at basement level was defunct.</p> <p><b><u>Objective evidence</u></b></p>

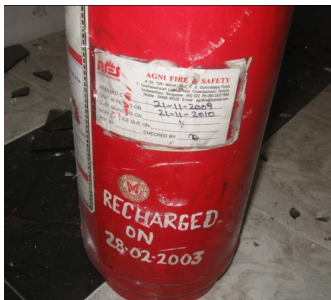
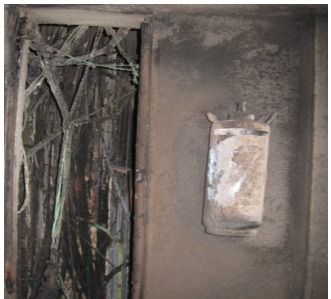
Details	As per the NOC issued on 3-4-1993 and CC issued on 27-7-1999	Observations / lapses as noticed during the inspection of the site and building on 3-3-2010
Portable fire extinguishers	Installation of suitable type of portable fire extinguishers covering the basement parking area, main switch board rooms, transformer yard, generator rooms, inside each lift room, at each staircase landing was insisted. This was found complied while issuing clearance certificate.	<p>Installation of portable fire extinguishers, as recommended, was confirmed during the final inspection at the time of clearance. But most of these extinguishers were found missing and a few available extinguishers were found defective.</p> <p><b><u>Objective evidence</u></b></p>

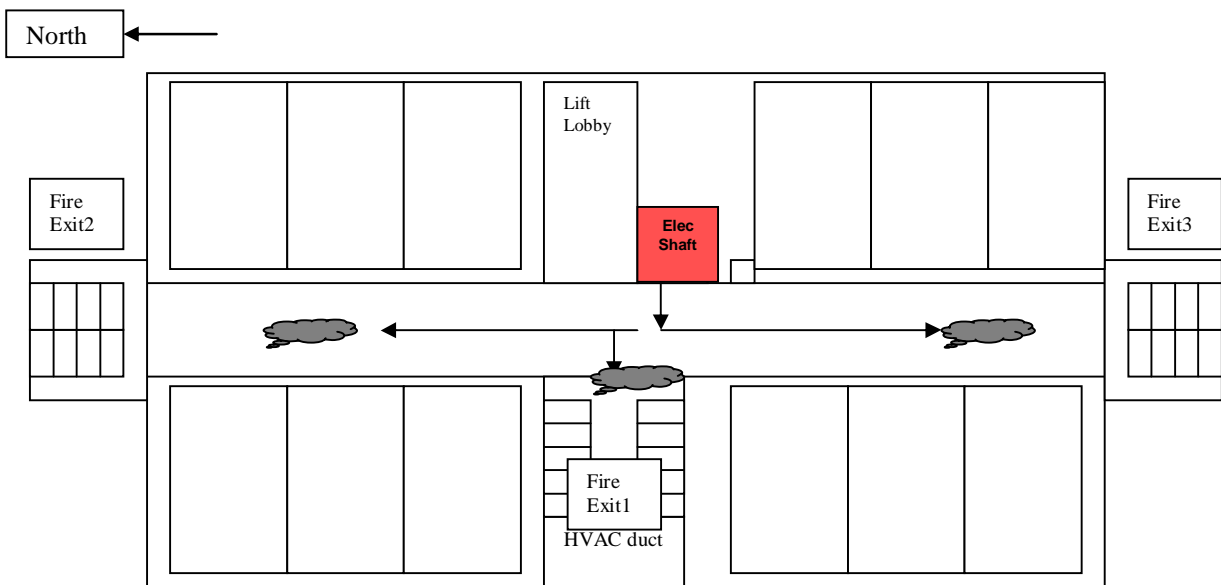
FIRST FLOOR – Fire Exit number 2 and 3 were locked at ground floor.

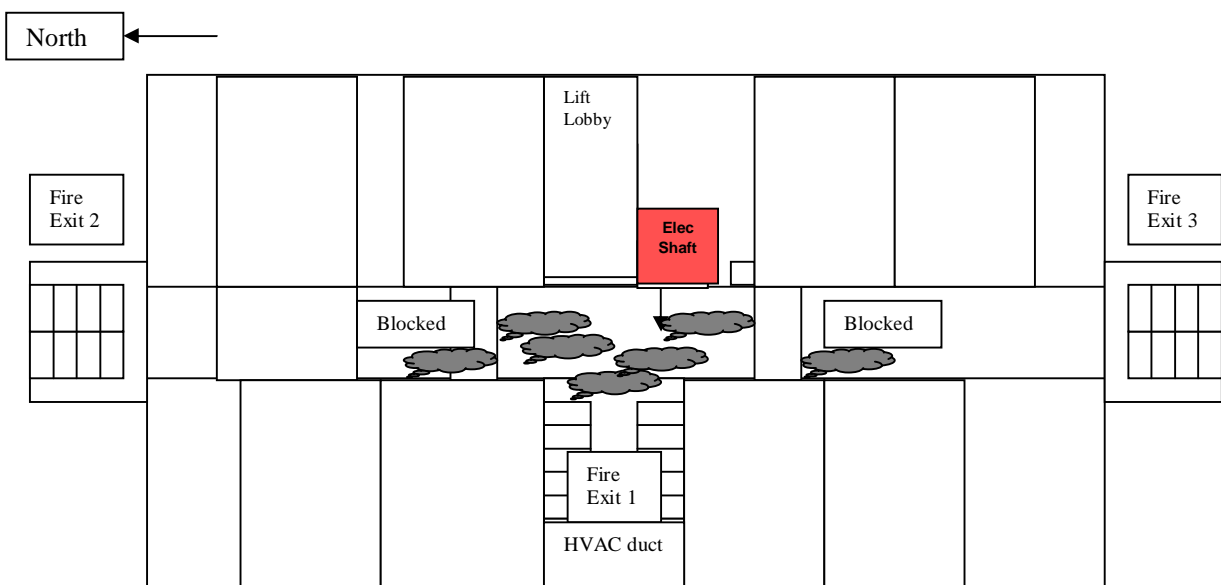
SECOND, THIRD AND FOURTH FLOORS – Two fire exits were blocked due to interior work.

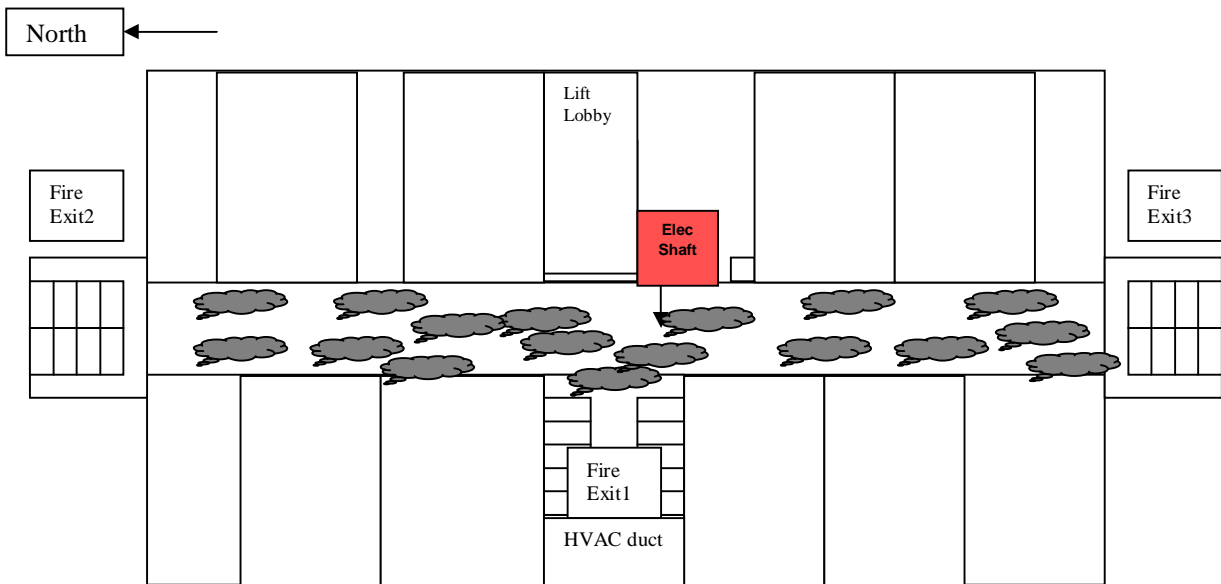
FIFTH & SIXTH FLOORS – Smoke traveled in lobby as well as staircase. The occupants above fifth floor were left with only one Fire exit number 1 to escape, which was full of smoke.

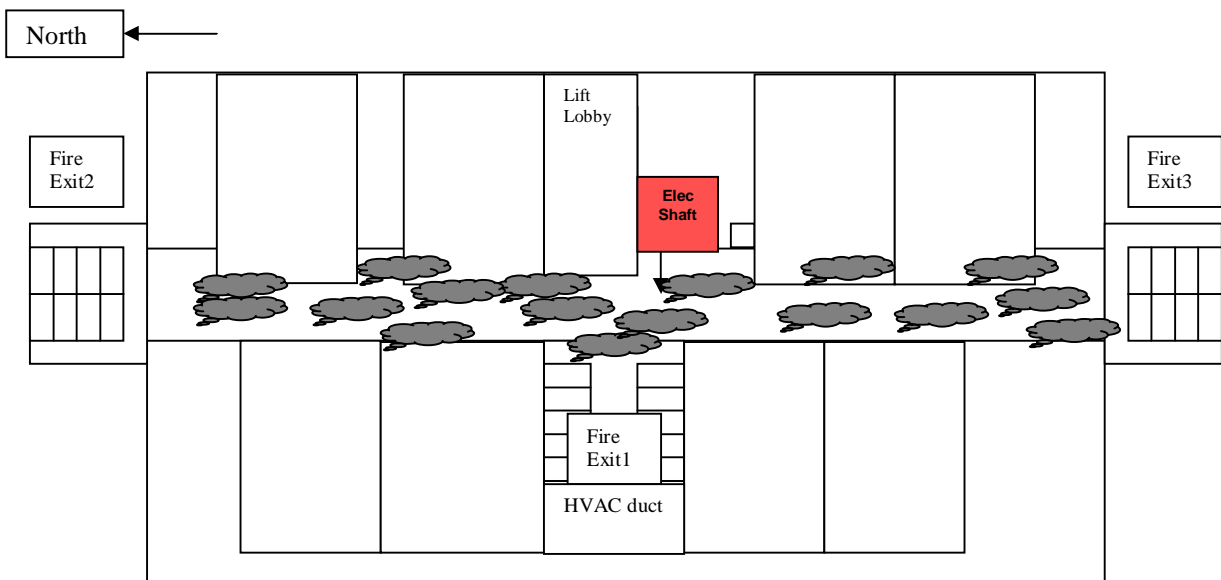
SEVENTH FLOOR – Smoke traveled in lobby as well as staircase. The occupants were left with only one Fire exit number 1 to escape, which was full of smoke. Access to terrace locked. Fire Service Staff had to break terrace door after reaching the seventh floor from fire exit 3.
