ADOPT A LAKE SCHEME

LAKES LEASED

Independent Report On Status of Lakes in Bangalore
Under Lake Development Authority

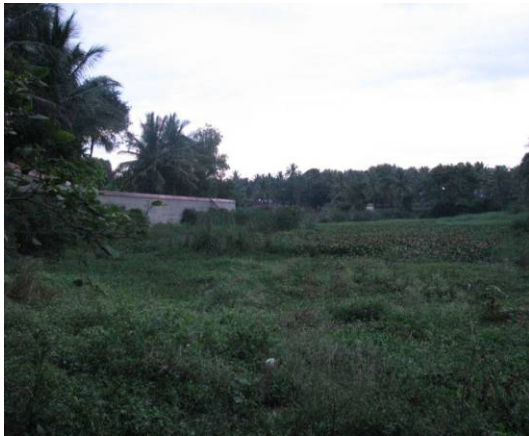
The lake is extensively eutrophicated, and there is discharge of sewage into the lake from the south and western shores of the lake. One cannot see the sewage effluent pipe and the sewage being discharged because of the presence of wild vegetation, but one can clearly detect the presence of sewage because of its distinct smell. There is not much water in the lake and the little water that is left is black.

The area around the lake has a very foul smell. It is almost impossible to approach the lake as it is bounded on the north and east by temple property and the south and west are blocked by excessive overgrowth of vegetation. There is also dumping of garbage at the south and west bank of the lake.

Picture 1a: Temple wall abutting the lake and extensive growth of wild vegetation.

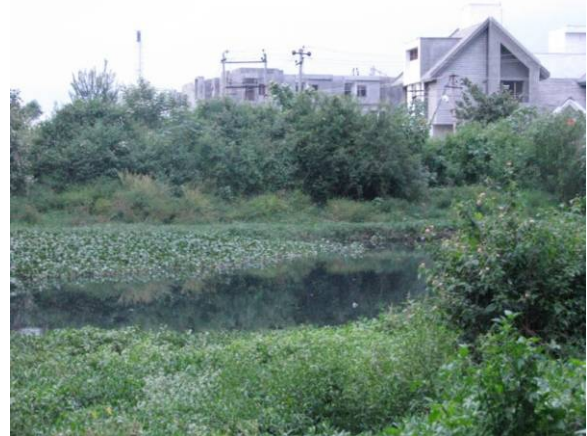
Picture 1c: The lake water is black and foul smelling

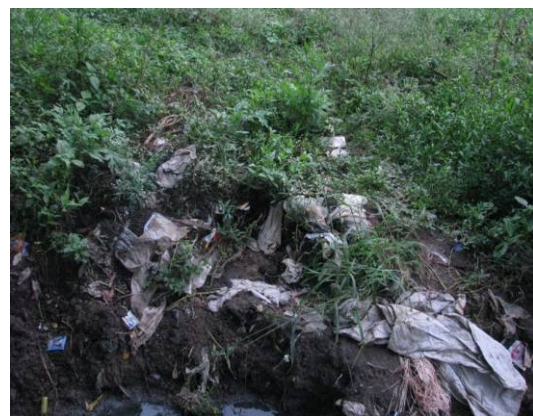
Picture 1b: Solid waste dumped along the south and west bank of lake

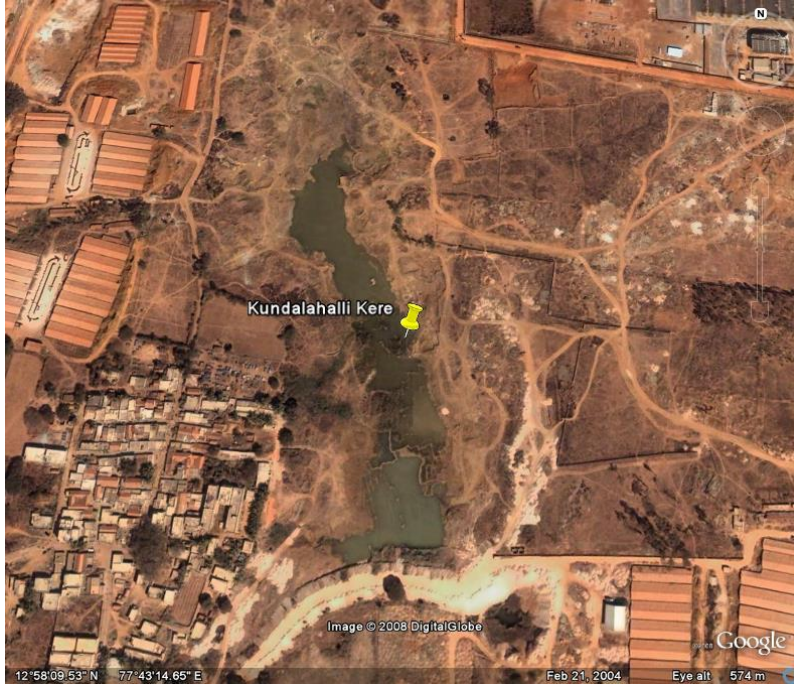
Google Earth Image of Kundalahalli Lake⁵

The lake water is murky, and the survey team noticed pieces of thermocol floating in the lake. The approach road adjoins the southern bank of the lake. Along the east bank, there is a significant amount of anchored vegetation. About 100 metres from the east bank, construction activities were being carried out. On the west bank, there was a small heap of rubble and a bore well from which water was being pumped out. Two electric towers can be seen standing in the lake, and they carry high voltage electric wires.

The survey team observed an outer & inner concrete wall, separated by a fence, on the northern bank. There was a small Basava Mantapa adjoining the lake, and some grass and other shoreline vegetation. The lake is extensively used for grazing cattle.

The fence along the south-eastern & eastern banks is broken in some places. There has been an attempt to develop a garden along the eastern bank, but this seems to have been abandoned, as the garden is overgrown and unkempt.

The survey team observed that the workers on the construction sites use the lake for bathing, swimming and washing clothes. At the south end, the survey team noticed fishing nets and a coracle, so it was evident that the lake is also used for fishing.

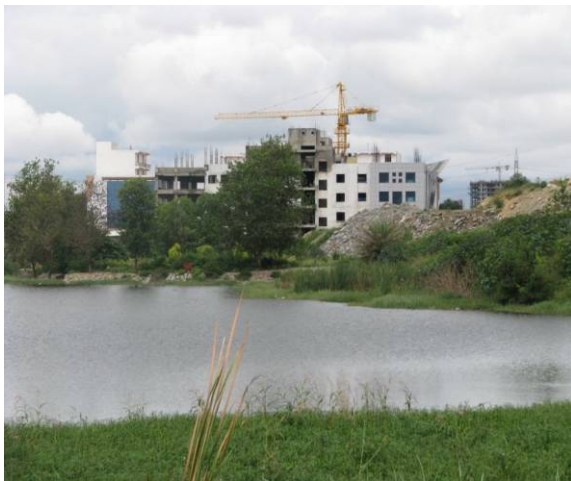
Picture 2a: Construction work being carried out near the east bank of the lake.

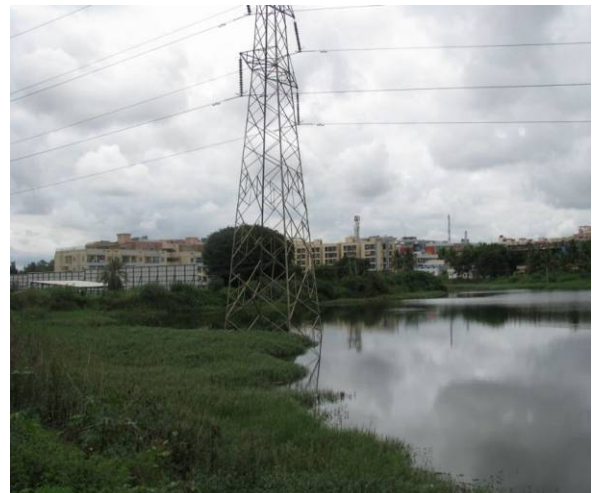
Picture 2b: One of the two electric towers erected on the lake.

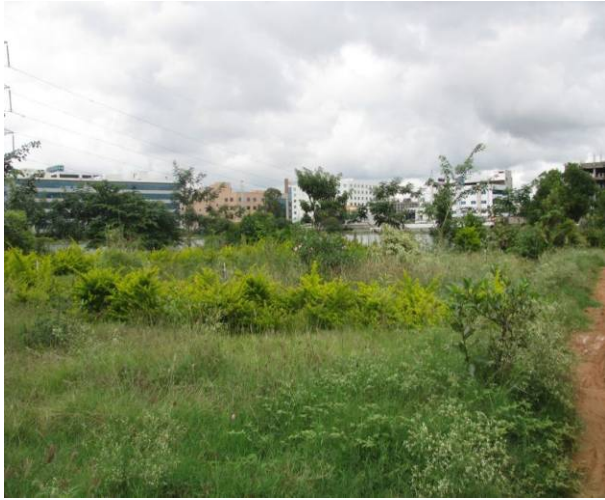
Picture 2c: Attempts along the east bank to develop a garden which has later been abandoned.

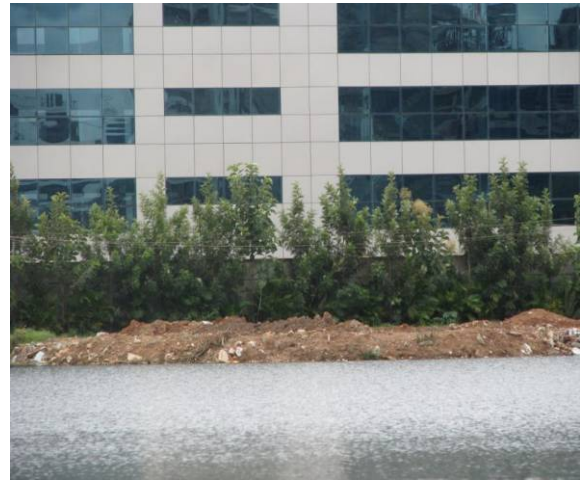
Picture 2e: Thermocol pieces drifting on the lake surface.

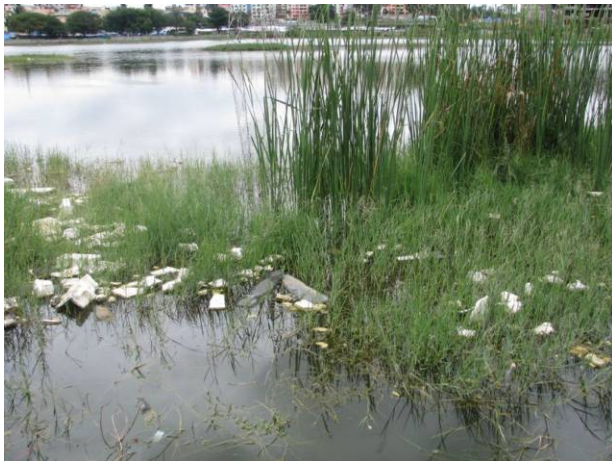
Picture 2d: Rubble dumped along the west bank.

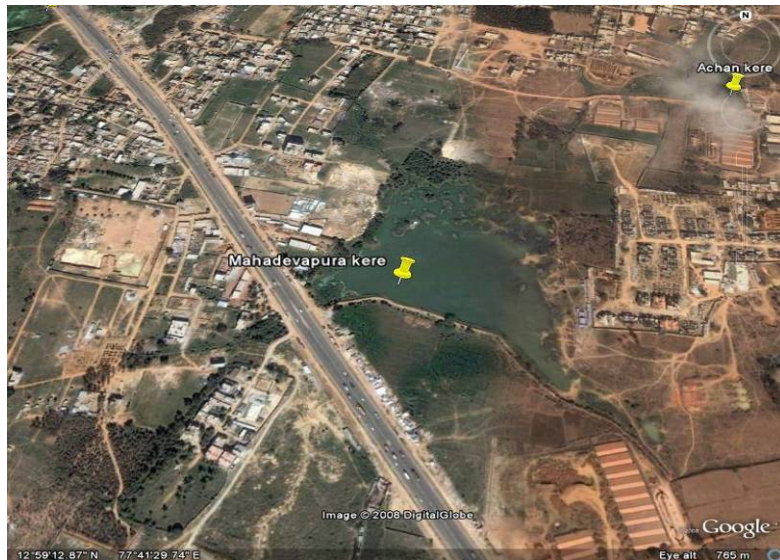
Google Earth Image of Mahadevapura Lake⁹

The water is murky, and there is excessive growth of aquatic vegetation at the north of the lake. Shoreline vegetation is present all along the bund located on the eastward side. A compound wall

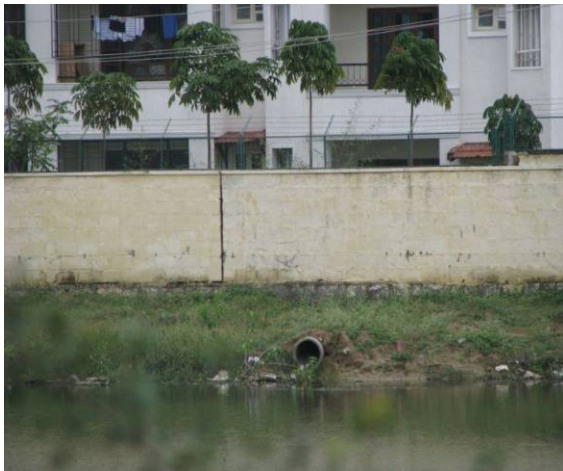
of a residential layout has been built adjoining the north bank, and an outlet pipe from the layout can be seen. While the team was carrying on the survey, there was no discharge from the pipe but enquiries posed to the fishermen revealed that there is occasional discharge of sewage from the pipe. On the west bank and along the achkat, there is construction work in progress. The survey team also noticed mud being dumped along this bank. The lake boundary has not been fenced.

Picture 3a: Outlet pipe at the north bank that occasionally discharges sewage

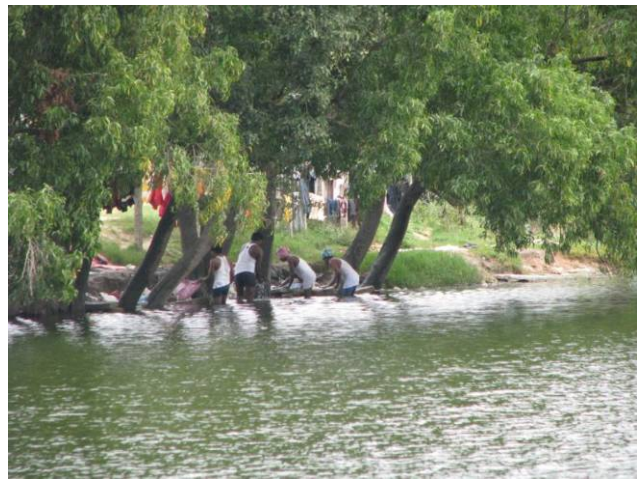
Fishing is carried out; even though the fishermen themselves acknowledge that the water is polluted. The survey team also noticed people washing clothes in the lake. Enquiries revealed that usually people wash clothes first at the lake, and then dip them slightly in tap water, to get rid of the smell.

Picture 3b: Local people washing clothes along the south bank

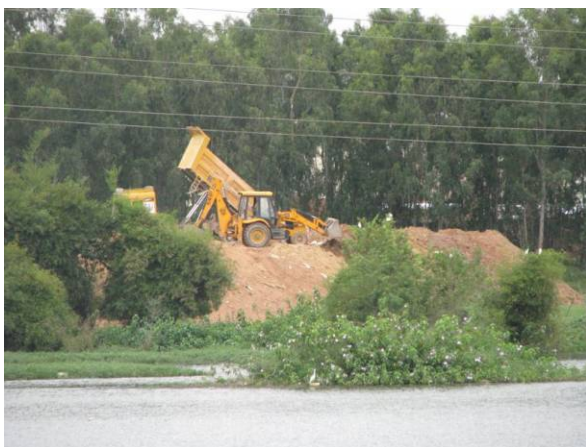
Picture 3c: Mud being dumped along the west bank

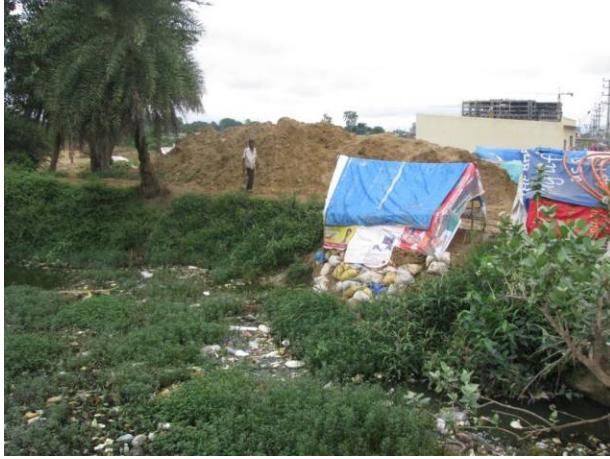
Picture 3e: Garbage dumped along the south east bank.

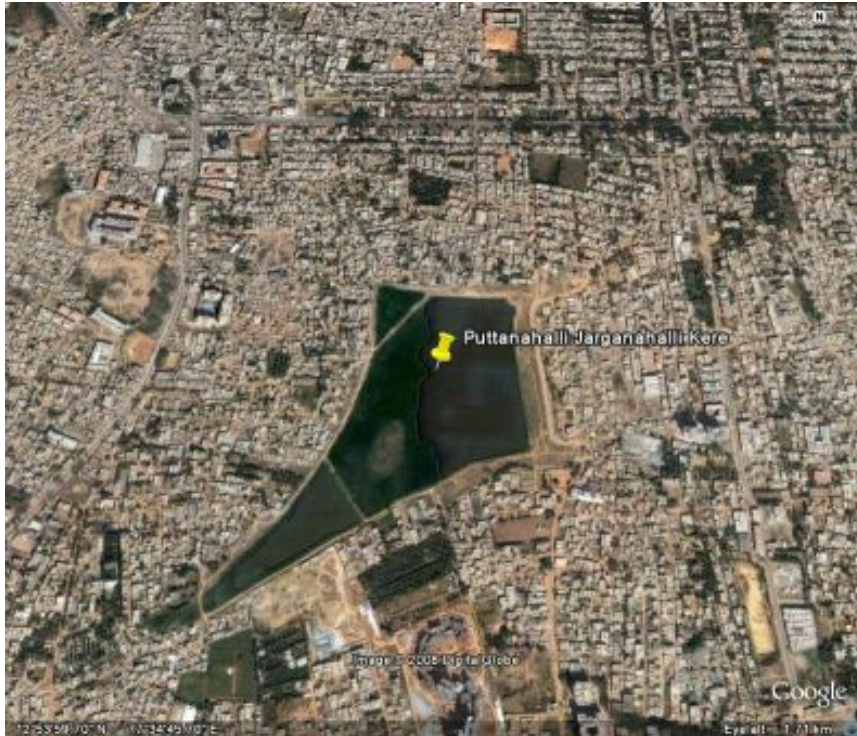
Google Earth Image of Puttanahalli Jagarahalli Lake¹³

The water present is muddy and murky, but there is excessive growth of aquatic vegetation and the waters are eutrophicated. Both floating and anchored floating vegetation was observed.

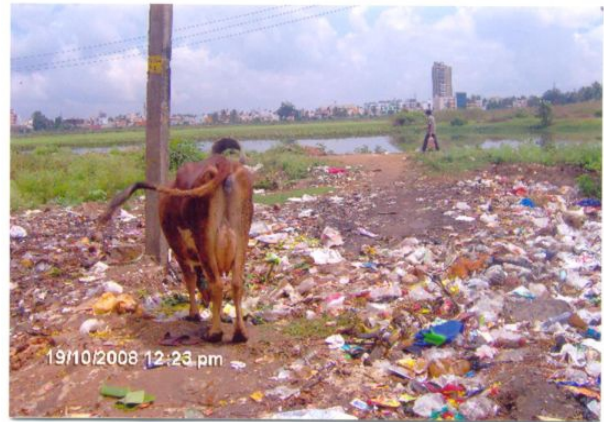
The lake has been desilted & fenced by the LDA in 2005, and the west bank has been partially bunded. However, there is dumping of solid waste (including industrial waste) along the shore and part of the lake has been reclaimed for construction. On the Puttanahalli side, housing and industrial layouts have mushroomed, and sewage inflow poses a threat to the lake.

Picture 4b: Solid waste being dumped on the west bank (Jarganahalli); The lake is extensively eutrophicated.

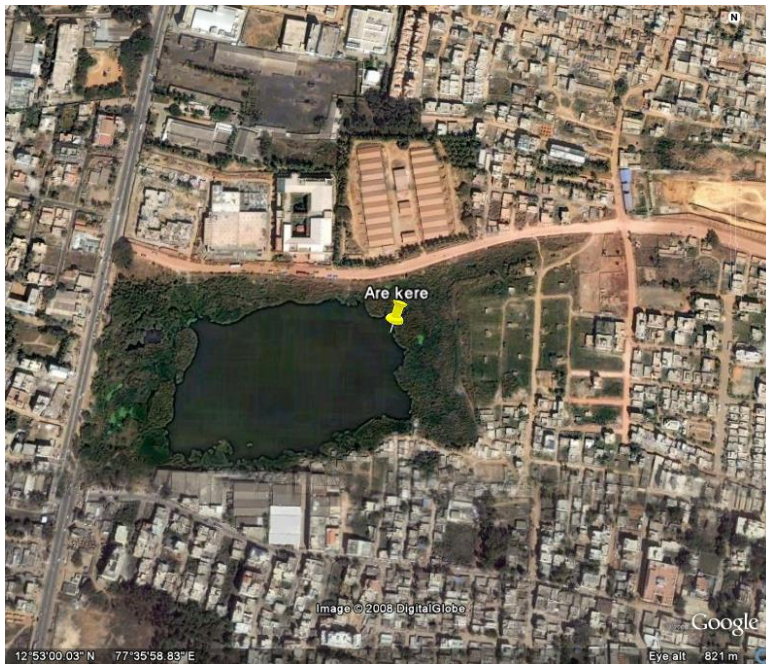
Google Earth Image of Arakere¹⁵

Arakere Lake abuts Banerghatta Road, between Arakere and Hulimavu villages. It is a medium sized lake with an area of 15.16 hectares.¹⁶ This lake is proposed to be developed under the EOI scheme of the Lake Development Authority.¹⁷

Enquiries revealed that fishing, bathing and other uses have been abandoned because of excessive sewage inflow and the subsequent deterioration of the lake.

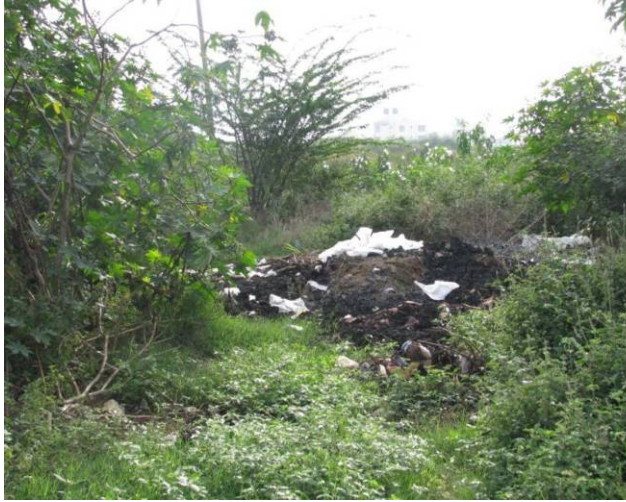
Picture 5a: Incinerated waste being dumped on the lake bank.

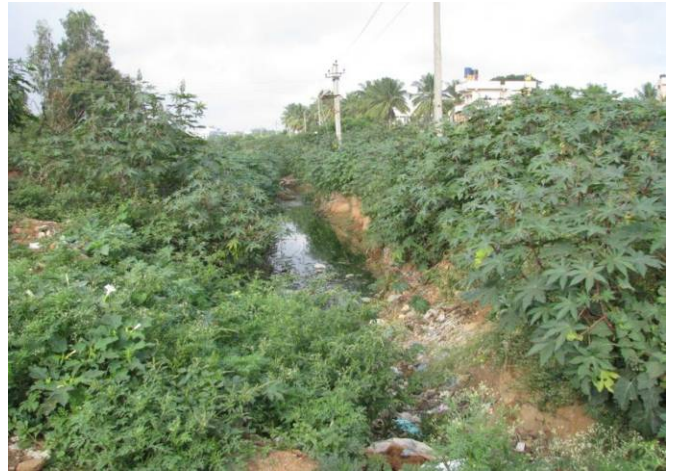
Picture 5b: Lake Water is murky. Fishing has been abandoned because of sewage inflow into the lake.

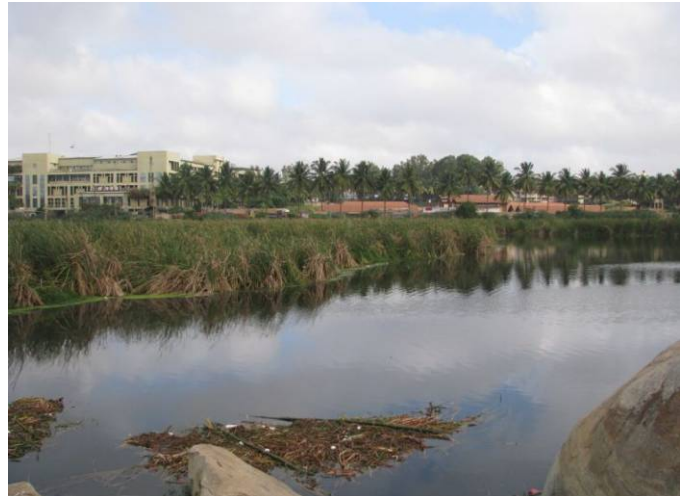
Picture 5c: Sewage discharge along the shore.

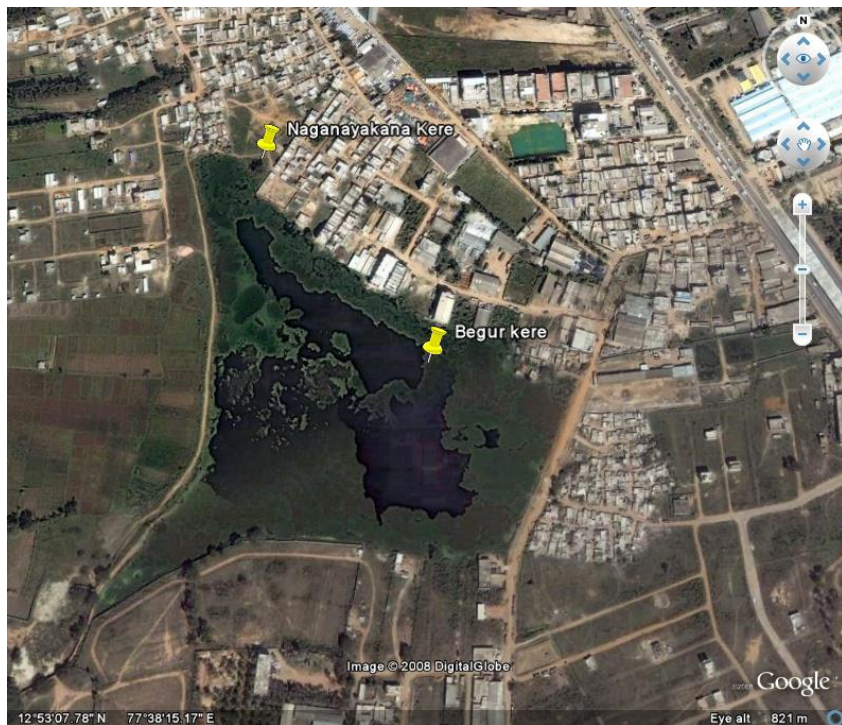
Google Earth Image of Begur Lake¹⁸

The lake is located towards east of Begur and west of Hosur road. It is a medium size lake, extending up to 36.69 hectares in area.¹⁹ The lake is proposed to be developed under the EOI scheme of the LDA.²⁰

The water appears slightly clear. The survey team observed that the water is used for bathing, washing clothes and fishing. The road adjoins the west bank of the lake. The north and east banks are heavily built up. The survey team observed construction being carried on at the southwest end of the lake. Enquiries revealed that sewage flowed into the lake, along the north bank.

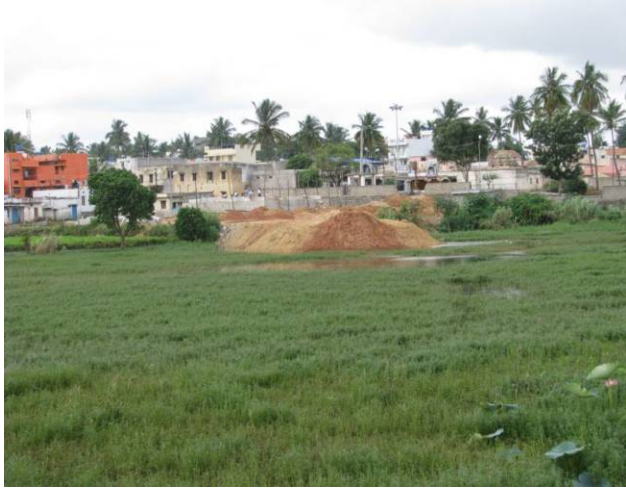
Picture 6a: Construction activities being carried out at south west bank of the lake.

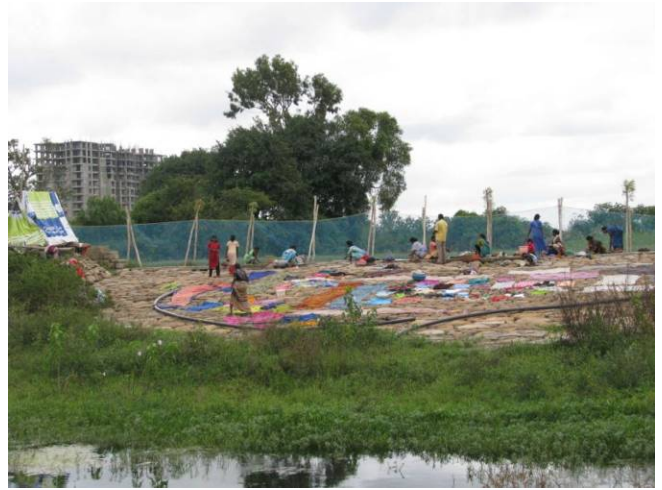
Picture 6b: Local people washing clothes at the lake

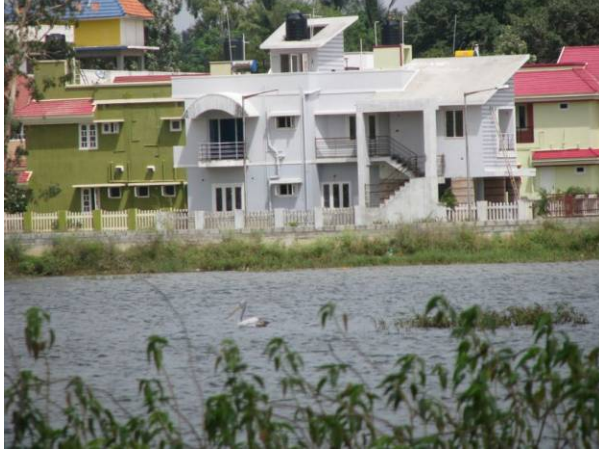
On the north bank of the lake, the survey team noticed that buildings have been constructed right up to the shoreline, and there was even a mud road leading right up to the lake. The east and west banks are also built up, but the south bank is relatively free from construction. However, the local people told us that even here; a BDA layout was being planned!

Picture 7a: Construction along the north bank of the lake upto the shoreline.

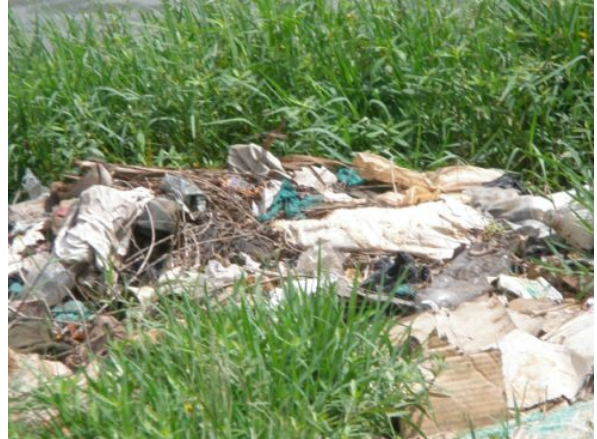
Picture 7b: Waste being dumped along the shore

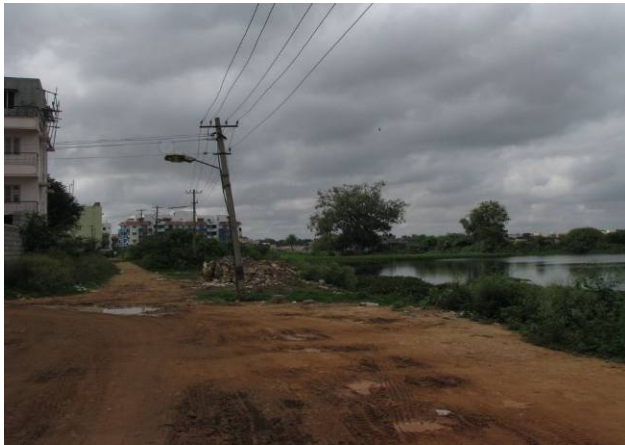
Houses are present on the north east end of the lake within approximately 50m. The layout that has been developed within the past 10 years since the real estate boom happened in Bangalore.

Picture 8a: Construction of residential houses within 50m of Lake periphery on the Northeast end.

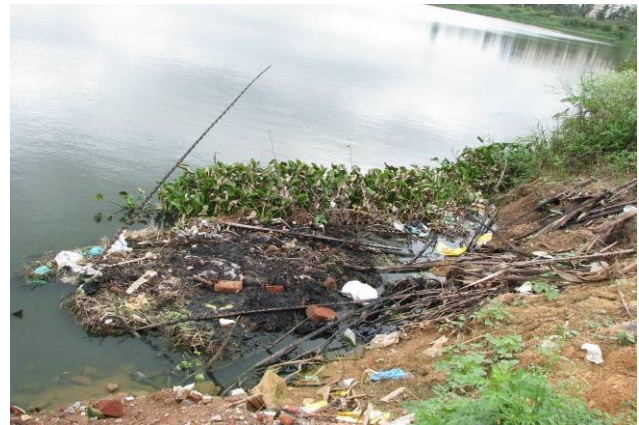
Prior to that there were Paddy fields in the area. The houses do not come under BDA or any Panchayat and the untreated sewage from these houses is disposed into the north east corner of the lake.

Picture 8b: Sewage being let into the lake

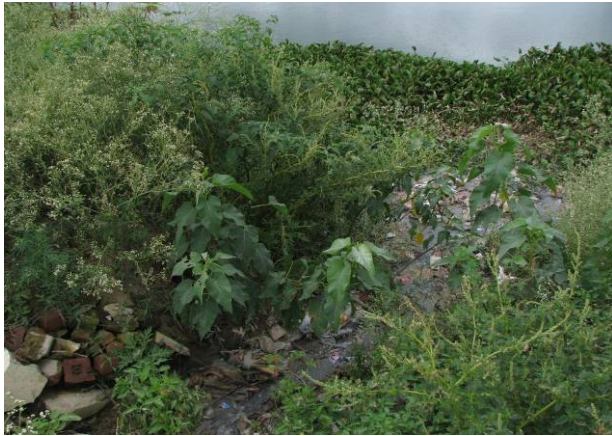
Garbage is also being dumped at the bank close to the area where sewage is disposed, some of which also enters the water body and can be seen floating on the lake water. Some people also use the lake water for washing clothes. The residents of the area use bore well water for drinking purposes and have commented on a definite change in the taste of water over the years. The residents also commented on an increase in outbreaks of Chikun Gunya in the region.

Picture 8c: Garbage dumped in the lake.

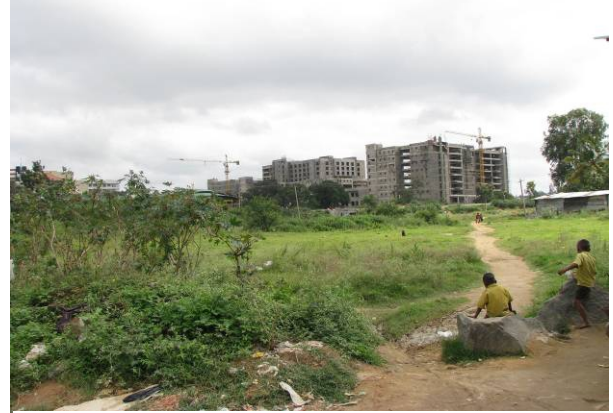
There are huge buildings that are coming up at 250m from the north east bank of the lake. The labour working on construction of these buildings also lives at this end and the water used by them for bathing and other domestic purposes is also being discharged into the lake. All this has resulted in muddy grey water in the lake water around where the sewage, garbage, and other domestic waste are being discharged. It is just a matter of time before the whole lake becomes muddy grey water floating with garbage waste, making it aesthetically intolerant and subsequently slowly causing it to become eutrophic in nature.

Picture 8d: Construction of huge building 250 m from lake periphery

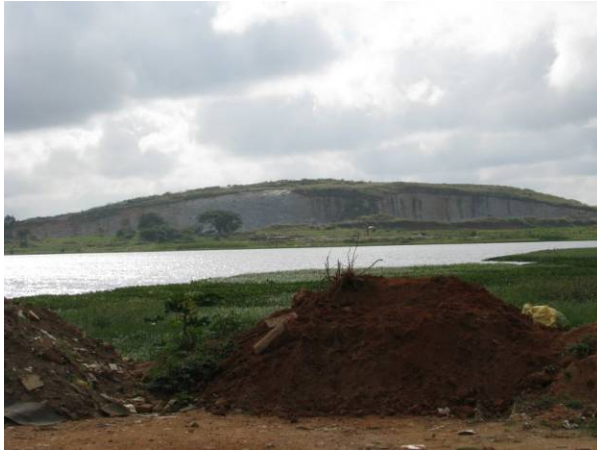
Picture 9a: Mud dumped along the west bank.

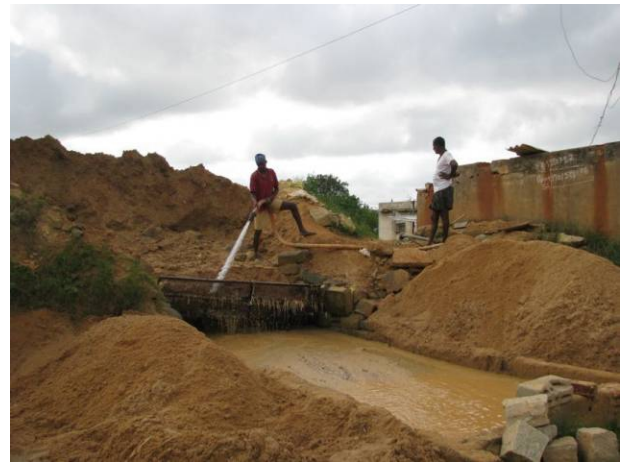
Though the water appeared somewhat clear, enquiries to local residents revealed that sewage is being dumped into the lake from the residential layouts. Because of sewage contamination, there is no fishing. The villagers from Hulimavu have stopped washing clothes, bathing or swimming in the lake as the water is contaminated. Mudlifting from the tank bed has become rampant, and this has altered the depth of the lake, according to local residents.

Picture 9b: Sand being segregated by jet stream processing with soil lifted from the lake bed.

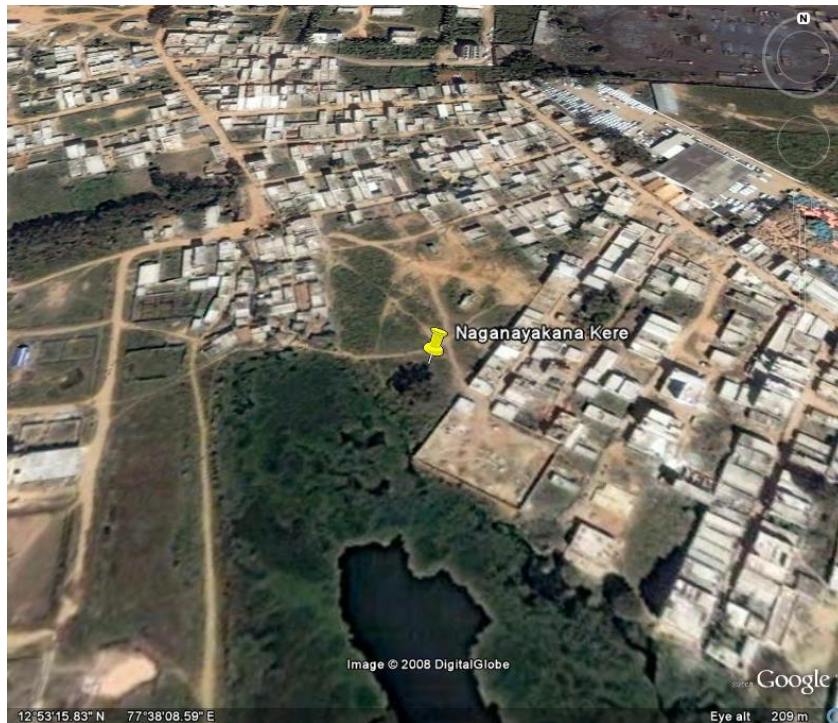
Google Earth Image of Naganaikana Lake²⁹

This lake is located near Begur village, Bommanahalli, Hosur Road. It is a medium sized lake, extending to 42.16 hectares, located in Sy. No. 168 of Begur & Sy. No. 86 of Singasandra³⁰. *Locally, it is known as Singasandra Kere (not to be confused with the Singasandra Lake on Hosur Road). The lake that the residents used to refer to as Naganayakanahalli Kere, has been built over, according to them.* Therefore, it may be assumed that only one of the two lakes are now present. Naganaikana lake has been proposed for development, under the Expression of Interest Scheme of the LDA.³¹

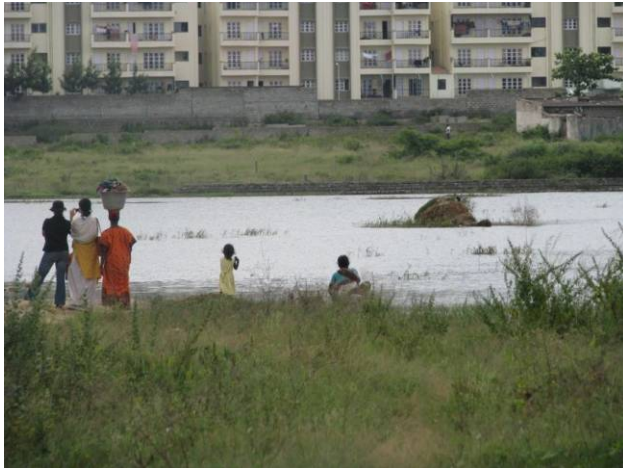
The north bank of the lake is separated from the road by about 250 metres, but the residents told us that the land in between was being converted into BDA sites. The South and East banks are heavily built up, with buildings extending right up to the lake. Sewage contamination and encroachments pose a major threat to the lake.

Picture 10a: Buildings extending right upto the lake along the south bank.

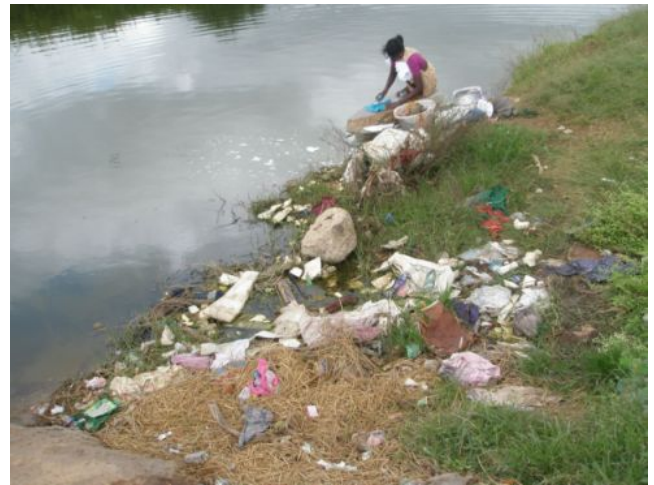
Though water is present in the lake, it is murky and not used for drinking. When the survey team visited the lake, the water gave a foul stench. In spite of this, local residents use the water for washing clothes. This is because the village borewell has dried up, and residents have to purchase water for Rs1/ per pot for their daily use. This means they cannot spend too much water for washing clothes, and are forced to use the lake water for economic reasons. There is fishing, but

Picture 10b: Local villager washing clothes in the lake though water is foul smelling and solid waste is dumped along the bank.

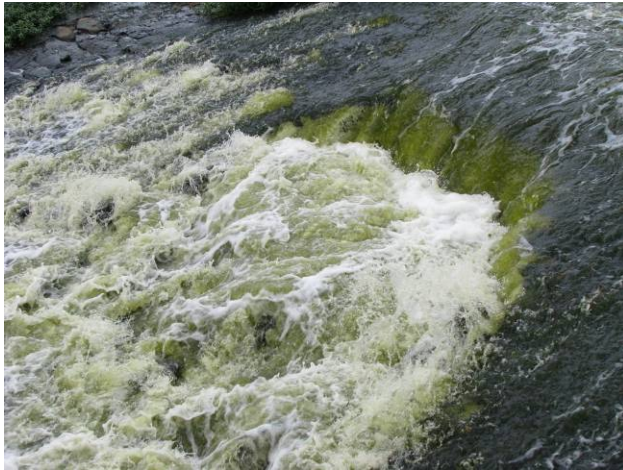
At the south end of the lake there is a bund via which water flows in a channel towards the farms; east of the road. These waters are frothy, are green in colour and emit a nauseating smell.

Picture 11a: Water flowing from the lake is greenish.

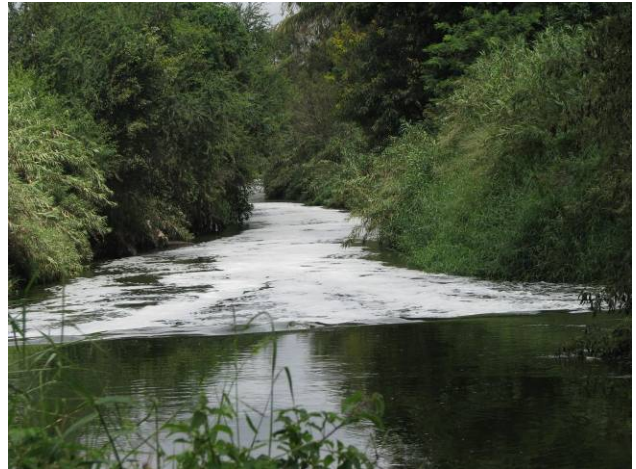
The water is eutrophicated and foamy in nature with a distinct nauseating smell which seemed more as a result of discharge of industrial effluent rather than normal sewage. A road runs east of the lake wherein there is continuous movement of traffic. Bird life is sparse and aquatic vegetation abounds the lake, probably due to the high intake of untreated sewage. There are also some patches of algal blooms in certain pockets of the lake.

Picture 11b: Froth seen in backwater channels of Varthur lake

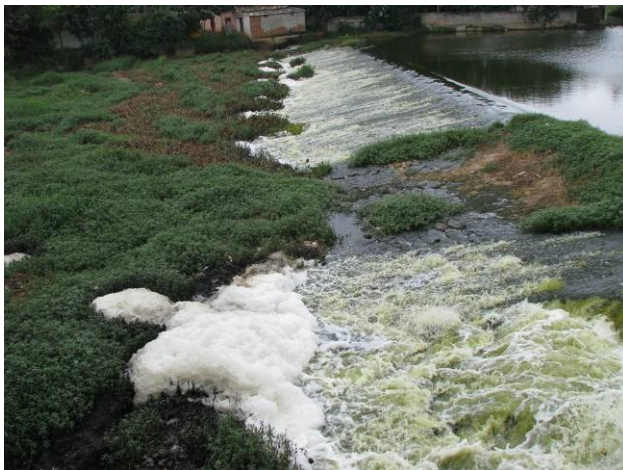
Picture 11c: Froth can be clearly observed where water falls from the lake bund

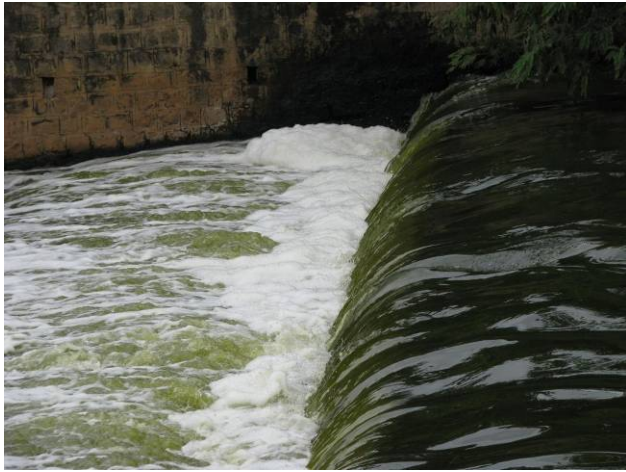
Picture 11d: Froth seen more clearly in the backwaters of Varthur Lake where there was a slight fall.

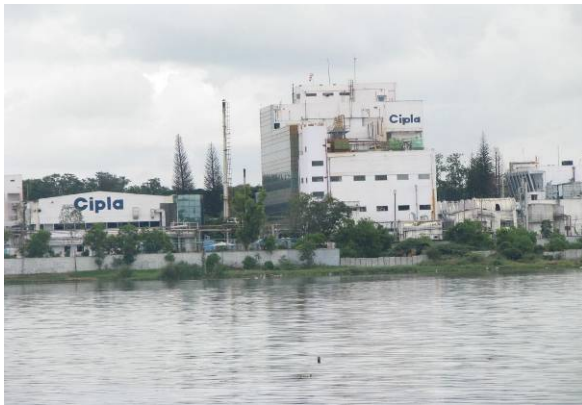
Complaints have been made to government authorities about problems being faced by them due to the disposal of sewage, but no action has been taken till date. Cipla is one of the companies located at the east bank of the lake. This company used to discharge effluents into the lake, but this has been stopped after complaints were made against them by the fishermen of the area.

Picture 12c: The company, Cipla at the periphery of the lake.
