Comprehensive Assessment of Thippagondanahalli Reservoir Catchment Area and its Preservation Zone

Volume-II
(Writ Petitions)

Center for Lake Conservation (CLC)
Environmental Management and Policy Research Institute (EMPRI)

August, 2015

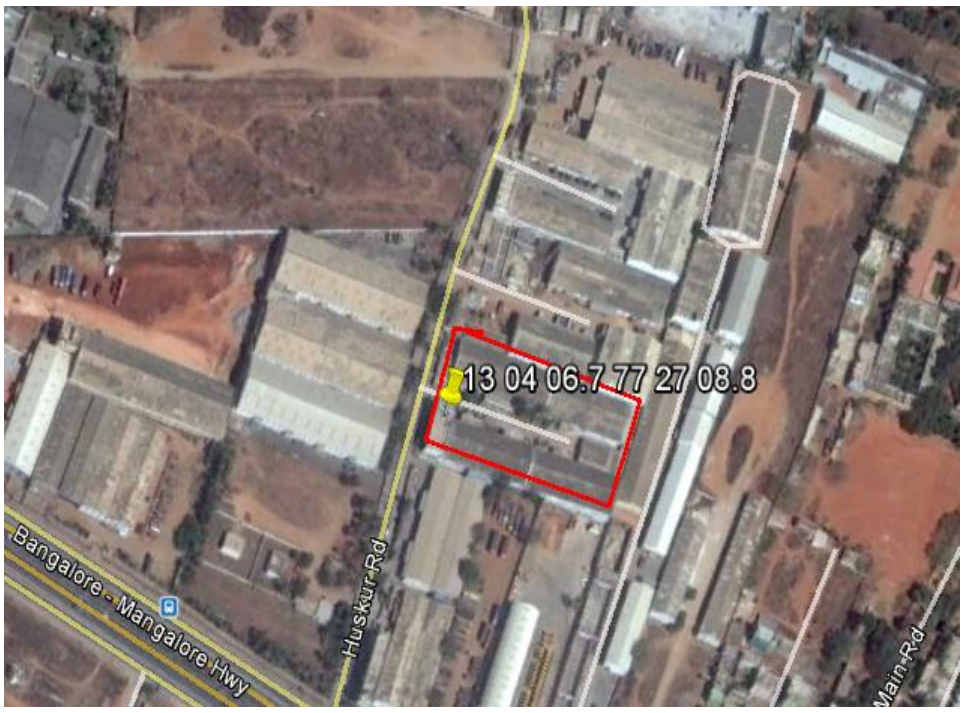
11.4.1.4. Writ Petition No. 38483/2013: In the Survey No. 6 of an extent of 6 Acres, four godowns (Figure-11.7) has been constructed in the year 2001-02. In this survey number along with godowns four shops were found which have been rented out. Out of four godowns two godowns are rented out and remaining two are vacant. It was also found that one of the godowns been partitioned and rented out to two companies i.e. M/s. Reliance Communication and M/s. Franke Faber (I) Pvt. Ltd. Currently the godowns were stored with mobile accessories, kitchen cookware and electronic goods. Further, it was found that two godowns are vacant. Overall 40 employees are working in these companies. One borewell was found in this survey number which is the main source of water. Further it was found that daily 1500 lts of water is being utilized and subsequently, the waste water is being discharged into septic tank.

Figure-11.7: Location of WP superstructure in Google Earth image-2014

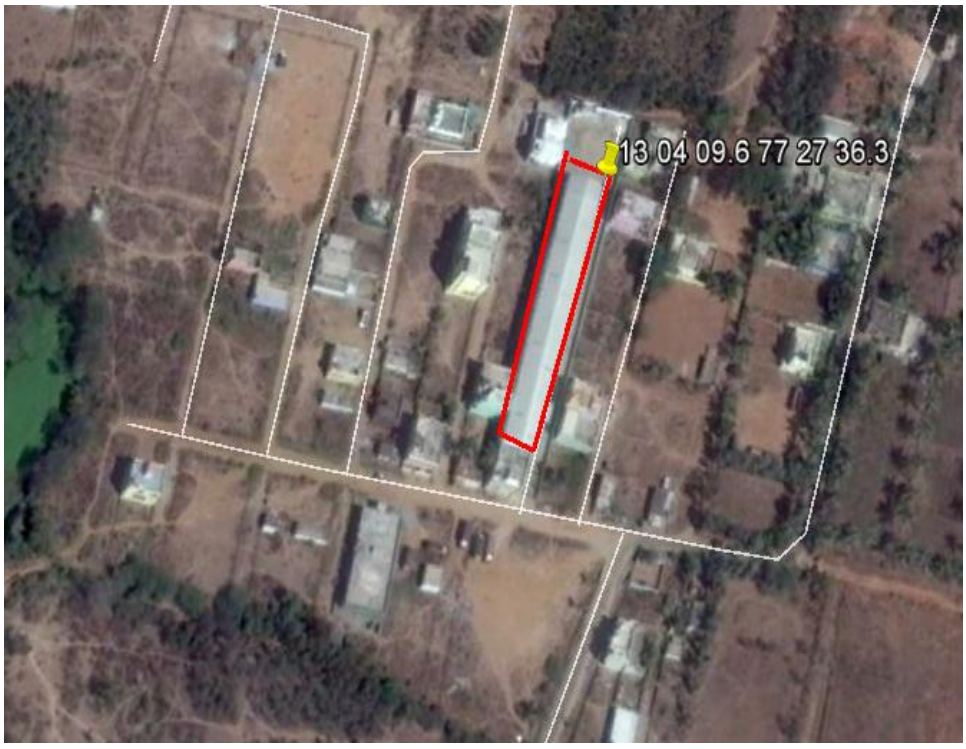
Figure-11.28: Location of WP superstructure in Google Earth image-2014

11.4.2.8. Writ Petition No. 40508/2013: In the Survey No. 12/7, 1, 7B of an extent of 36 Guntas, one godown (Figure-11.28) has been constructed in the year 2007. During the survey it was found that the godown is rented out to the company i.e. M/s. Arpitha Agencies and presently cello company products were stored in the godown. Further one borewell was observed in this survey number, which is in non-working condition.

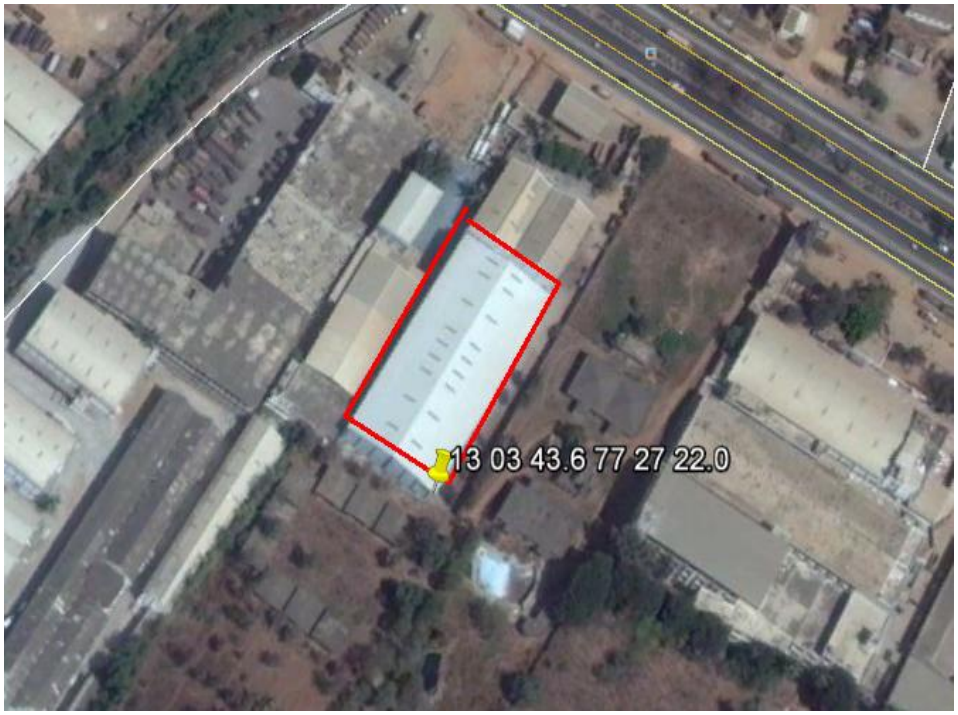
Figure-11.31: Location of WP superstructure in Google Earth image-2014

11.4.2.11. Writ Petition No. 38218/2013: In the Survey No. 52/3of an extent of 2.1 Acres, four godown (Figure-11.31) have been constructed in the year 1970 and 2004 (three godowns). These godowns are rented out to the companies i.e. M/s. Navneeth Publications, M/s. Fusion Chapels, and M/s. Plaster Construction Technology (I) Ltd. Presently, these godowns are stored with furnitures, construction materials, books, and chapels. It was also found that overall 20 employees were working in these godowns.

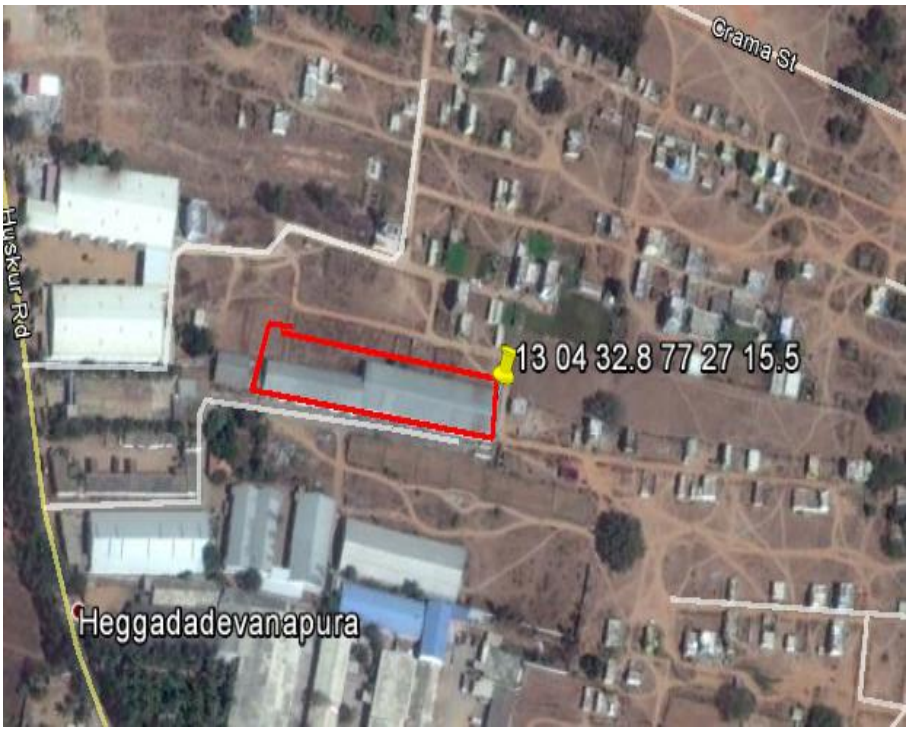
Figure-11.36: Location of WP superstructure in Google Earth image-2014

11.4.3.4. Writ Petition No. 38698/2013: In the Survey No. 72/1of an extent of 1.37 Acres, two godowns (Figure-11.36) were found. Presently theses godowns are vacant and it was found that earlier it was rented to some company. After the issue of closure notice from BDA the godown has been closed.

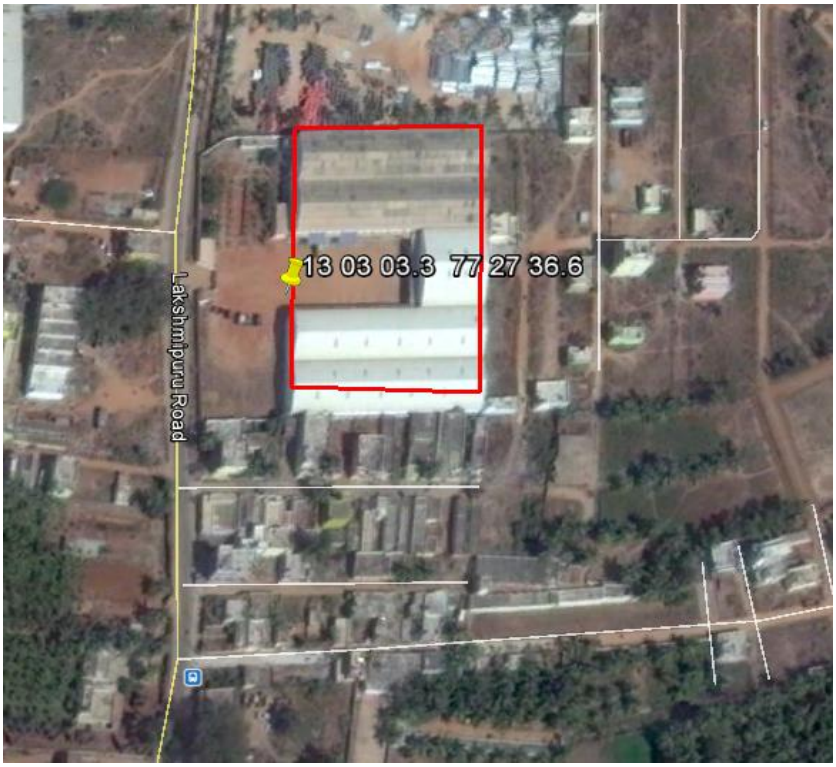
Figure-11.60: Location of WP superstructure in Google Earth image-2014

11.4.7.2. Writ Petition No. 38501/2013: In the Survey No. 24/2 of an extent of 8.1 Acres, two godowns (Figure-11.60) have been constructed in the year 2006. The two godowns are rented out to the companies i.e. M/s. Meyer and M/s. Jyothi Laboratories Ltd. Presently these godowns are stored with pharmaceutical and detergents products. Overall 33 employees are working in these godowns. One borewell was found in this survey number which is the main source of water. The godown is having septic tank for the discharge of waste water and adoption of rainwater harvesting system was observed during the survey.

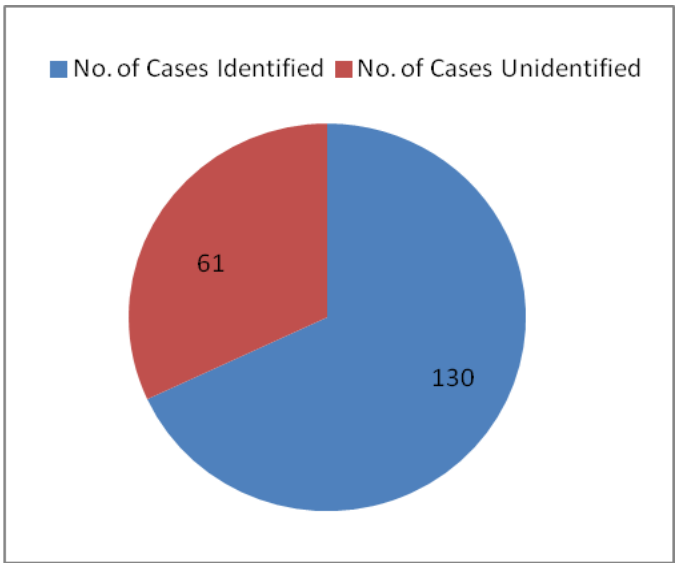
During the ground truth verification, out of 191 cases 130 residential houses were identified and remaining 61 houses could not be identified (Figure-12.6). Pertaining to the unidentified residential houses, while interacting with the local people it was found that few owners sold their houses, few owners rented out their houses and relocated to Bengaluru and also it was found that few owners have passed away.

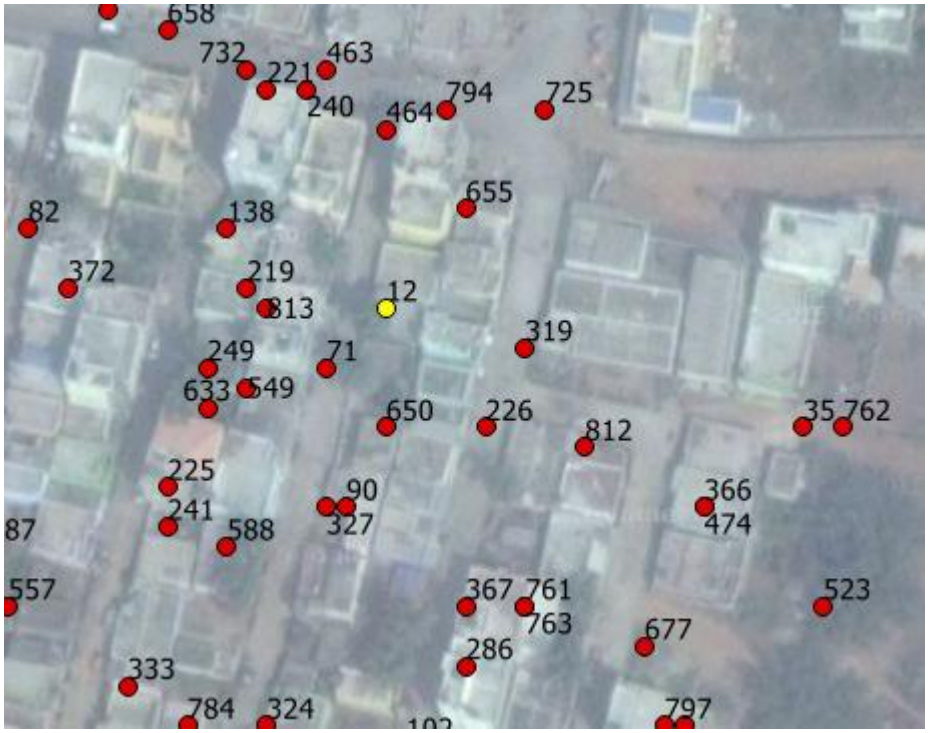
Petitioner No. 12	
Residential Building

Remarks: During the ground truth verification it was found that G+1 building has been constructed. During the interaction with the petitioner it was found that the house was constructed in the year 1989 (Figure-12.8) in the site allotted by the Government under the Ashraya Yojane Scheme and presently four members are living in the house.

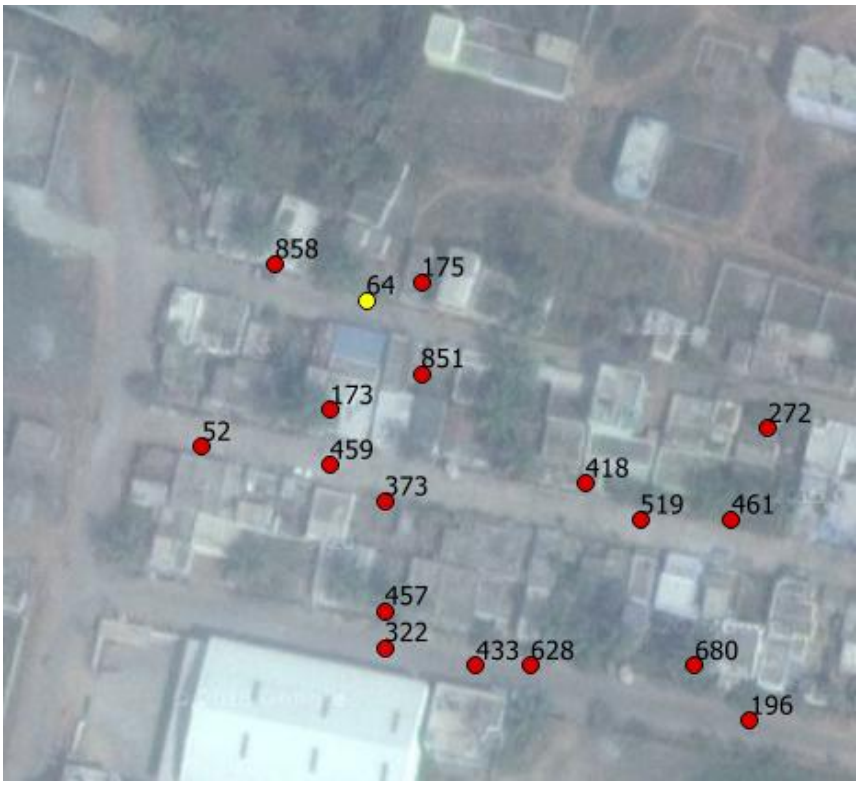
Petitioner No. 64	
Residential House

Remarks: During the ground truth verification it was found that single house has been constructed in the ground floor. During the interaction with the petitioner it was found that the house was constructed in the year 1998 (Figure-12.15) in the site allotted by the Government under the Ashraya Yojane Scheme and electricity supply has been provided under the Bhagya Jyothi Scheme. Presently two members are living in the house.

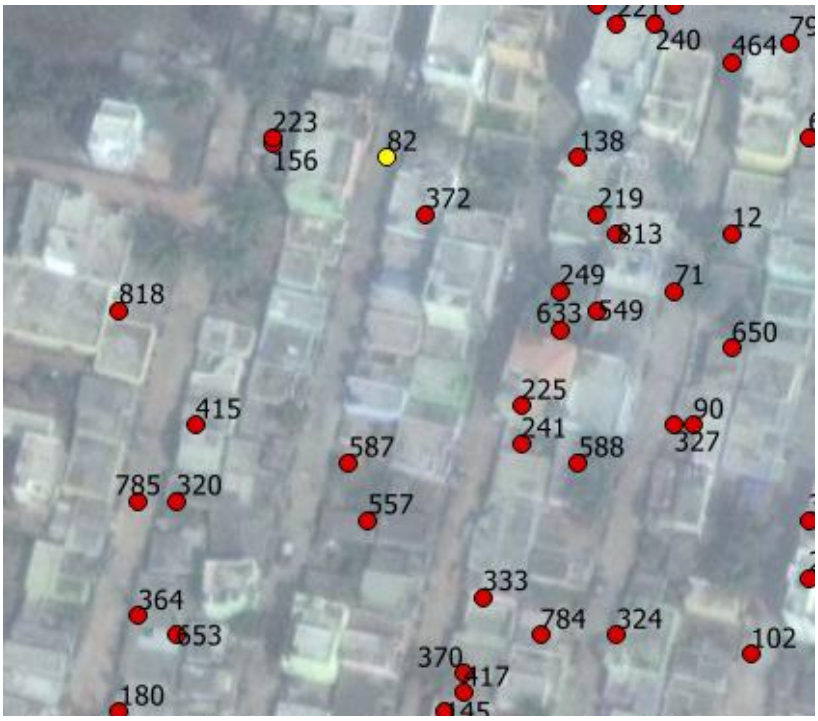
Petitioner No. 82	
Residential Building

Remarks: During the ground truth verification it was found that G+1 building has been constructed. During the interaction with the petitioner it was found that the old house was constructed in the year 1996 (Figure-12.17) which has been renovated in the year 2003. It was found that the house was constructed in the site allotted by the Government under the Ashraya Yojane Scheme and presently nine members are living in these houses.

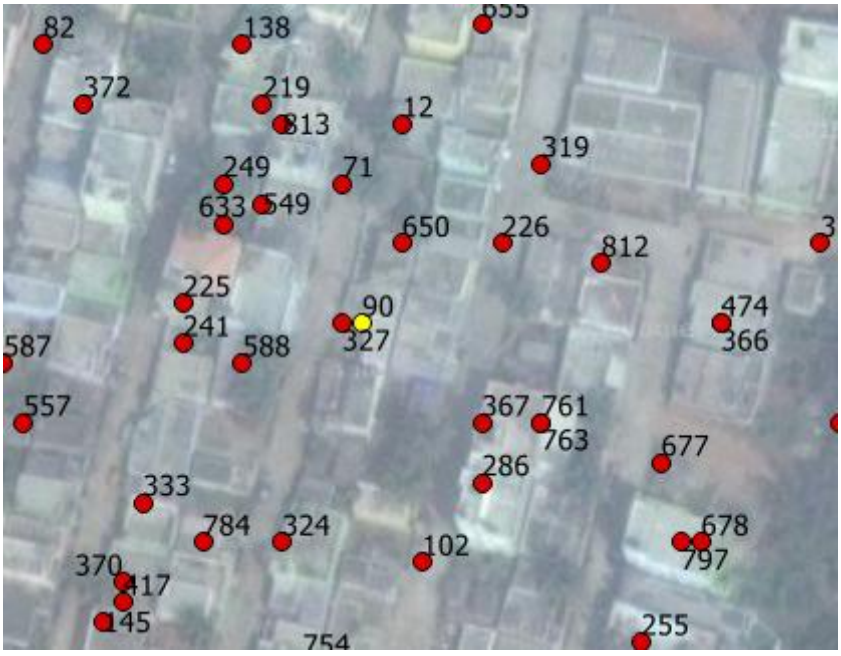
Petitioner No. 90 and 327	
Residential Building

Remarks: During the ground truth verification it was found that two petitions have been filed by the members of the same family and further it was found that G+1 building has been constructed. During the interaction with the petitioner it was found that the house was constructed in the year 2001 (Figure-12.18) in the site allotted by the Government under the Ashraya Yojane Scheme and presently six members are living in these houses.

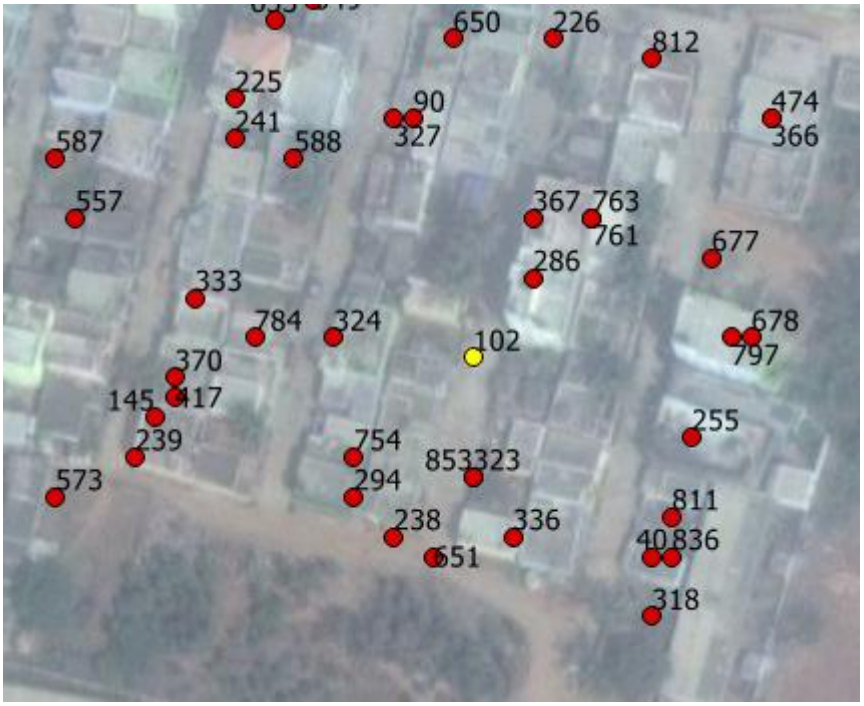
Petitioner No. 102	
Residential House

Remarks: During the ground truth verification it was found that three houses have been constructed in the ground floor. During the interaction with the petitioner it was found that the house was constructed in the year 2000 (Figure-12.20) in the site allotted by the Government under the Ashraya Yojane Scheme and presently eight members are living in these houses.

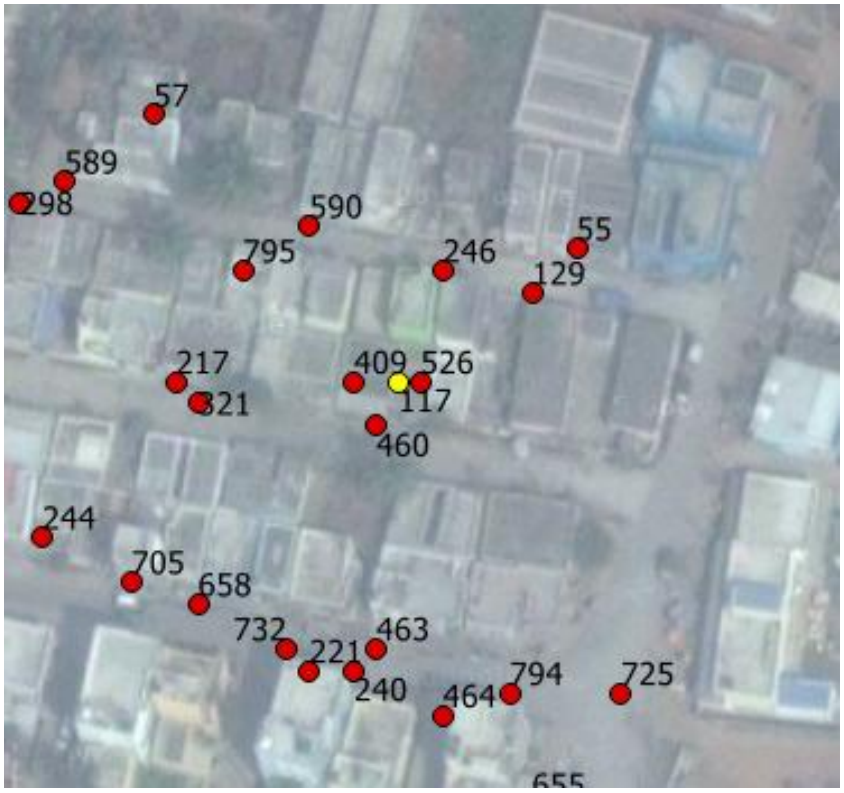
Petitioner No. 117	
Residential House

Remarks: During the ground truth verification it was found that single house has been constructed in the ground floor. During the interaction with the petitioner it was found that the house was constructed in the year 1987 (Figure-12.21) in the site allotted by the Government under the Ashraya Yojane Scheme and presently five members are living in this house.

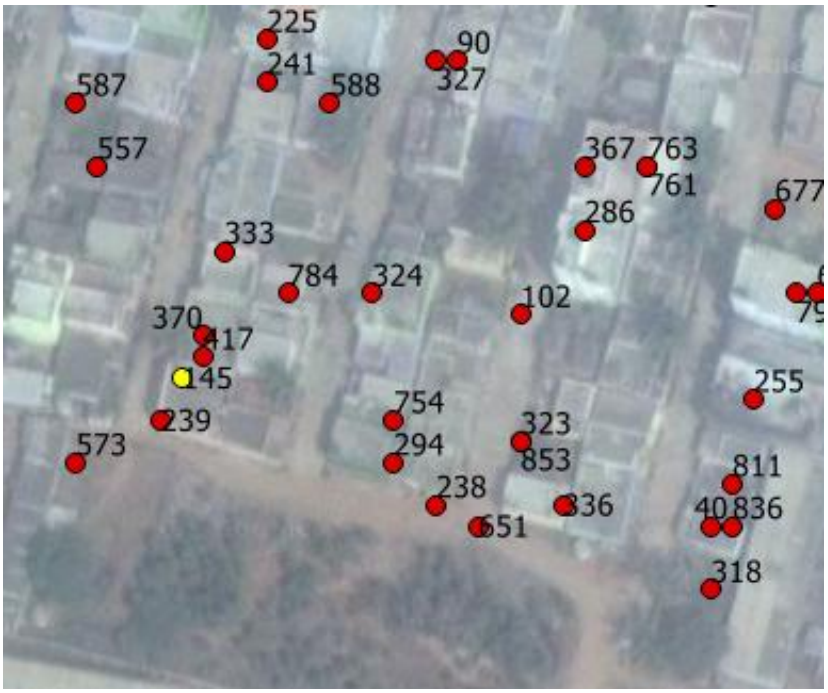
Petitioner No. 145	
Residential House

Remarks: During the ground truth verification it was found that single house has been constructed in the ground floor in the inherited land. During the interaction with the petitioner it was found that the house was constructed in the year 2008 (Figure-12.24) and presently three members are living in the house.

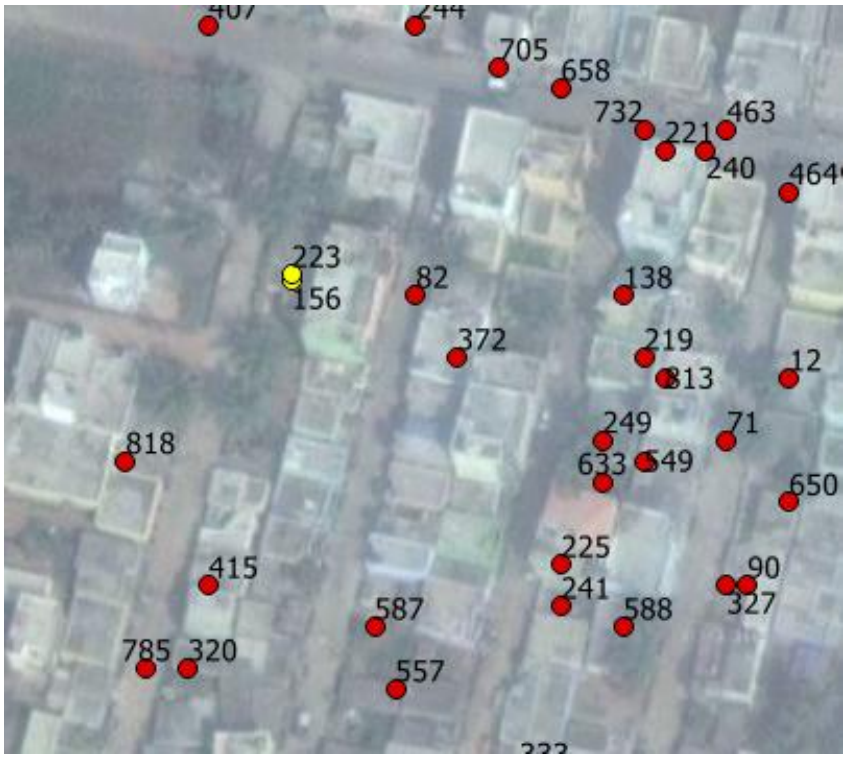
Petitioner No. 156	
Residential House

Remarks: During the ground truth verification it was found that three houses have been constructed in the ground floor. During the interaction with the petitioner it was found that the house was constructed in the year 1997 (Figure-12.25) in the site allotted by the Government under the Ashraya Yojane Scheme and presently three families are living in these houses.

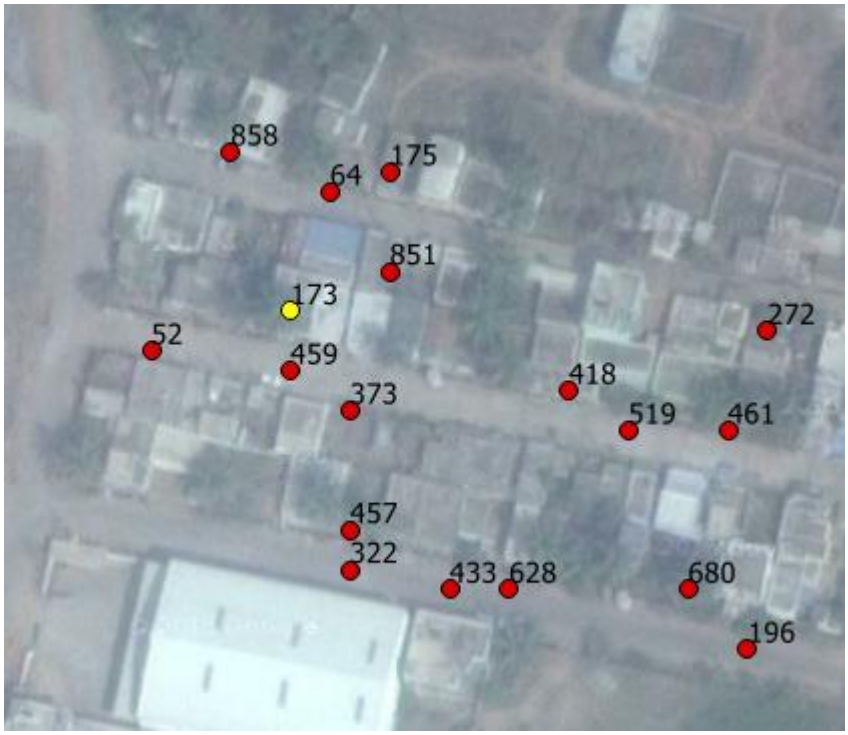
Petitioner No. 173	
Residential House

Remarks: During the ground truth verification it was found that single house has been constructed in the ground floor. During the interaction with the petitioner it was found that the house was constructed in the year 1987 (Figure-12.26) in the site allotted by the Government under the Ashraya Yojane Scheme and electricity supply has been provided under the Bhagya Jyothi scheme. Presently six members are living in the house.

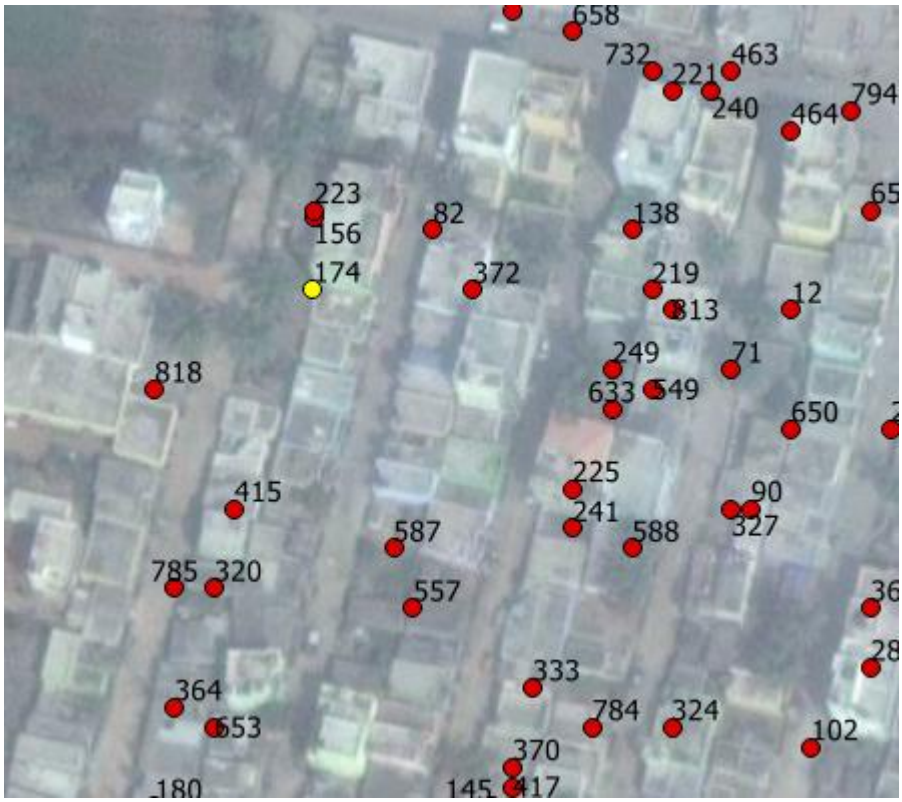
Petitioner No. 174	
Residential Building

Remarks: During the ground truth verification it was found that G+1 building has been constructed in the inherited land. During the interaction with the petitioner it was found that the house was constructed in the year 2000 (Figure-12.27) in an area 30'x35' and presently five members are living in the house.

Figure-12.27: GPS location of the petitioner house (Yellow colour) on Google Earth Image of 2014

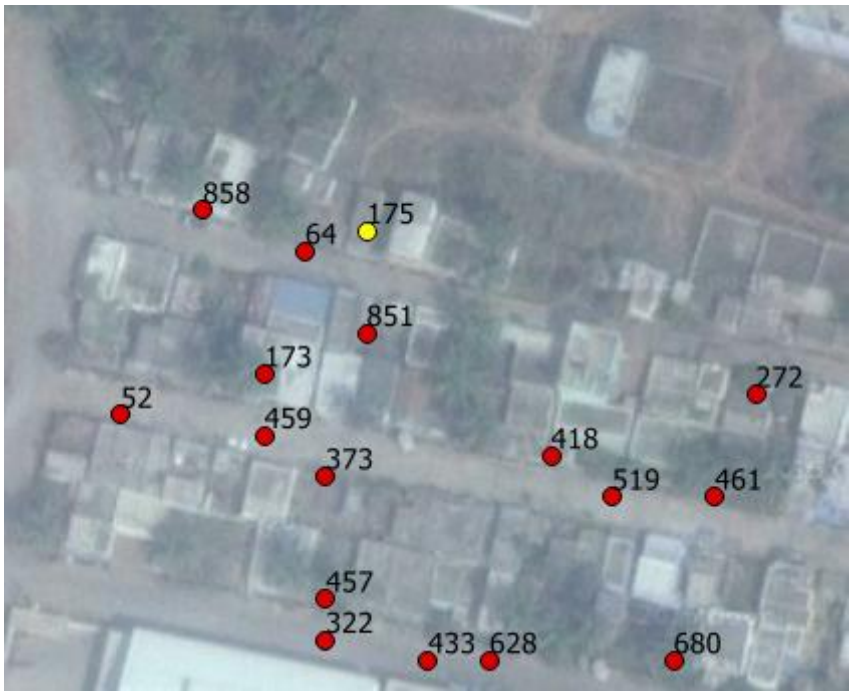
Petitioner No. 175	
Residential Building

Remarks: During the ground truth verification it was found that two buildings have been constructed *i.e.* one G+ 1 building and single house in the ground floor in the existing site. During the interaction with the petitioner it was found that the buildingss were constructed in the year 1987 (Figure-12.28) and 2007 in the site allotted by the Government under the Ashraya Yojane Scheme and also electricity supply has been provided under the Bhagya Jyothi scheme. Presently a total of nine members are living in these houses.

Figure-12.28: GPS location of the petitioner house (Yellow colour) on Google Earth Image (2014) in the Adakimaranahalli Village

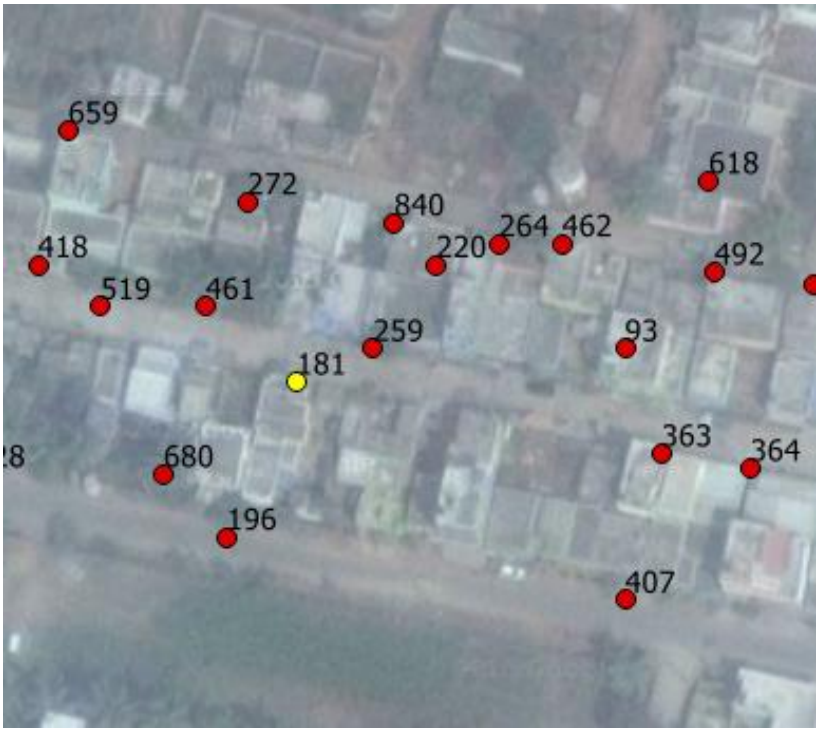
Petitioner No. 181	
Residential Building

Remarks: During the ground truth verification it was found that two G+1 buildings have been constructed and further it was found that among the two buildings, one of the G+1 building under construction was in progress. During the interaction with the petitioner it was found that the old house was constructed in the year 1995 (Figure-12.30) and presently five members are living in the house.

Figure-12.30: GPS location of the petitioner house (Yellow colour) on Google Earth Image (2014) in the Adakimaranahalli Village

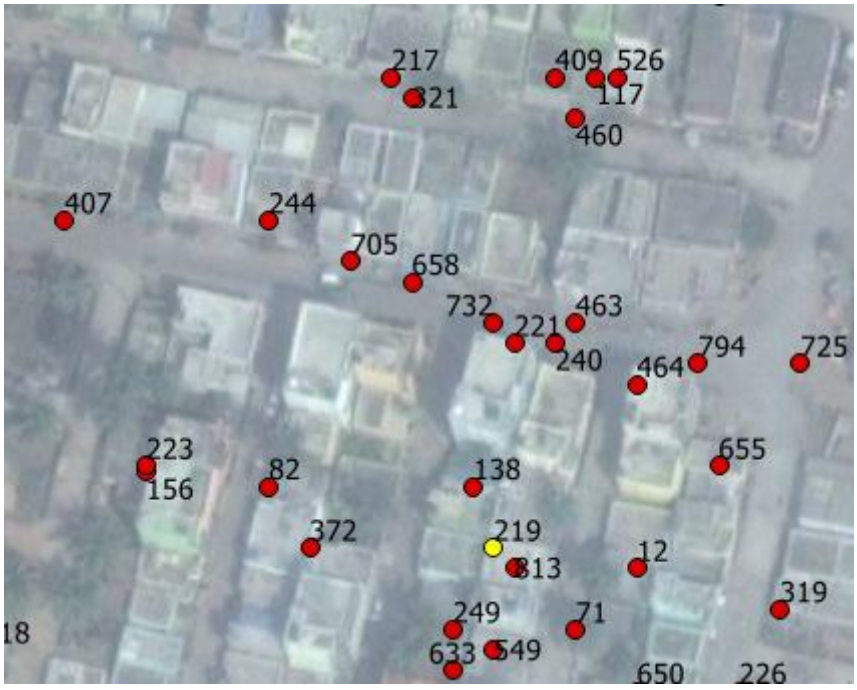
Petitioner No. 219 and 813	
Residential House

Remarks: During the ground truth verification it was found that two petitions have been filed by the members of the same family and further it was found that single house has been constructed in the ground floor. While carrying out the ground truth verification, the petitioners house was locked and as per the information collected from the neighbours, the house was constructed in the year 1987 (Figure-12.33) and renovated in the year 2009. Further it was found that the house constructed in the site allotted by the Government under the Ashraya Yojane Scheme and presently four members are living in the house.

Figure-12.33: GPS location of the petitioner house (Yellow colour) on Google Earth Image (2014) in the Adakimaranahalli Village

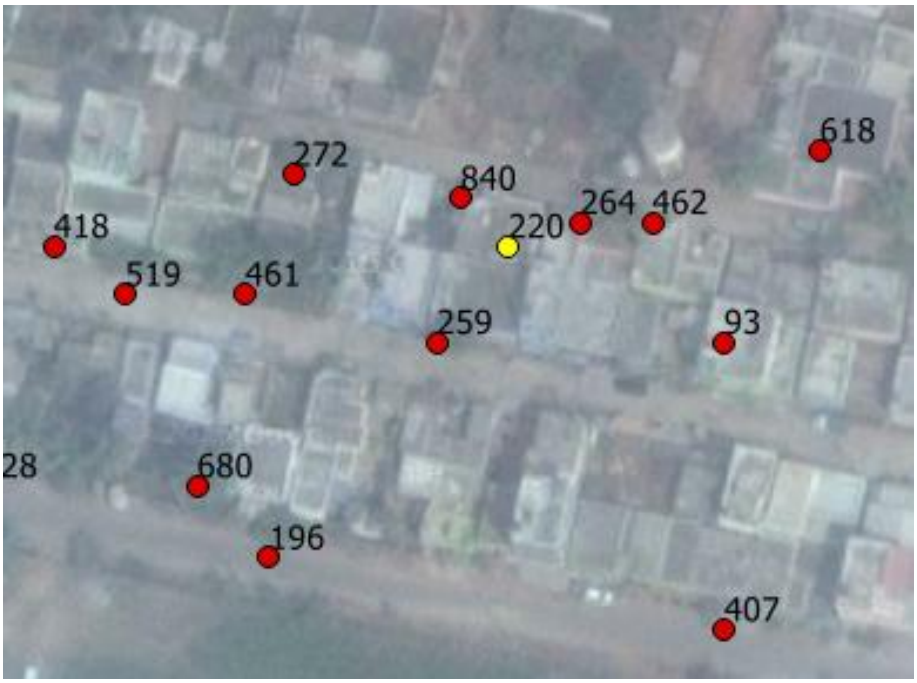
Petitioner No. 220	
Residential House along with shop

Remarks: During the ground truth verification it was found that two houses along with shop have been constructed in the ground floor. During the interaction with the petitioner it was found that the house was constructed in the year 1987 (Figure-12.34) in site allotted by the Government under the Ashraya Yojane Scheme and presently three members are living in these houses.

Figure-12.34: GPS location of the petitioner house (Yellow colour) on Google Earth Image (2014) in the Adakimaranahalli Village

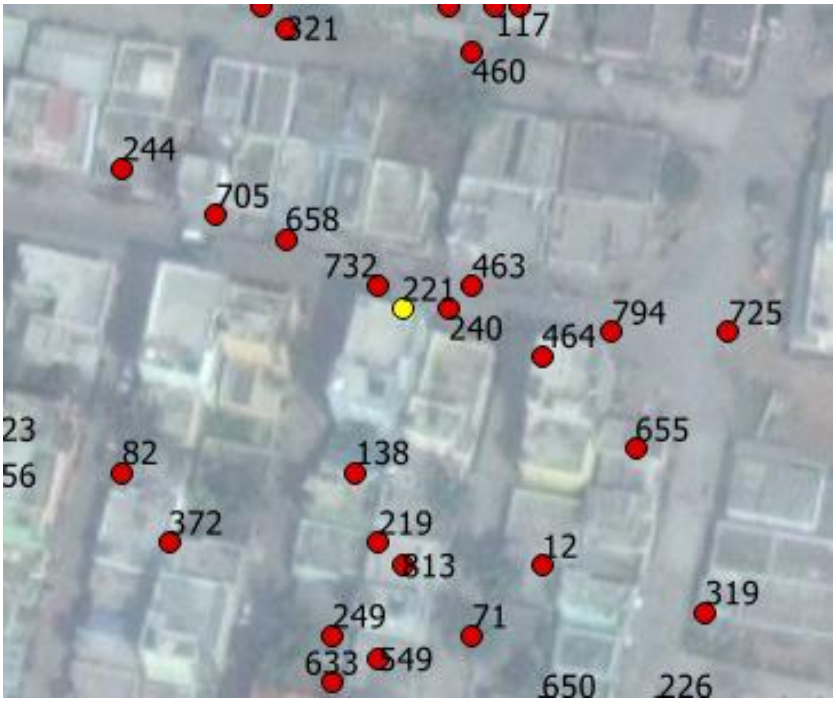
Petitioner No. 221	
Residential Building along with shops

Remarks: During the ground truth verification it was found that G+2 building along with two commercial shops have been constructed in the existing site. During the interaction with the petitioner it was found that the building was constructed in the year 1980 (Figure-12.35) and further renovated in the year 2012. It was also found that the house has been constructed in site allotted by the Government under the Ashraya Yojane Scheme and presently a total of thirteen members are living in these houses.

Figure-12.35: GPS location of the petitioner house (Yellow colour) on Google Earth Image (2014) in the Adakimaranahalli Village

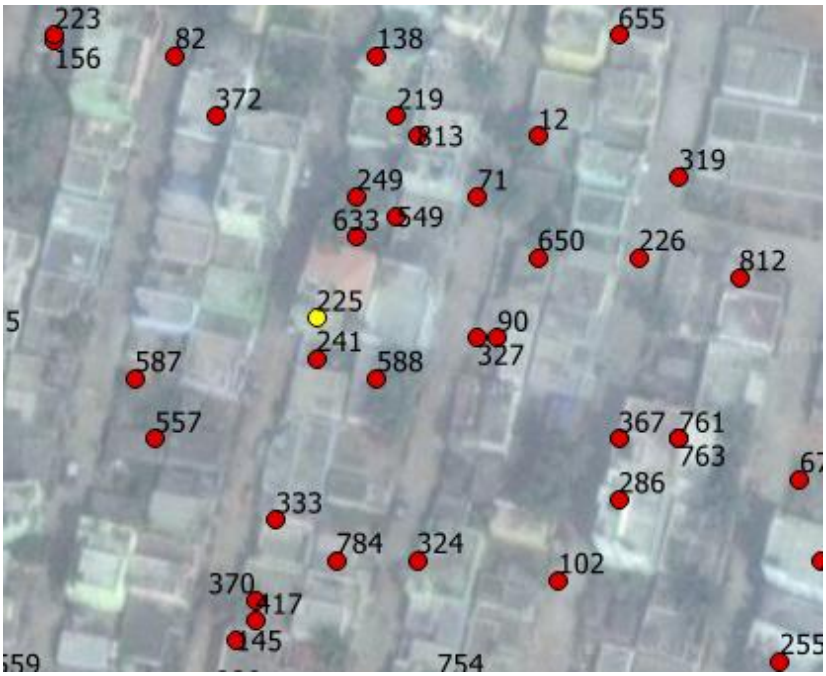
Petitioner No. 225 and 588	
Residential House

Remarks: During the ground truth verification it was found that two petitions have been filed from the members of the same family and further it was found that single house has been constructed in the ground floor. During the interaction with the petitioners it was found that the house was constructed in the year 2010 (Figure-12.37) in the site allotted by the Government under the Ashraya Yojane Scheme and presently five members are living in the house.

Figure-12.37: GPS location of the petitioner house (Yellow colour) on Google Earth Image (2014) in the Adakimaranahalli Village

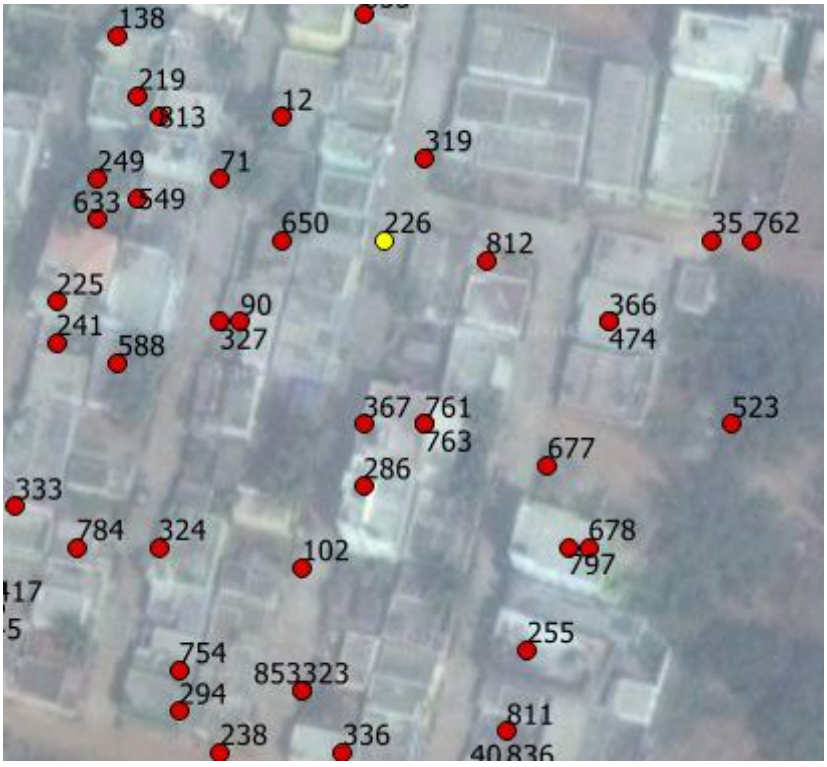
Petitioner No. 226	
Residential House

Remarks: During the ground truth verification it was found that single house has been constructed in the ground floor (Figure-12.38). During the interaction with the petitioner it was found that the house was constructed in the site allotted by the Government under the Ashraya Yojane Scheme and presently four members are living in the house.

Figure-12.38: GPS location of the petitioner house (Yellow colour) on Google Earth Image (2014) in the Adakimaranahalli Village

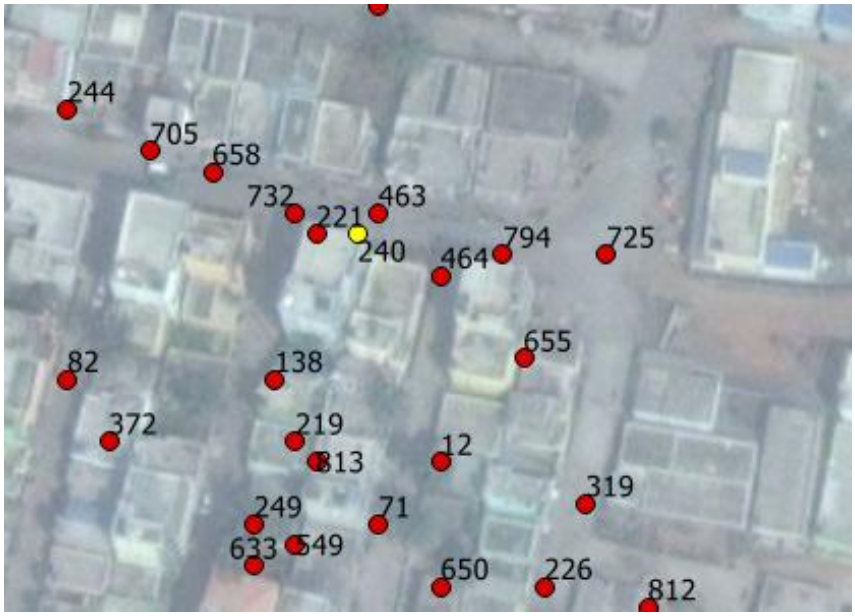
Petitioner No. 240, 243 and 732	
Residential House along with shop

Remarks: During the ground truth verification it was found that three petitions have been filed by the members of the same family and further it was found that two houses along with one commercial shop was constructed in the ground floor. During the interaction with the petitioners it was found that the house was constructed in the year 1995 (Figure-12.41) in the site allotted by the Government under the Ashraya Yojane Scheme and presently ten members are living in these houses.

Figure-12.41: GPS location of the petitioner house (Yellow colour) on Google Earth Image (2014) in the Adakimaranahalli Village

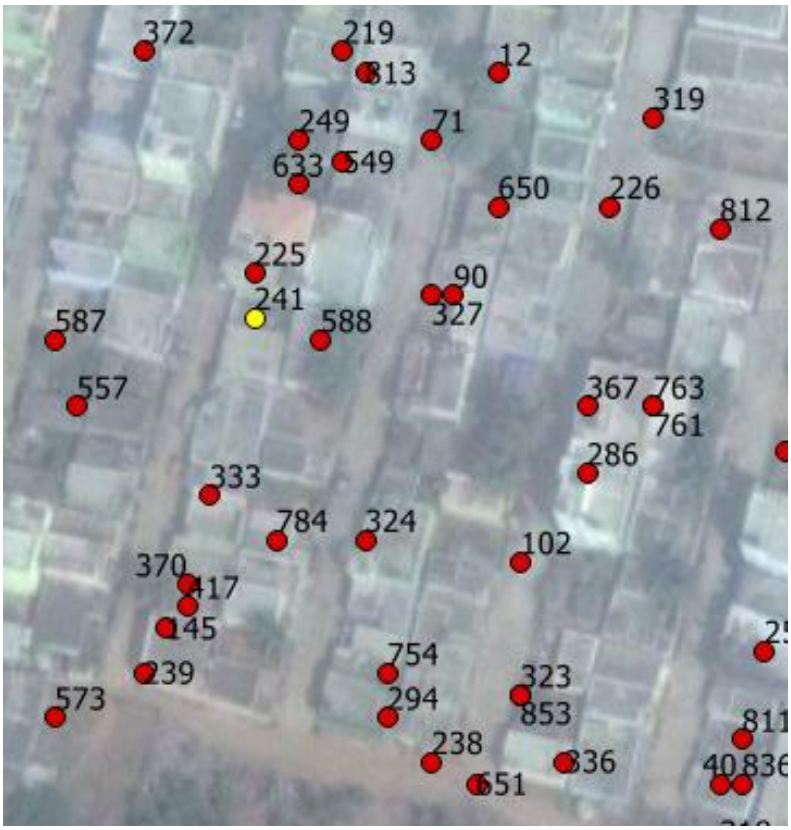
Petitioner No. 241	
Residential House

Remarks: During the ground truth verification it was found that single house has been constructed in the ground floor. During the interaction with the petitioner it was found that the house was constructed in the year 1985 (Figure-12.42) in the site allotted by the Government under the Ashraya Yojane Scheme and presently five members are living in the house.

Figure-12.42: GPS location of the petitioner house (Yellow colour) on Google Earth Image (2014) in the Adakimaranahalli Village

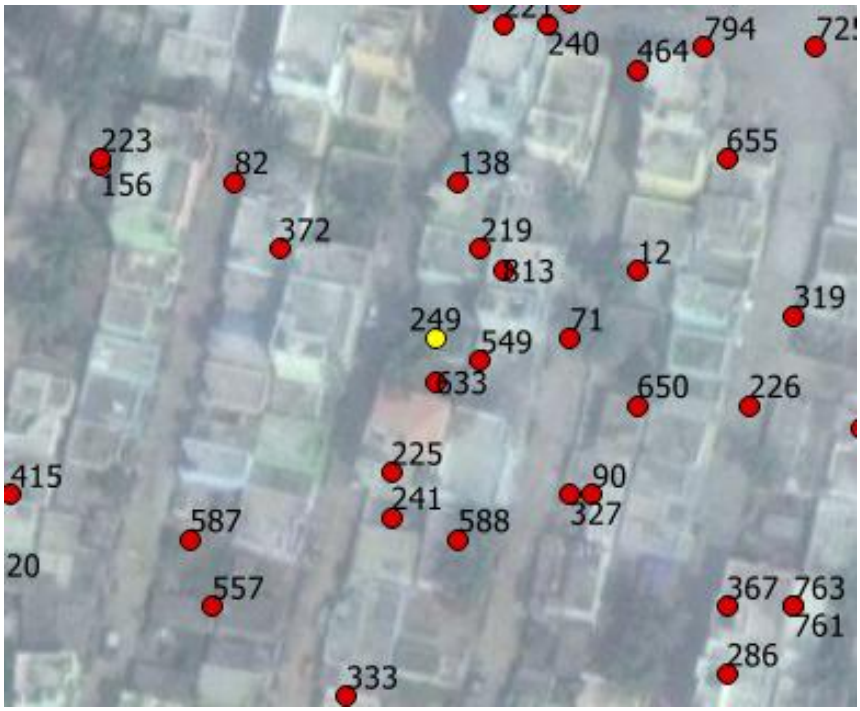
Petitioner No. 249 and 633	
Residential Building

Remarks: During the ground truth verification it was found that two petitions have been filed by the members of the same family and further it was found that G+3 building along with shop has been constructed in the existing site. During the interaction with the petitioner it was found that after the demolition of old house the new building was constructed in the year 2014 (Figure-12.45) in the site allotted by the Government under the Ashraya Yojane Scheme and presently, three families and a total of twelve members are living in these houses.

Figure-12.45: GPS location of the petitioner house (Yellow colour) on Google Earth Image (2014) in the Adakimaranahalli Village

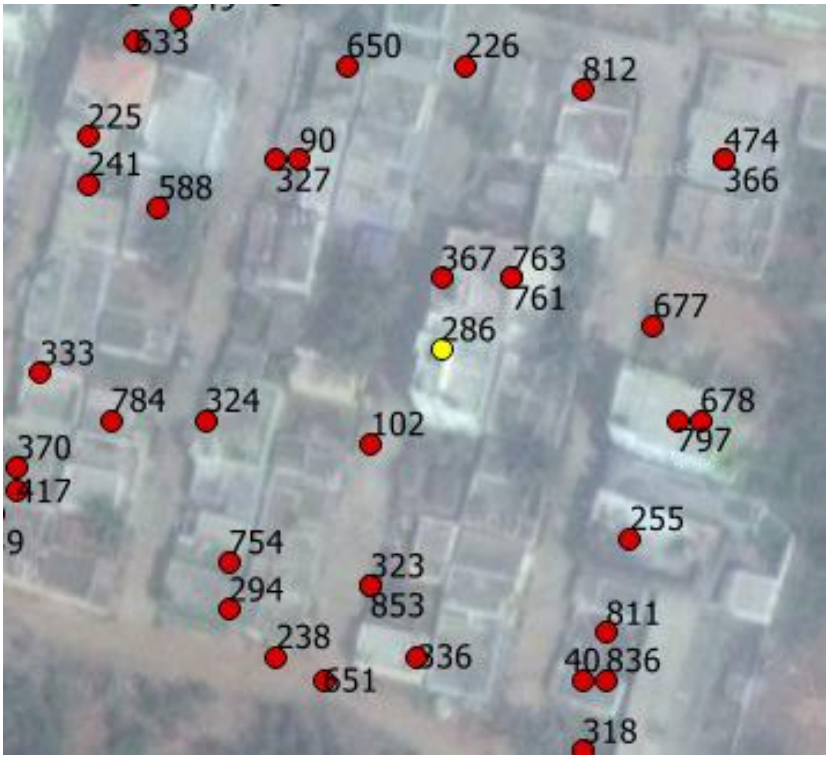
Petitioner No. 286	
Residential Building

Remarks: During the ground truth verification it was found that G+2 building has been constructed and further it was found that the second floor was having two rooms. During the interaction with the petitioner it was found that the house was constructed in the year 2013 (Figure-12.51) in the site allotted by the Government under the Ashraya Yojane Scheme and presently four members are living in these houses.

Figure-12.51: GPS location of the petitioner house (Yellow colour) on Google Earth Image (2014) in the Adakimaranahalli Village

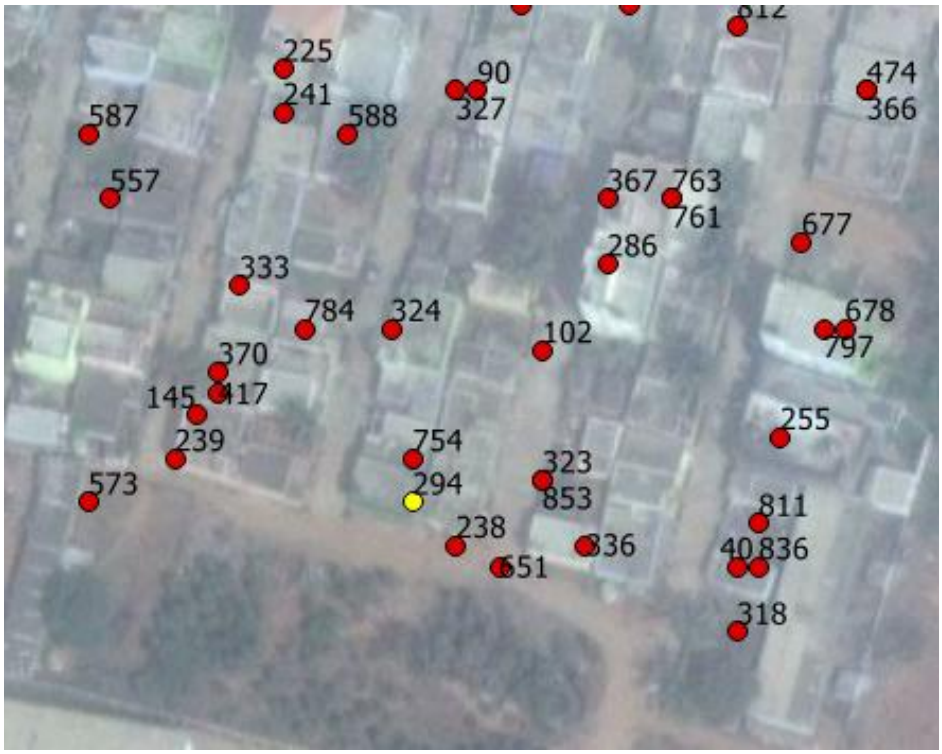
Petitioner No. 294	
Residential House

Remarks: During the ground truth verification it was found that five houses have been constructed in the ground floor. During the interaction with the petitioner it was found that the old house was constructed in the year 1987 (Figure-12.52) which has been renovated in the year 2002 and further it was found that the house has been constructed in the site allotted by the Government under the Ashraya Yojane Scheme. Presently, five families and a total of twelve members are living in these houses.

Figure-12.52: GPS location of the petitioner house (Yellow colour) on Google Earth Image (2014) in the Adakimaranahalli Village

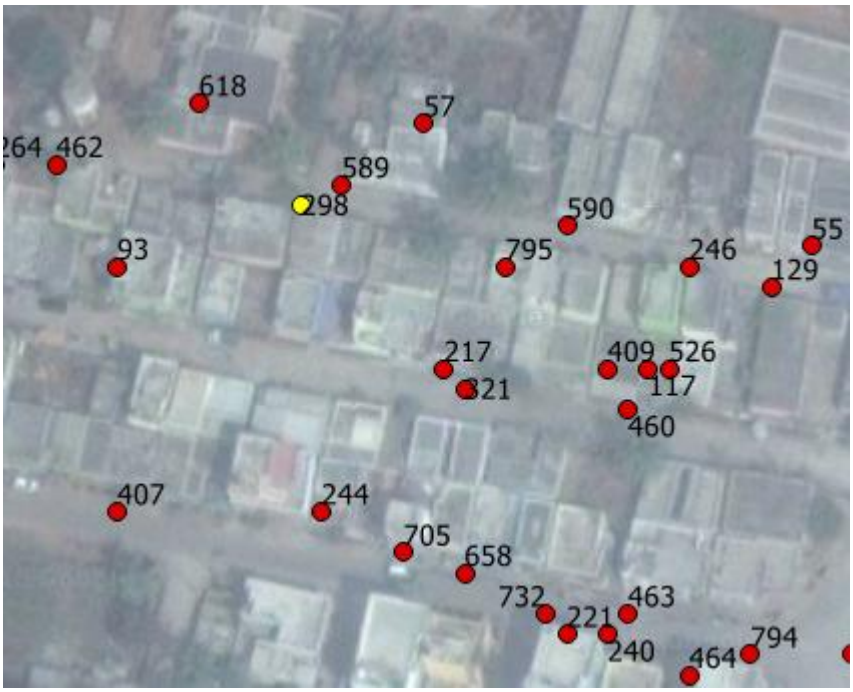
Petitioner No. 298	
Residential House

Remarks: During the ground truth verification it was found that four houses have been constructed in the ground floor. During the interaction with the petitioner it was found that the house was constructed in the year 1990 (Figure-12.53) in the site allotted by the Government under Ashraya Yojane Scheme and presently a total of eight members are living in these houses.

Figure-12.53: GPS location of the petitioner house (Yellow colour) on Google Earth Image (2014) in the Adakimaranahalli Village
