Comprehensive Assessment of Thippagondanahalli Reservoir Catchment Area and its Preservation Zone

Volume-II
(Writ Petitions)

Center for Lake Conservation (CLC)
Environmental Management and Policy Research Institute (EMPRI)

August, 2015

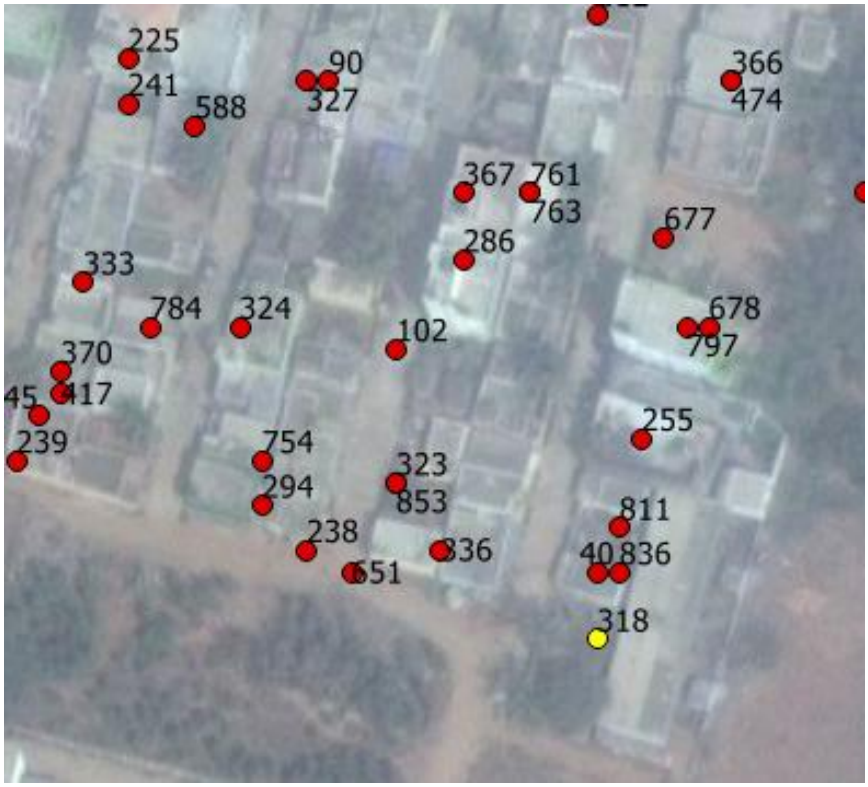
Petitioner No. 318	
Residential House

Remarks: During the ground truth verification it was found that four houses have been constructed in the ground floor During the interaction with the petitioner it was found that the house was constructed in the site allotted by the Government under Ashraya Yojane Scheme and further it was found that the old house was constructed in the year 1993 (Figure-12.54) which has been renovated in the year 2012. Presently a total of eighteen members are living in these houses.

Figure-12.54: GPS location of the petitioner house (Yellow colour) on Google Earth Image (2014) in the Adakimaranahalli Village

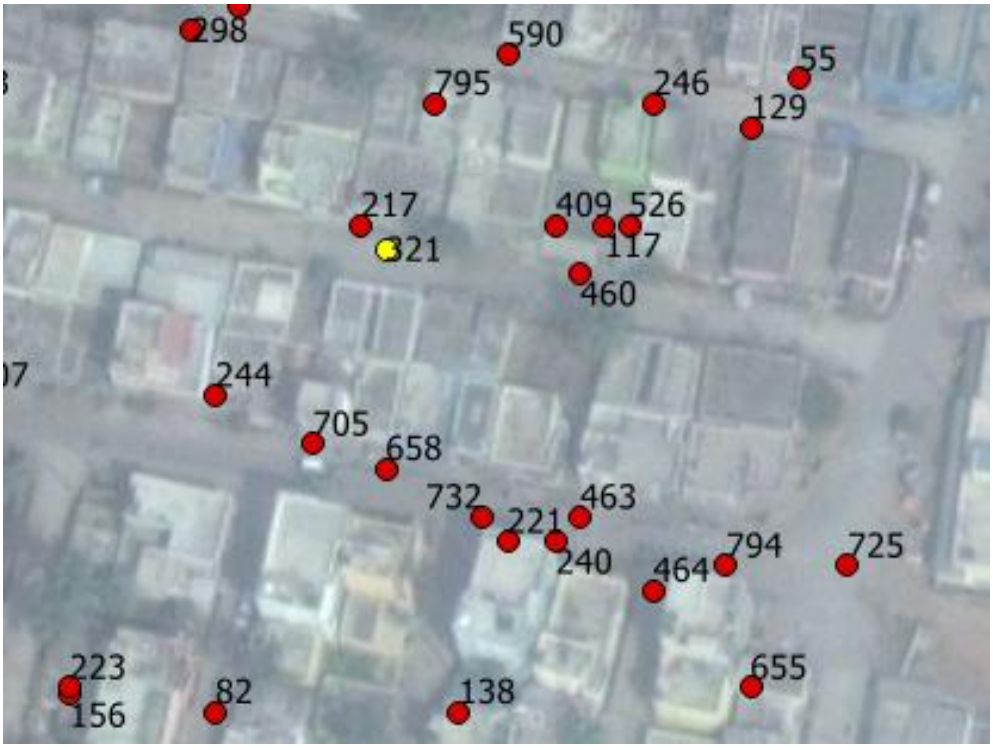
Petitioner No. 321	
Residential Building

Remarks: During the ground truth verification it was found that house G+1 building has been constructed and further it was found that first floor was having one room (Figure-12.56). While carrying out the ground truth verification, the petitioner house was locked and as per the information collected from the neighbours the house was constructed in the site allotted by the Government under the Ashraya Yojane Scheme and presently four members are living in the house.

Figure-12.56: GPS location of the petitioner house (Yellow colour) on Google Earth Image (2014) in the Adakimaranahalli Village

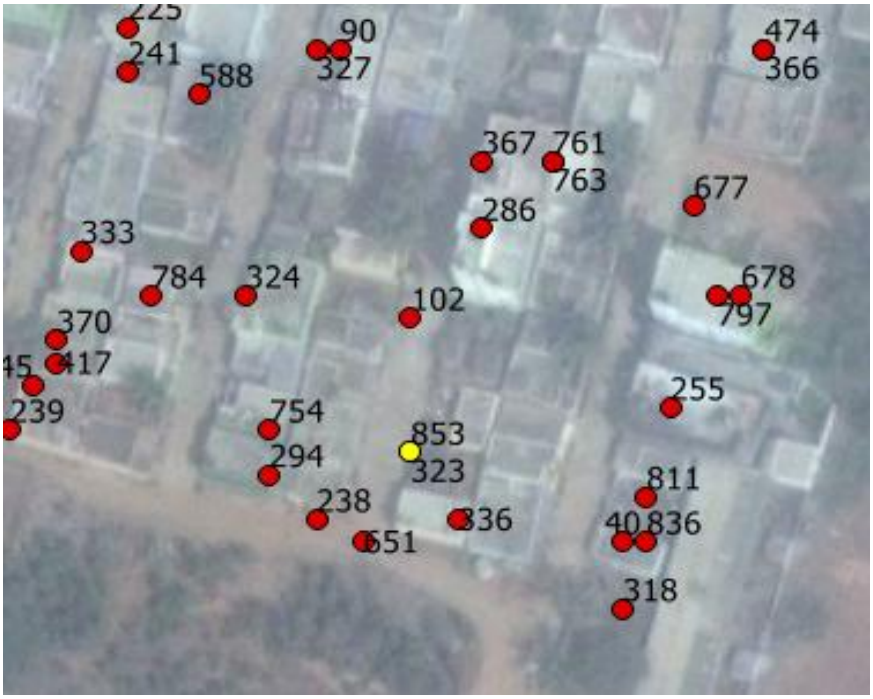
Petitioner No. 323 and 853	
Residential House

Remarks: During the ground truth verification it was found that two petitions have been filed by the members of the same family and further it was found that three houses have been constructed in the ground floor. During the interaction with the petitioner it was found that the house was constructed in the year 1993 (Figure-12.58) in the site allotted by the Government under the Ashraya Yojane Scheme and presently a total of fourteen members are living in these houses.

Figure-12.58: GPS location of the petitioner house (Yellow colour) on Google Earth Image (2014) in the Adakimaranahalli Village

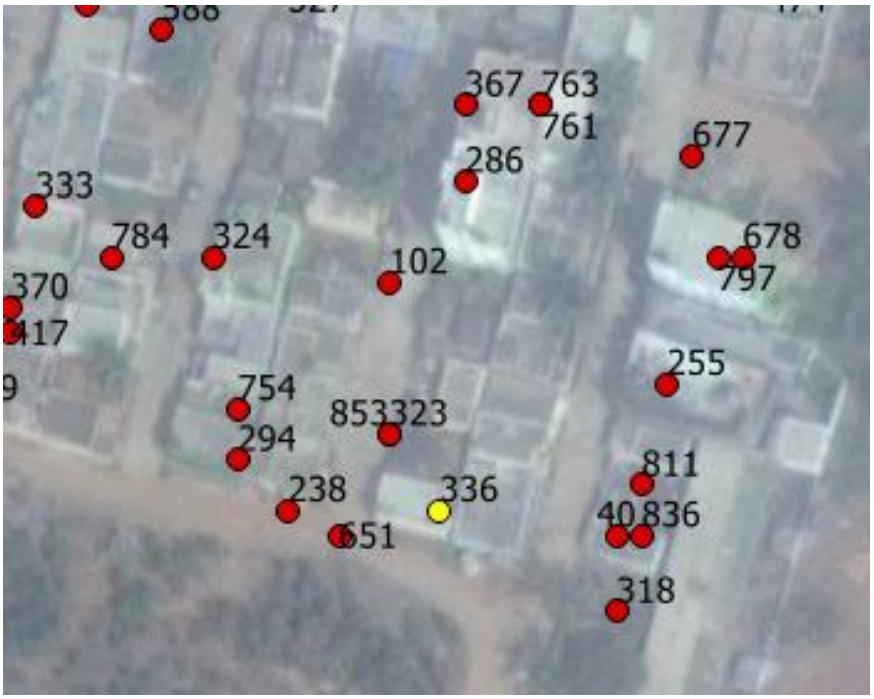
Petitioner No. 336	
Residential House

Remarks: During the ground truth verification it was found that three houses have been constructed in the ground floor. During the interaction with the petitioner it was found that the house was constructed in the year 2013 (Figure-12.61) in the site allotted by the Government under the Ashraya Yojane Scheme and presently a total of ten members are living in these houses.

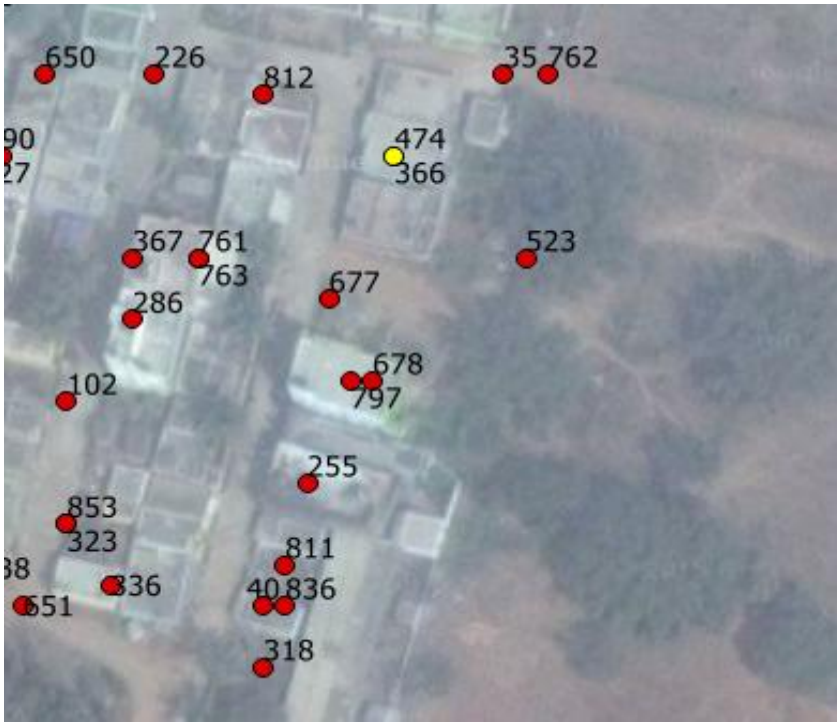
Petitioner No. 366 and 474	
Residential House

Remarks: During the ground truth verification it was found that two petitions have been filed by the members of same family and further it was found that single house has been constructed in the ground floor. During the interaction with the petitioner it was found that the house was constructed in the year 2005 (Figure-12.65) in the inherited land and presently three members are living in the house.

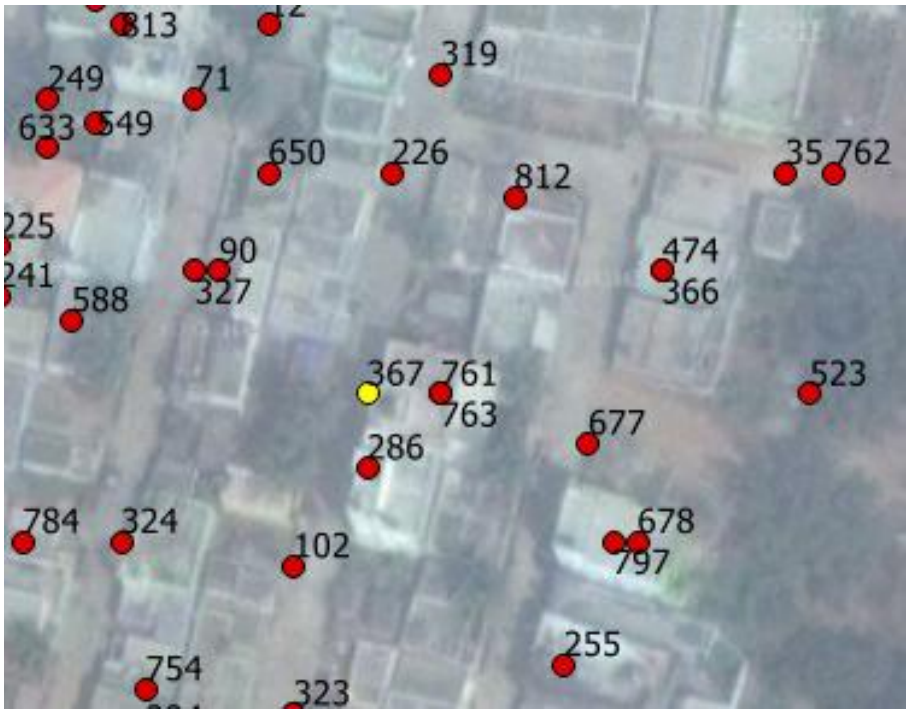
Petitioner No. 367	
Before Demolition	After demolition construction under progress
Changes observed during the field verification

Remarks: During the ground truth verification it was found that single house which was constructed in the year 1993 (Figure-12.66) has been demolished and construction of new building was under progress in the site allotted by the Government under the Ashraya Yojane Scheme.

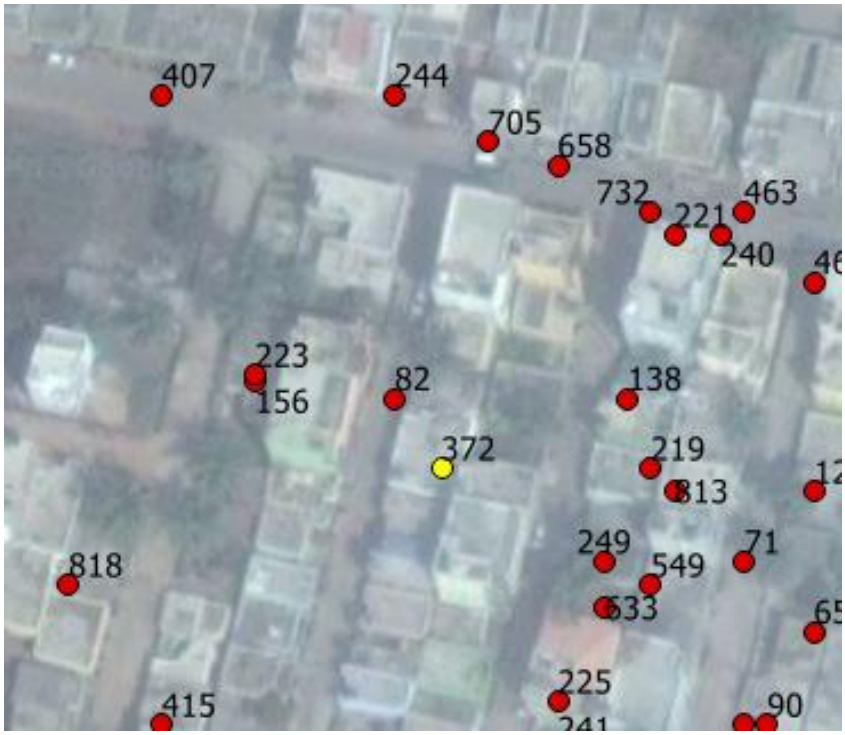
Petitioner No. 372	
Residential Building

Remarks: During the ground truth verification it was found that G+2 building has been constructed. During the interaction with the petitioner it was found that the old house was constructed in the year 1997 (Figure-12.68) which has been renovated in the year 2011. Further it was found that the house has been constructed in the site allotted by the Government under the Ashraya Yojane Scheme and presently nine members are living in these houses.

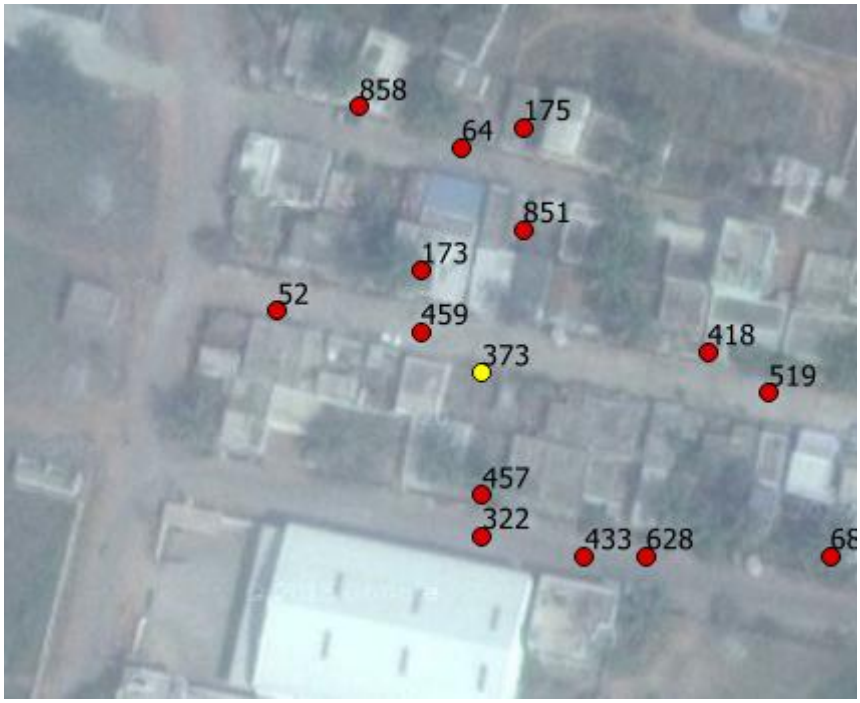
Petitioner No. 373	
Residential House

Remarks: During the ground truth verification it was found that two houses have been constructed in the ground floor. During the interaction with the petitioner it was found that the house was constructed in the year 2005 (Figure-12.69) in the site allotted by the Government under the Ashraya Yojane Scheme in the area 20'x25' and presently six members are living in these houses.

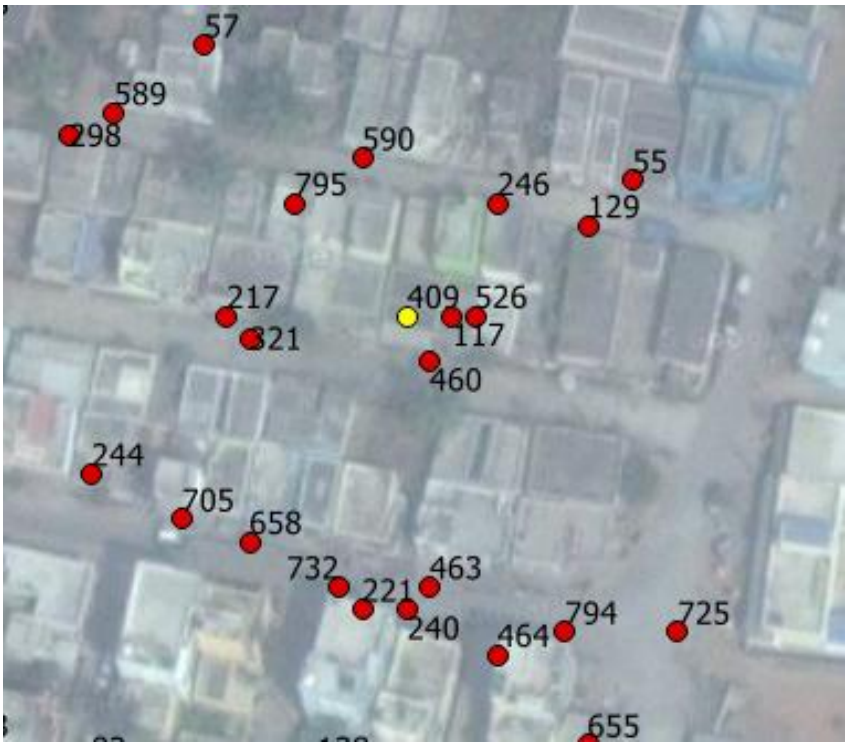
Petitioner No. 409	
Residential House along with shop

Remarks: During the ground truth verification it was found that three houses along with one shop have been constructed in the ground floor. During the interaction with the petitioner it was found that the house was constructed in the year 1987 (Figure-12.71) in the site allotted by the Government under the Ashraya Yojane Scheme and presently six members are living in these houses.

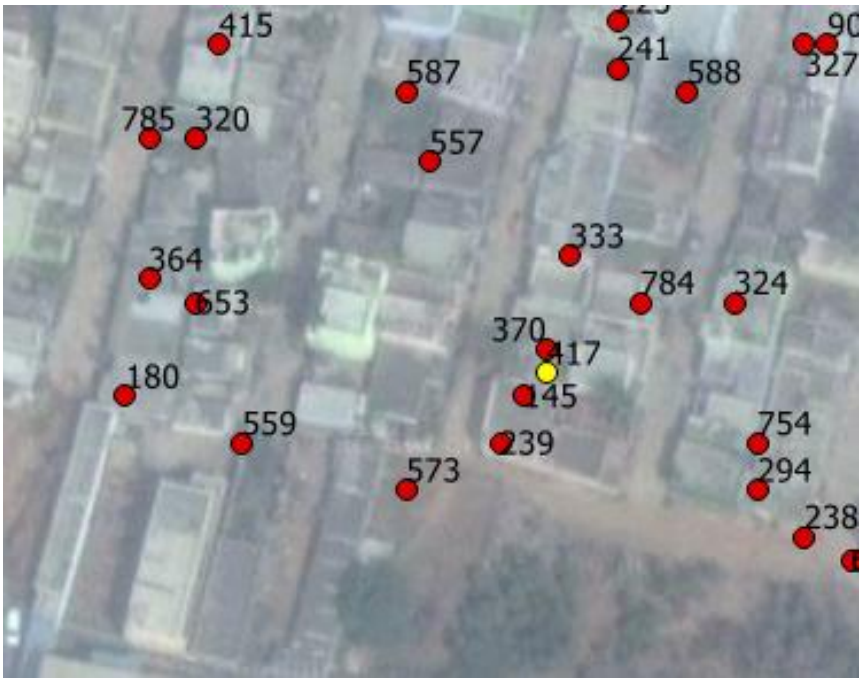
Petitioner No. 417	
Residential Building

Remarks: During the ground truth verification it was found that G+1 building has been constructed and further it was found that the building was having five houses. During the interaction with the petitioner it was found that the building was constructed in the year 2005 (Figure-12.73) in the site allotted by the Government under the Ashraya Yojane Scheme and presently fifteen members are living in these houses.

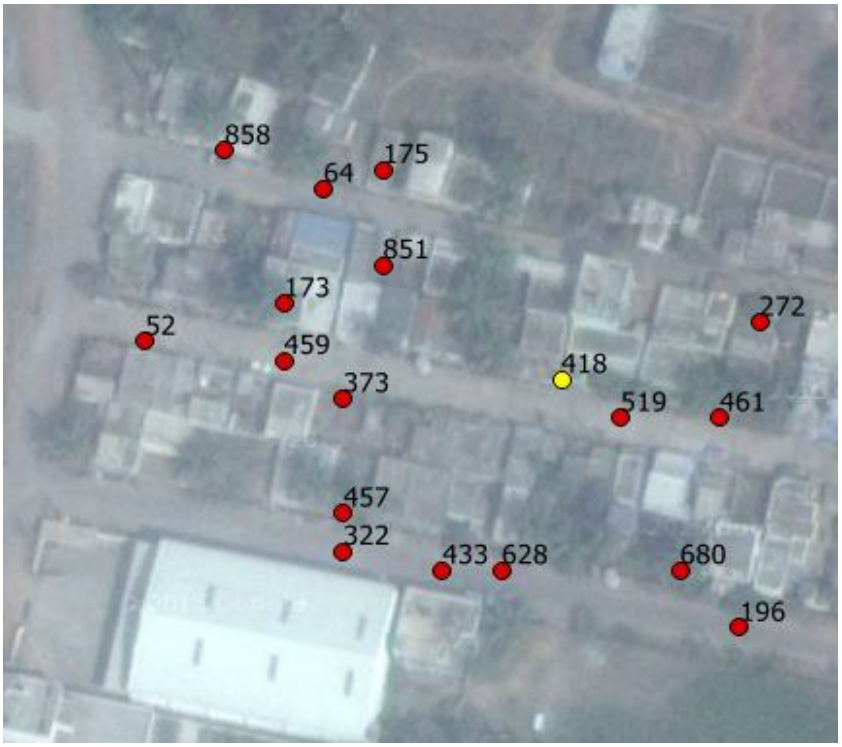
Petitioner No. 418	
Residential House

Remarks: During the ground truth verification it was found that single house has been constructed in the ground floor. During the interaction with the petitioner it was found that the house was constructed in the year 1986 (Figure-12.74) in the site allotted by the Government under the Ashraya Yojane Scheme and presently four members are living in this house.

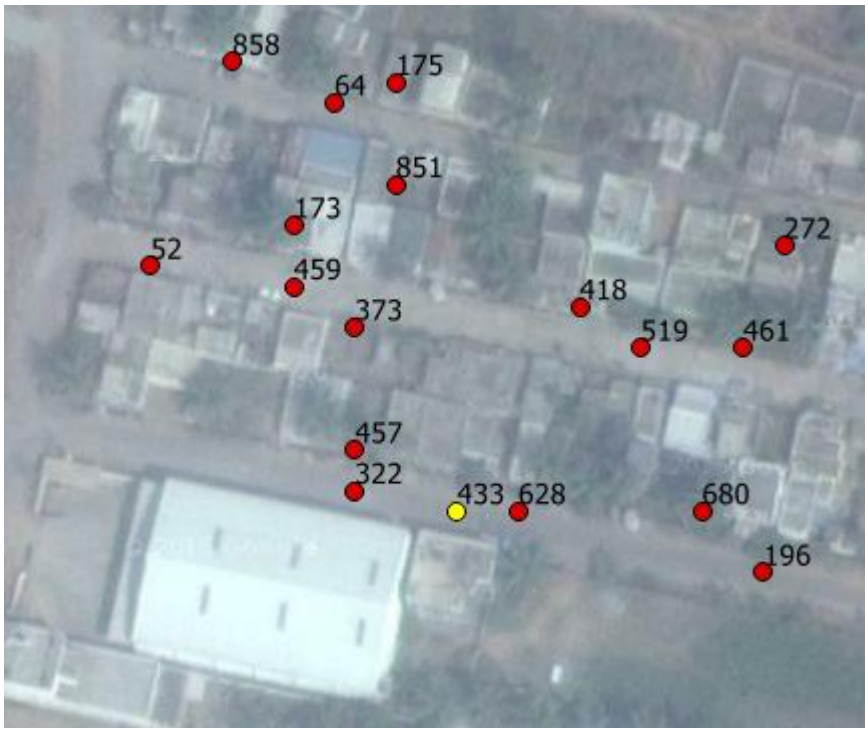
Petitioner No. 433	
Residential House

Remarks: During the ground truth verification it was found that two houses have been constructed in the ground floor. During the interaction with the petitioner it was found that the house was constructed in the year 1997 (Figure-12.75) in the site allotted by the Government under the Ashraya Yojane Scheme and presently two families, with a total of nine members are living in these houses.

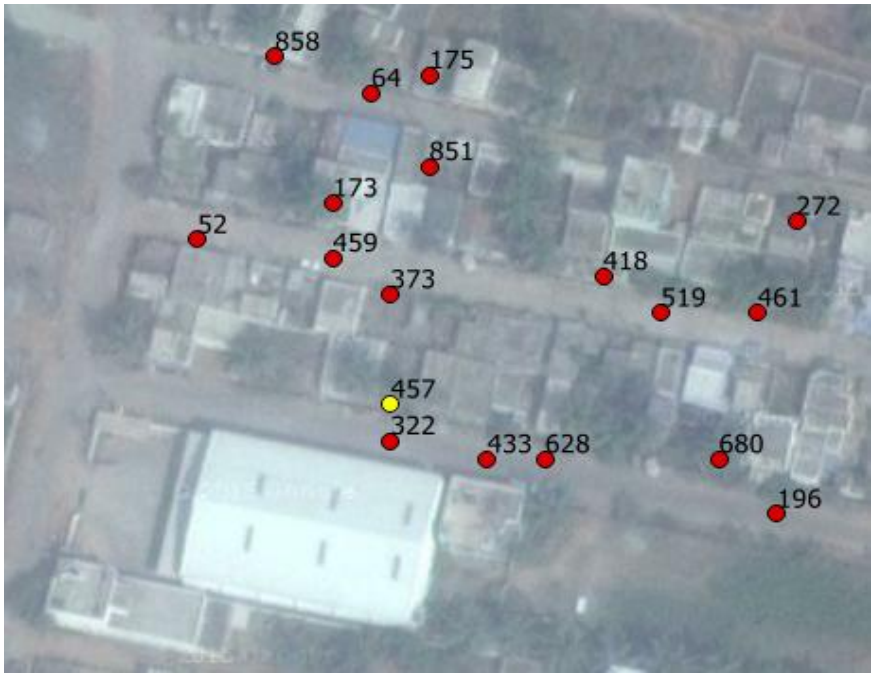
Petitioner No. 457	
Residential House

Remarks: During the ground truth verification it was found that three houses have been constructed in the ground floor (Figure-12.76). During the interaction with the petitioner it was found that the house was constructed in the site allotted by the Government under the Ashraya Yojane Scheme and also electricity supply have been provided under the Bhagya Jyothi and presently, three families with a total of twelve members are living in these houses.

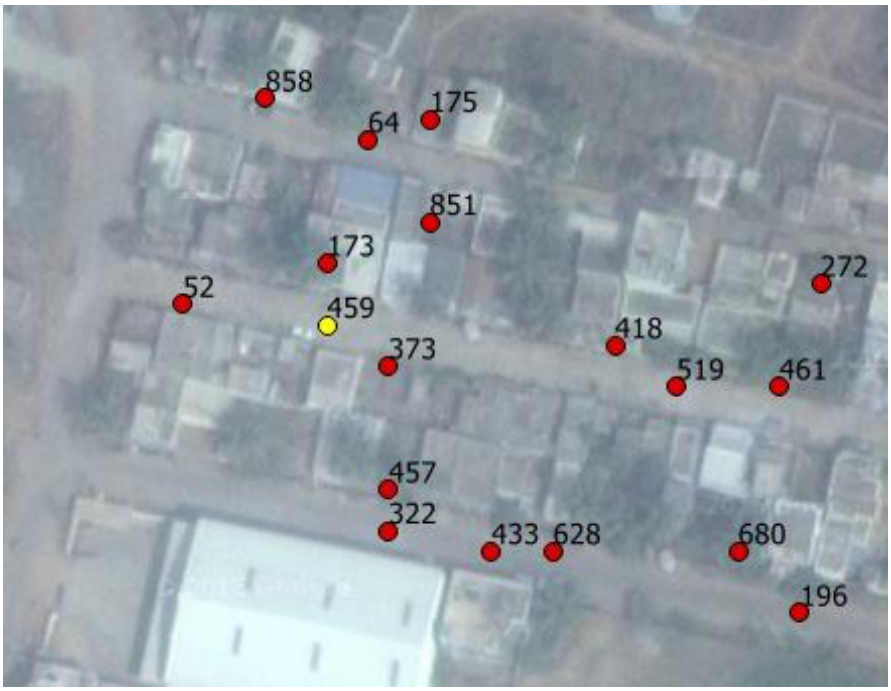
Petitioner No. 459	
Residential Building along with a shop

Remarks: During the ground truth verification it was found that G+1 building along with shop (flour mill) has been constructed. During the interaction with the petitioner it was found that the house has been constructed in the year 1987 (Figure-12.77) and further the house has been renovated in the year 2002 in the site allotted by the Government under the Ashraya Yojane Scheme and presently four members are living in the house.

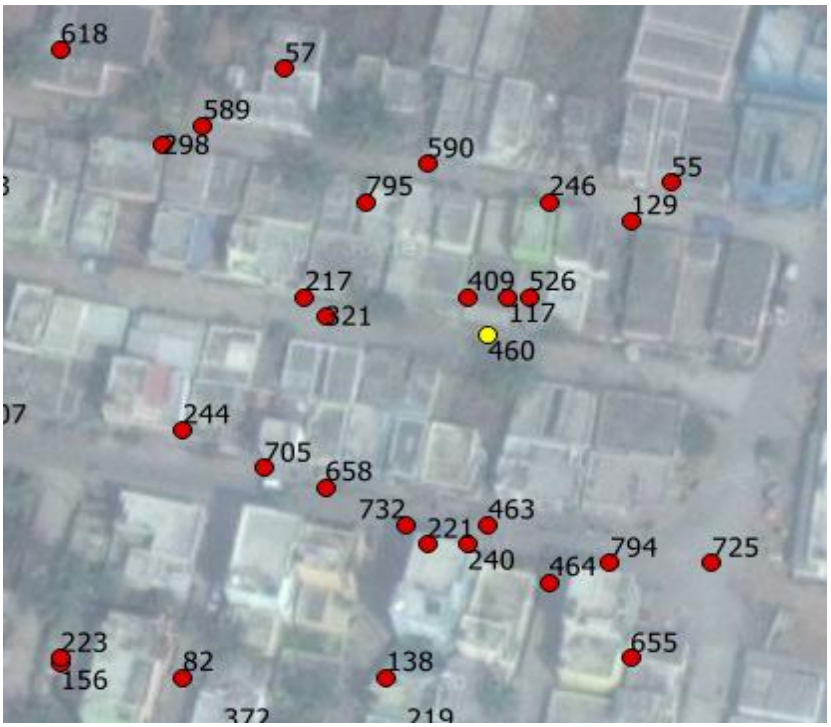
Petitioner No. 460 and 526	
Residential House

Remarks: During the ground truth verification it was found that two petitions have been filed by the members of the same family and further it was found that single house has been constructed in the ground floor. During the interaction with the petitioner it was found that the house was constructed in the year 1992 (Figure-12.78) in the site allotted by the Government under the Ashraya Yojane Scheme and presently four members are living in the house.

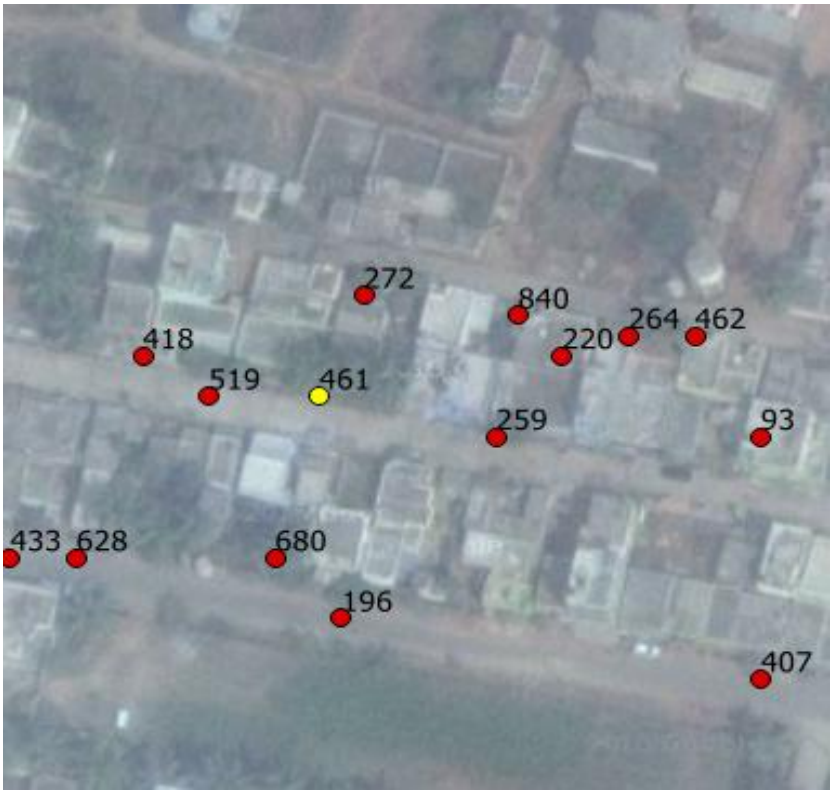
Petitioner No. 461	
Residential House

Remarks: During the ground truth verification it was found that single house has been constructed in the ground floor. During the interaction with the petitioner it was found that the house was constructed in the year 2003 (Figure-12.79) in the site allotted by the Government under the Ashraya Yojane Scheme and presently four members are living in the house.

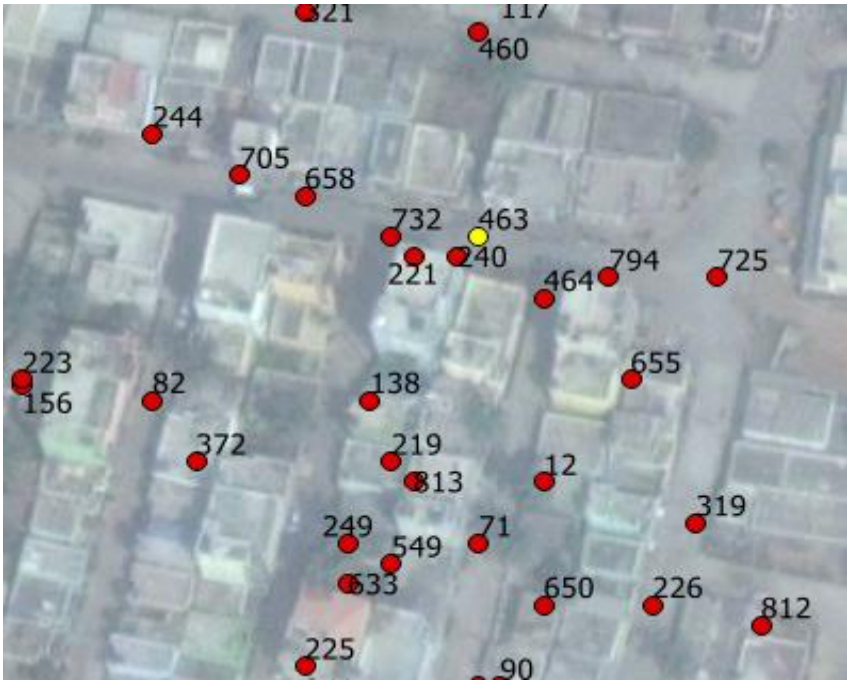
Petitioner No. 463	
Residential house along with a shop

Remarks: During the ground truth verification it was found that single house along with a shop has been constructed in the ground floor. During the interaction with the petitioner it was found that the new house was constructed in the year 1998 (Figure-12.81) after the demolition of the old building which was constructed in the year 1987 in the site allotted by the Government under the Ashraya Yojane Scheme. Presently five members are living in the house.

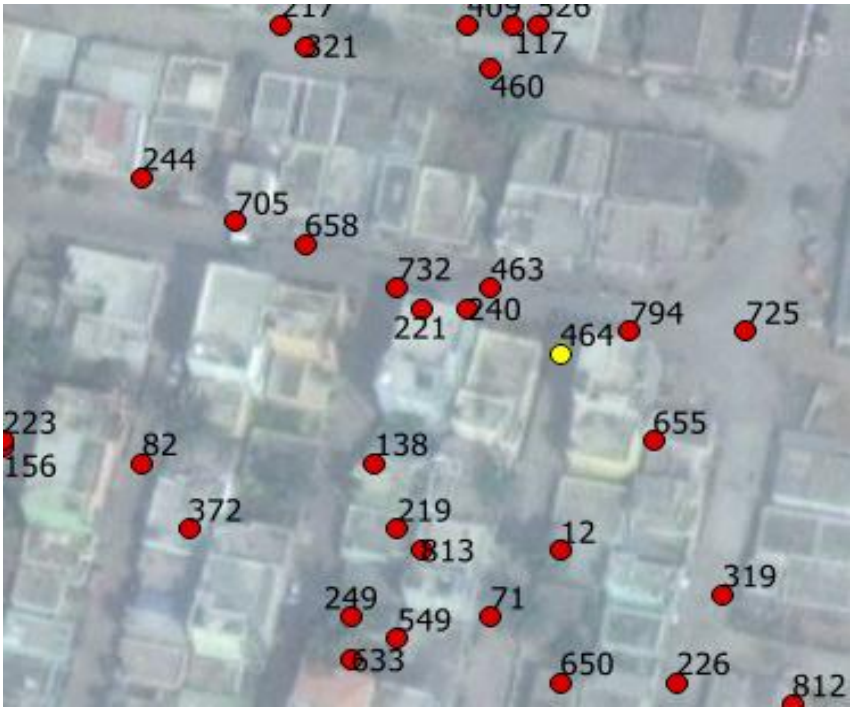
Petitioner No. 464	
Residential Building

Remarks: During the ground truth verification it was found that G+1 building has been constructed and further it was found that the first floor having a single room. During the interaction with the petitioner it was found that the house was constructed in the year 1996 (Figure-12.82) and further renovated in the year 2007. It was also found that, the house was constructed in the site allotted by the Government under the Ashraya Yojane Scheme and presently three members are living in the house.

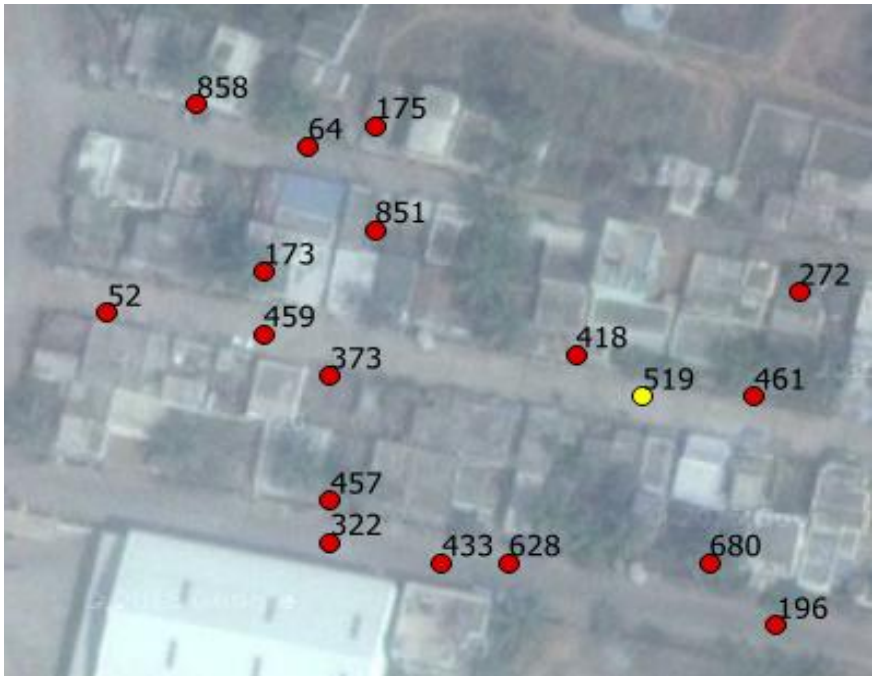
Petitioner No. 519	
Residential House

Remarks: During the ground truth verification it was found that single house has been constructed in the ground floor. During the interaction with the petitioner it was found that the house has been constructed in the year 2007 (Figure-12.84) in the site allotted by the Government under the Ashraya Yojane Scheme and presently four members are living in the house.

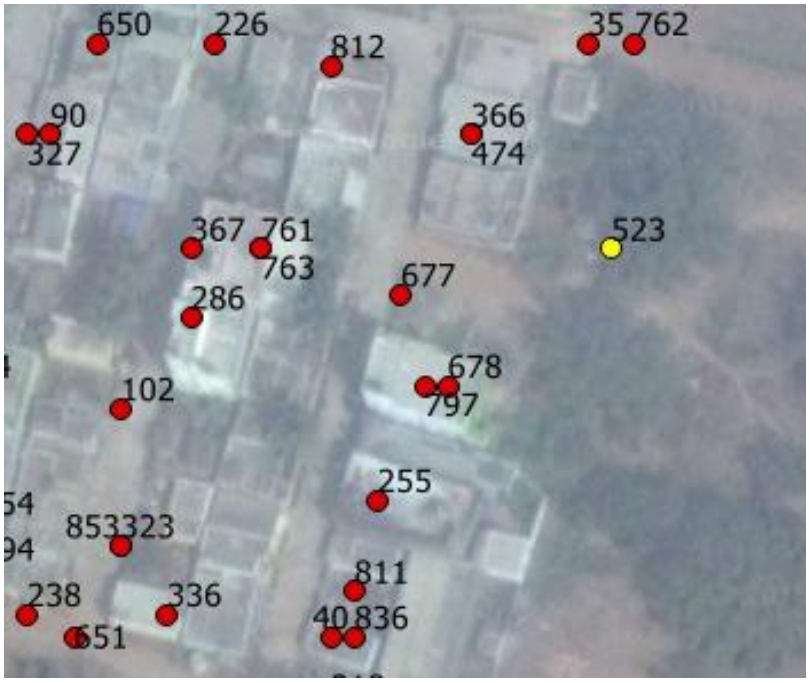
Petitioner No. 523	
Residential House

Remarks: During the ground truth verification it was found that two houses have been constructed in the ground floor (Figure-12.85). During the interaction with the petitioner it was found that the houses have been constructed in the inherited land and presently four members are living in these houses.

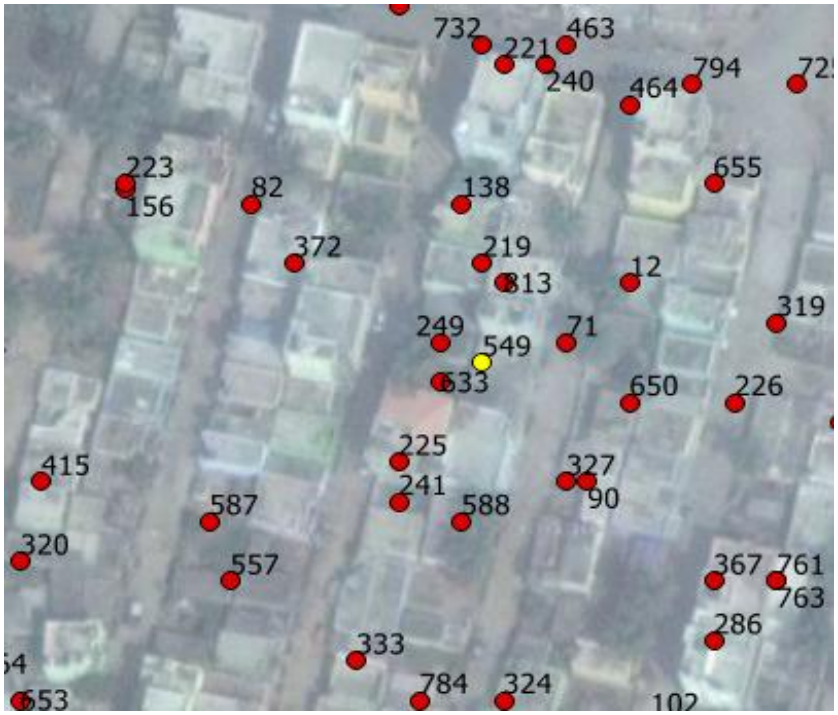
Petitioner No. 549	
Residential House

Remarks: During the ground truth verification it was found that single house has been constructed in the ground floor. During the interaction with the petitioner it was found that the house was constructed in the year 2009 (Figure-12.86) in the site allotted by the Government under the Ashraya Yojane Scheme and presently three members are living in the house.

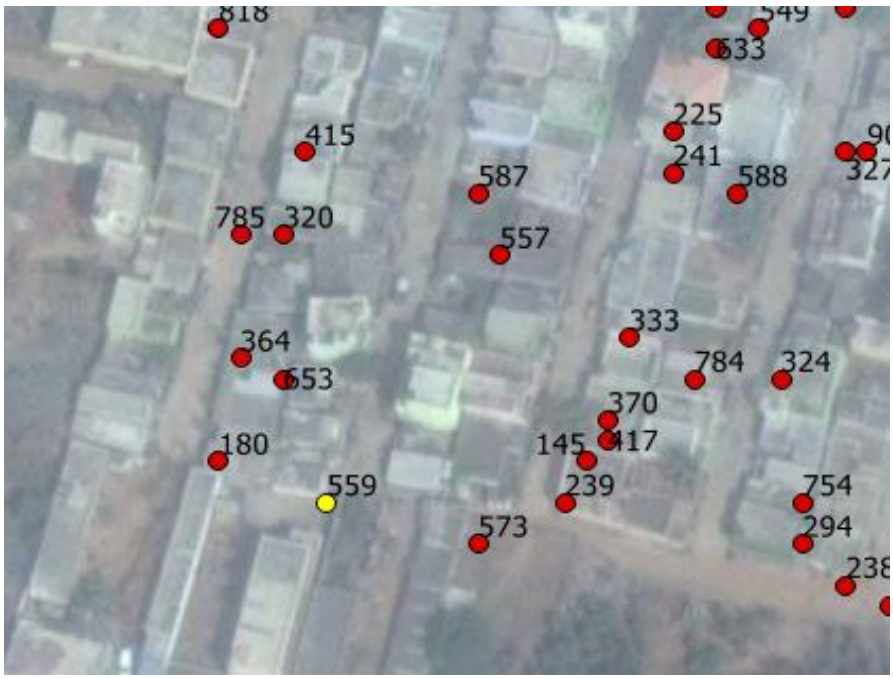
Petitioner No. *559*	
Residential House

Remarks: During the ground truth verification it was found that single house has been constructed in the ground floor. During the interaction with the petitioner it was found that the house has been constructed in the year 1995 (Figure-12.88) in the site allotted by the Government under the Ashraya Yojane Scheme and presently four members are living in the house.

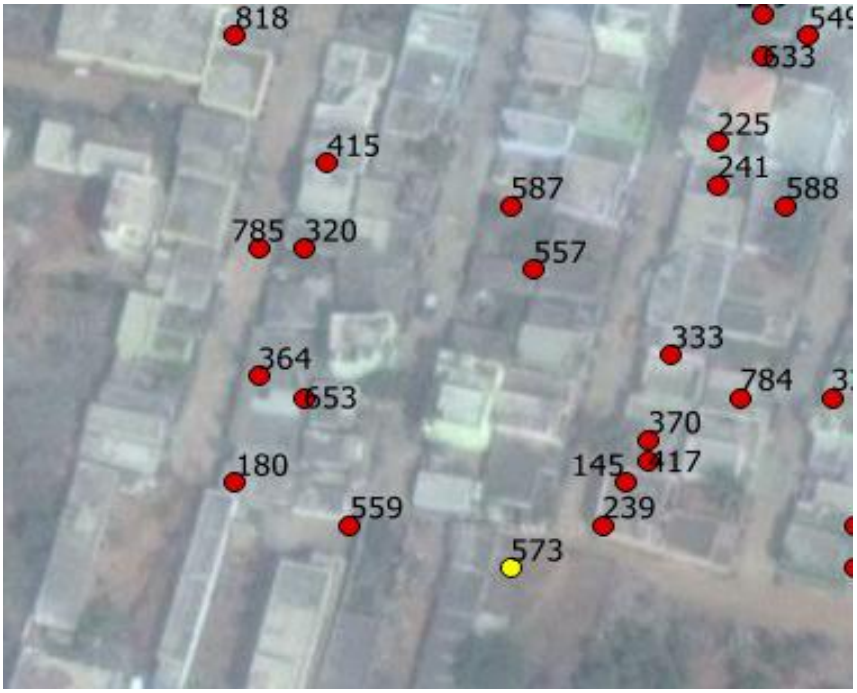
Petitioner No. 573	
Residential House

Remarks: During the ground truth verification it was found that single house has been constructed in the ground floor. During the interaction with the petitioner it was found that the house has been constructed in the year 2000 (Figure-12.89) site allotted by the Government under the Ashraya Yojane Scheme and presently t members are living in the house.

Figure-12.89: GPS location of the petitioner house (Yellow colour) on Google Earth Image (2014) in the Adakimaranahalli Village

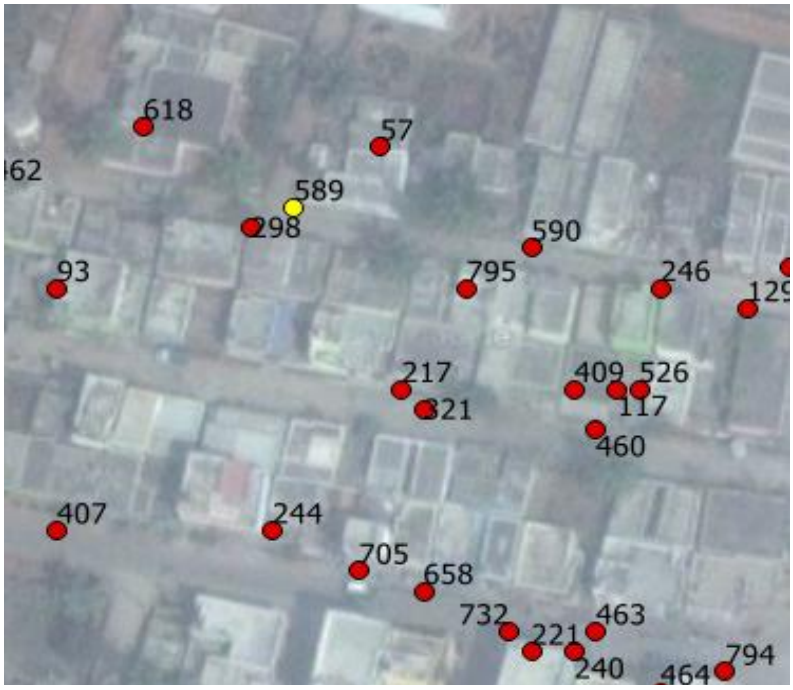
Petitioner No. 589	
Residential House along with the shop

Remarks: During the ground truth verification it was found that two houses along with a shop have been constructed in the ground floor. During the interaction with the petitioner it was found that the house was constructed in the year 1995 (Figure-12.91) which has been renovated in the year 2002. Further, it was found that the house has been constructed in the site allotted by the Government under the Ashraya Yojane Scheme and presently four members are living in these houses.

Figure-12.91: GPS location of the petitioner house (Yellow colour) on Google Earth Image (2014) in the Adakimaranahalli Village

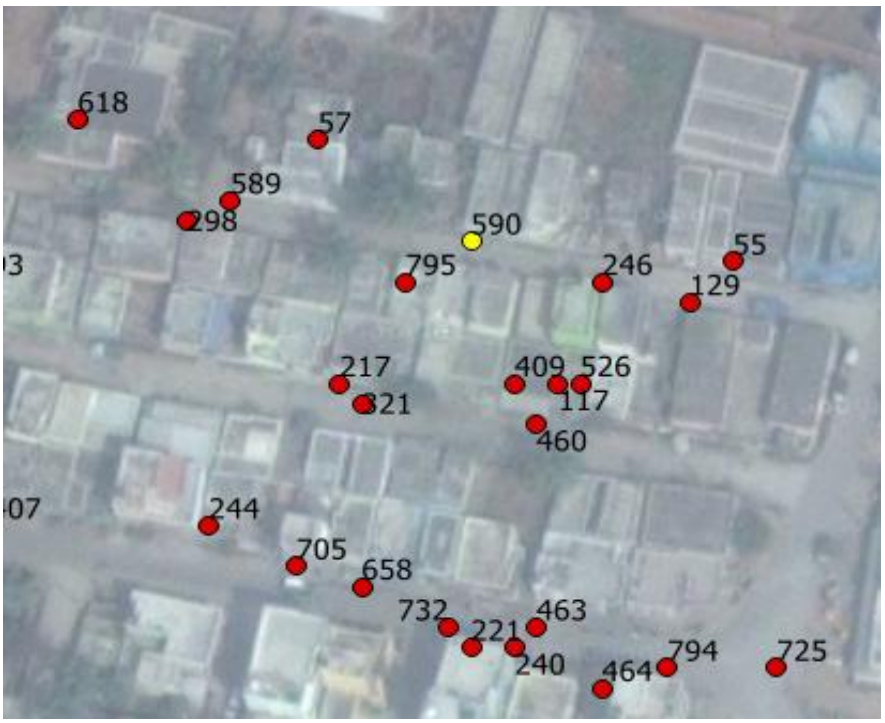
Petitioner No. 590	
Residential House

Remarks: During the ground truth verification it was found that single house has been constructed in the ground floor. During the interaction with the petitioner it was found that the house has been constructed in the year 1997 (Figure-12.92) and presently four members are living in the house.

Figure-12.92: GPS location of the petitioner house (Yellow colour) on Google Earth Image (2014) in the Adakimaranahalli Village

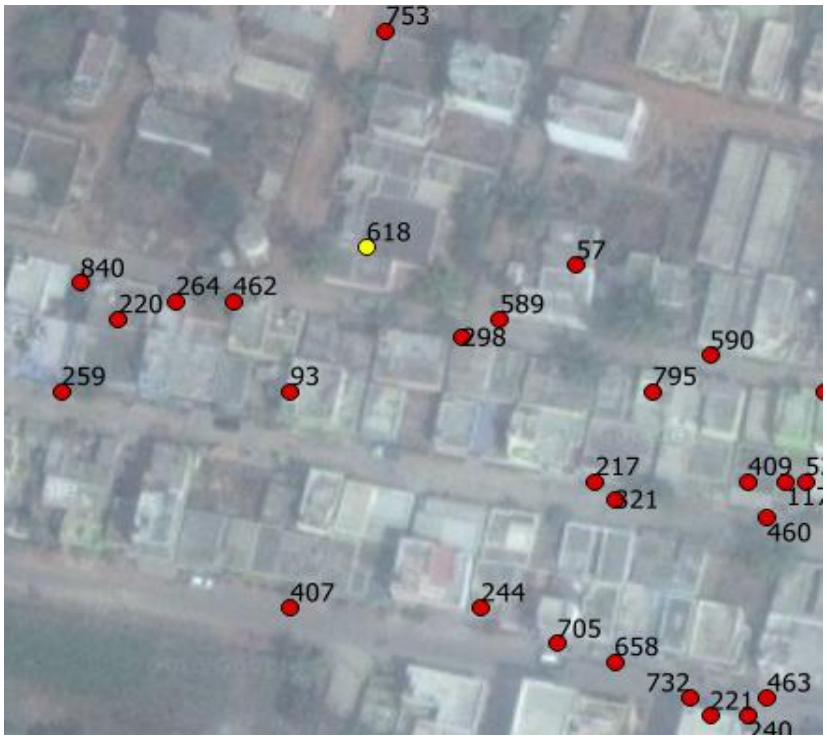
Petitioner No. 618	
Residential House

Remarks: During the ground truth verification it was found that two houses have been constructed in the ground floor. During the interaction with the petitioner it was found that the house was constructed in the year 2009 (Figure-12.94) and presently eight members are living in these houses.

Figure-12.94: GPS location of the petitioner house (Yellow colour) on Google Earth Image (2014) in the Adakimaranahalli Village

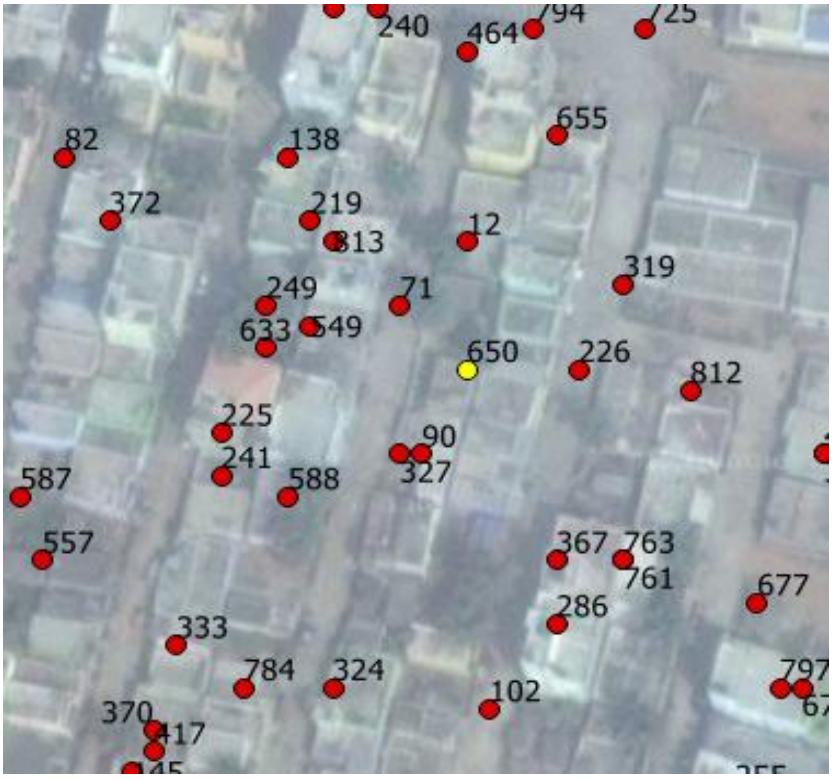
Petitioner No. 650	
Residential House

Remarks: During the ground truth verification it was found that single house has been constructed in the ground floor. During the interaction with the petitioner it was found that the house was constructed in the year 2010 (Figure-12.97) in the site allotted by the Government under the Ashraya Yojane Scheme and presently four members are living in the house.

Figure-12.97: GPS location of the petitioner house (Yellow colour) on Google Earth Image (2014) in the Adakimaranahalli Village

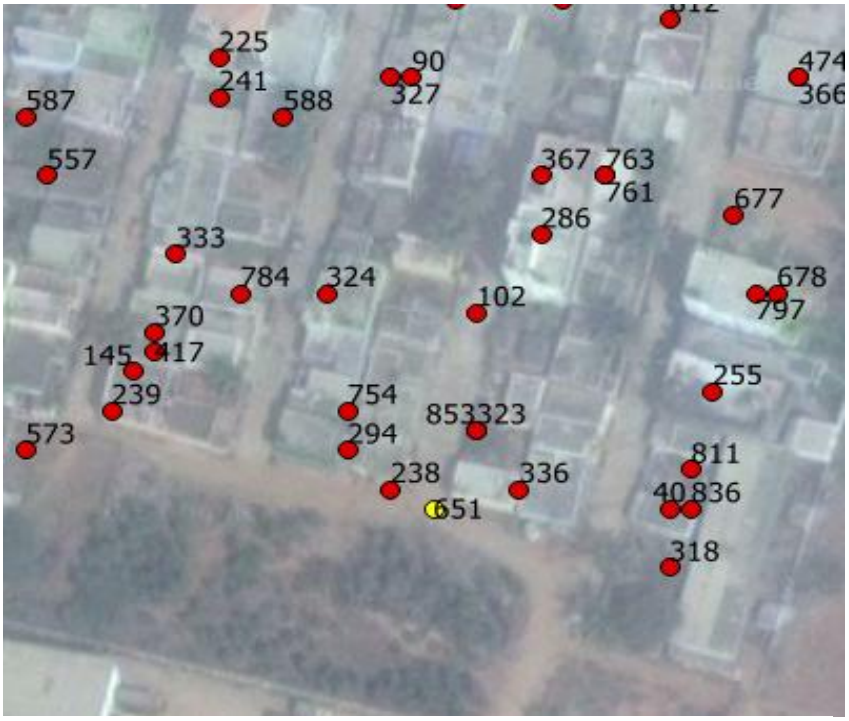
Petitioner No. 651	
Residential House

Remarks: During the ground truth verification it was found that three houses along with a shop have been constructed in ground floor. Further, it was found that currently the shop is vacant. During the interaction with the petitioner it was found that the house was constructed in the year 1994 (Figure-12.98) in the site allotted by the Government under the Ashraya Yojane Scheme and presently eleven members are living in these houses.

Figure-12.98: GPS location of the petitioner house (Yellow colour) on Google Earth Image (2014) in the Adakimaranahalli Village

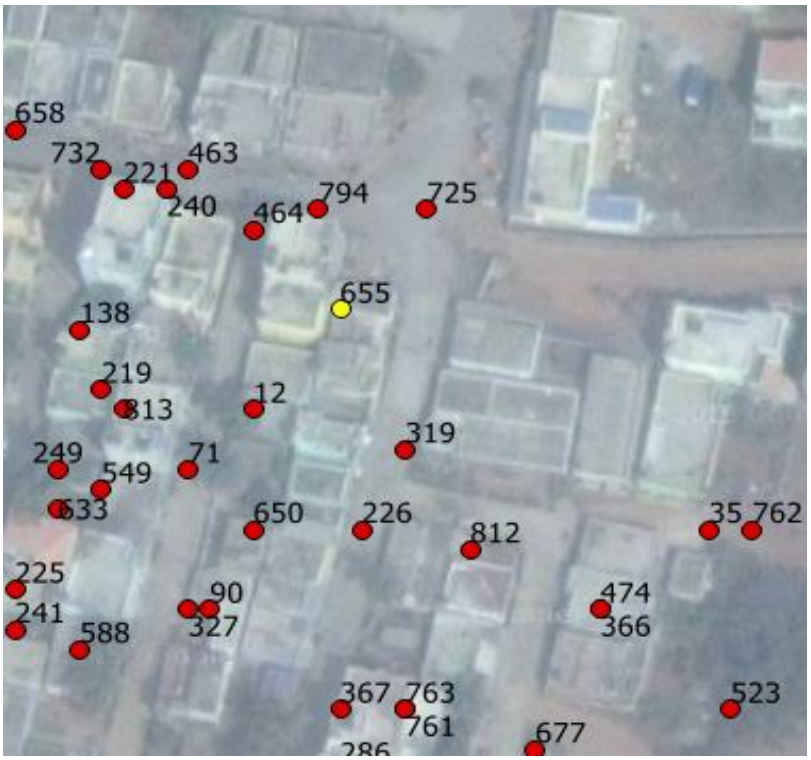
Petitioner No. 655	
Residential House

Remarks: During the ground truth verification it was found that two houses have been constructed in the ground floor. During the interaction with the petitioner it was found that the old house was constructed in the year 1996 (Figure-12.100) which has been renovated in the year 2010. It was also found that the house has been constructed in the site allotted by the Government under the Ashraya Yojane Scheme and presently three members are living in these houses.

Figure-12.100: GPS location of the petitioner house (Yellow colour) on Google Earth Image (2014) in the Adakimaranahalli Village

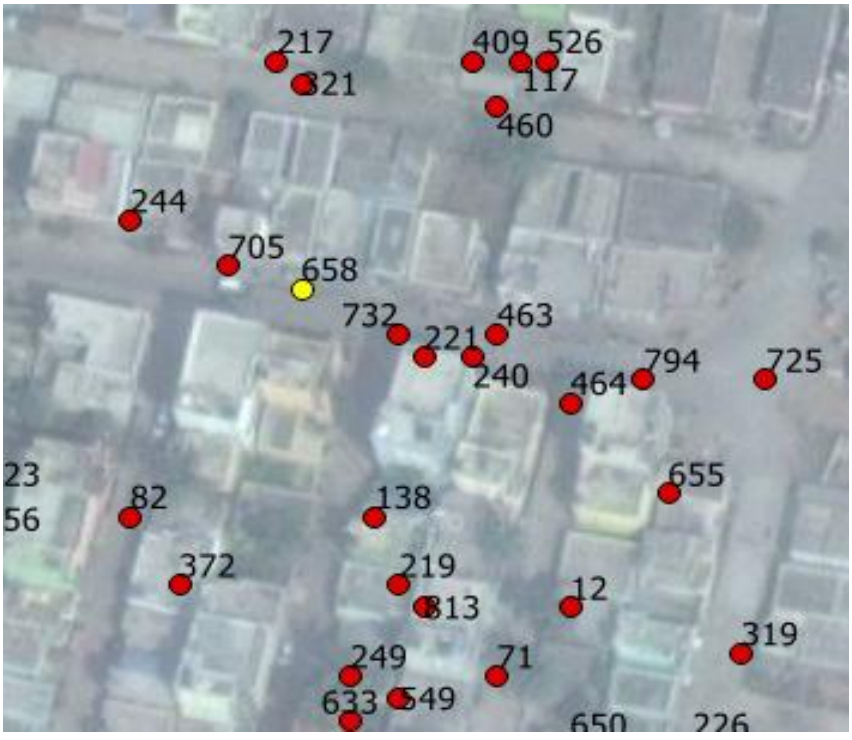
Petitioner No. 658	
Residential House

Remarks: During the ground truth verification it was found that single house has been constructed in the ground floor. During the interaction with the petitioner it was found that the house was constructed in the year 1994 (Figure-12.101) in the site allotted by the Government under the Ashraya Yojane Scheme and presently four members are living in the house.

Figure-12.101: GPS location of the petitioner house (Yellow colour) on Google Earth Image (2014) in the Adakimaranahalli Village
