Comprehensive Assessment of Thippagondanahalli Reservoir Catchment Area and its Preservation Zone

Volume-II
(Writ Petitions)

Center for Lake Conservation (CLC)
Environmental Management and Policy Research Institute (EMPRI)

August, 2015

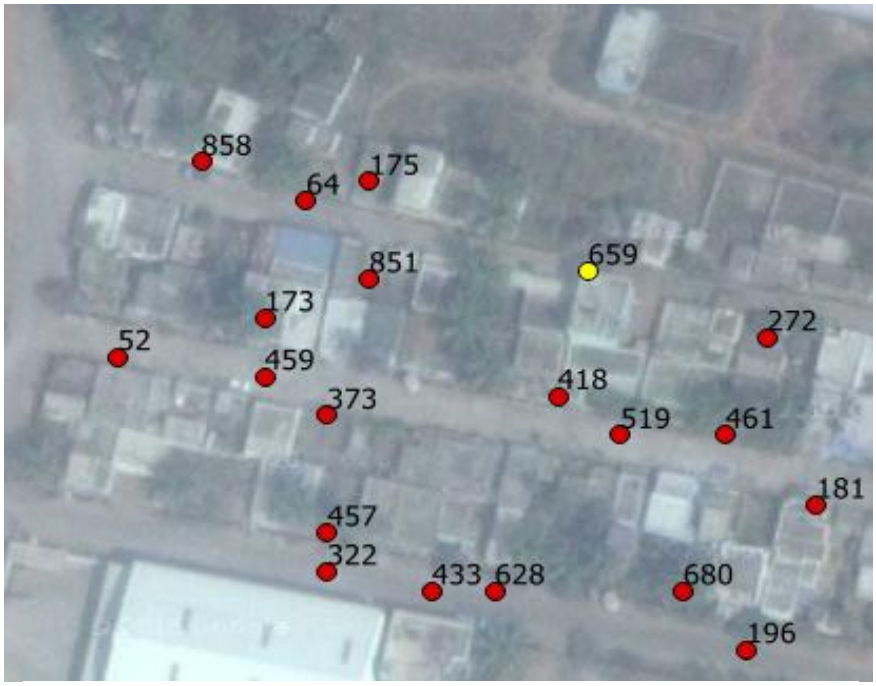
Petitioner No. 659	
Residential House

Remarks: During the ground truth verification it was found that three houses have been constructed in the ground floor. During the interaction with the petitioner it was found that the houses was constructed in the year 1990 (Figure-12.102) in the site allotted by the Government under the Ashraya Yojane Scheme and presently three families with twelve members are living in these houses.

Figure-12.102: GPS location of the petitioner house (Yellow colour) on Google Earth Image (2014) in the Adakimaranahalli Village

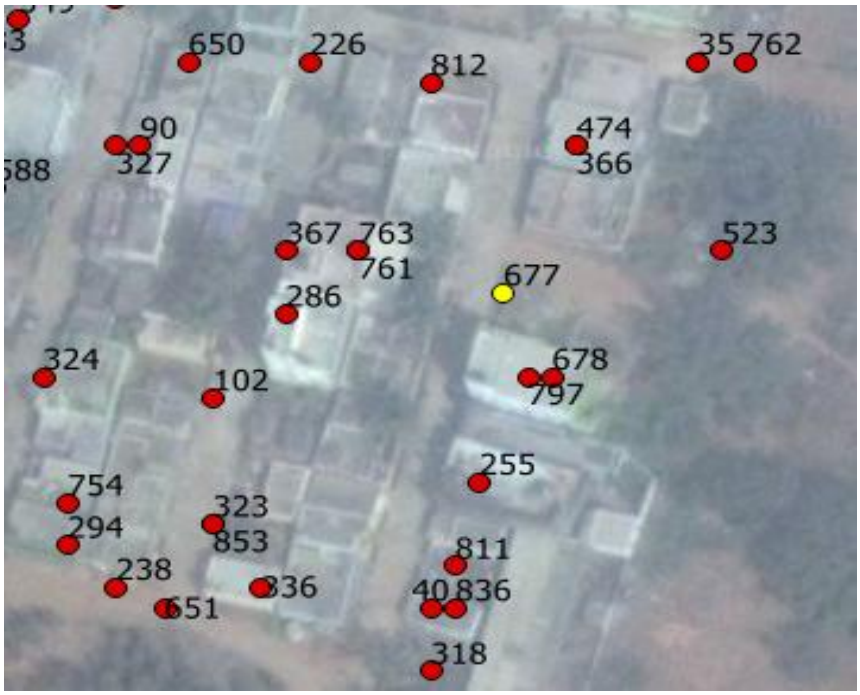
Petitioner No. 677	
Residential Building

Remarks: During the ground truth verification it was found that G+2 building has been constructed and further it was found that the building have five houses. During the interaction with the petitioner it was found that the building was constructed in the year 2014 (Figure-12.103) and presently a total of twenty members are living in these houses.

Figure-12.103: GPS location of the petitioner house (Yellow colour) on Google Earth Image (2014) in the Adakimaranahalli Village

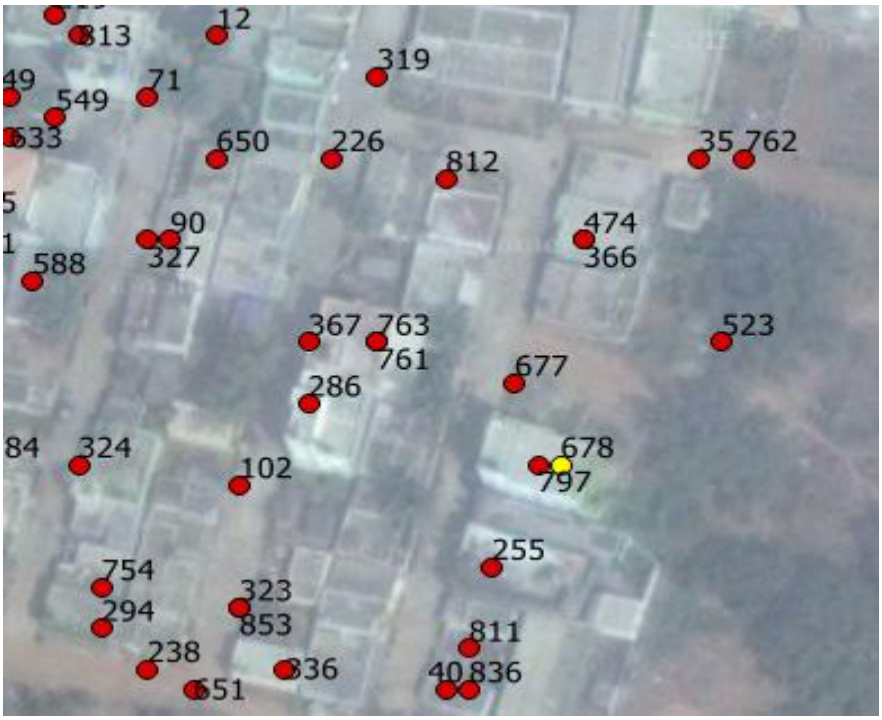
Petitioner No. 678 and 797	
Residential Building

Remarks: During the ground truth verification it was found that two petitions have been filed by the members of the same family and further it was found that G+2 building has been constructed and also building divided into eight houses. During the interaction with the petitioner it was found that the building was constructed in the year 2012 (Figure-12.104) and presently a total of twenty members are living in these houses.

Figure-12.104: GPS location of the petitioner house (Yellow colour) on Google Earth Image (2014) in the Adakimaranahalli Village

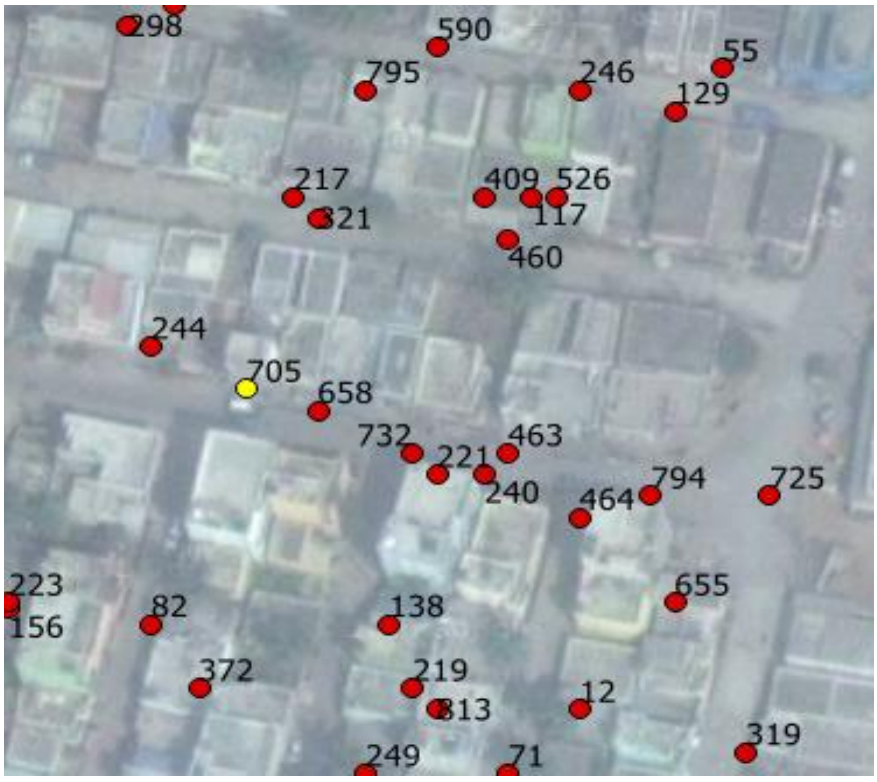
Petitioner No. 705	
Residential House

Remarks: During the ground truth verification it was found that three houses have been constructed in the ground floor. During the interaction with the petitioner it was found that the old house that was constructed in the year 1987 (Figure-12.106) has been renovated in the year 2005. Further it was found that the house was constructed in the site allotted by the Government under the Ashraya Yojane Scheme and presently five members are living in these houses.

Figure-12.106: GPS location of the petitioner house (Yellow colour) on Google Earth Image (2014) in the Adakimaranahalli Village

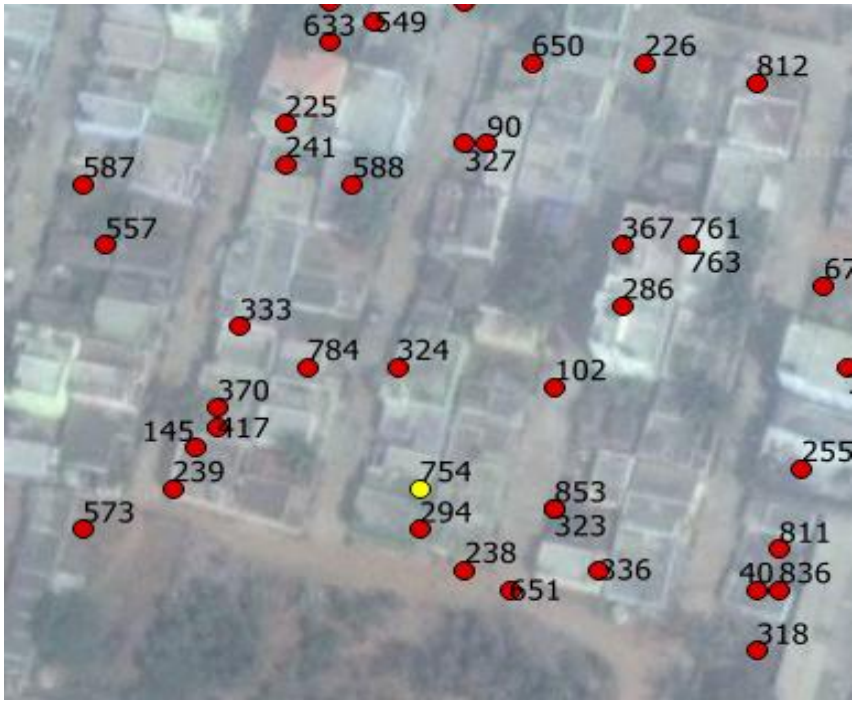
Petitioner No. 754	
Residential House

Remarks: During the ground truth verification it was found that the four houses have been constructed in the ground floor (Figure-12.109). While carrying out the ground truth verification, the petitioner house was locked and as per the information collected from the neighbours the house was constructed in the site allotted by the Government under the Ashraya Yojane Scheme and presently four families and overall eight members are living in these houses.

Figure-12.109: GPS location of the petitioner house (Yellow colour) on Google Earth Image (2014) in the Adakimaranahalli Village

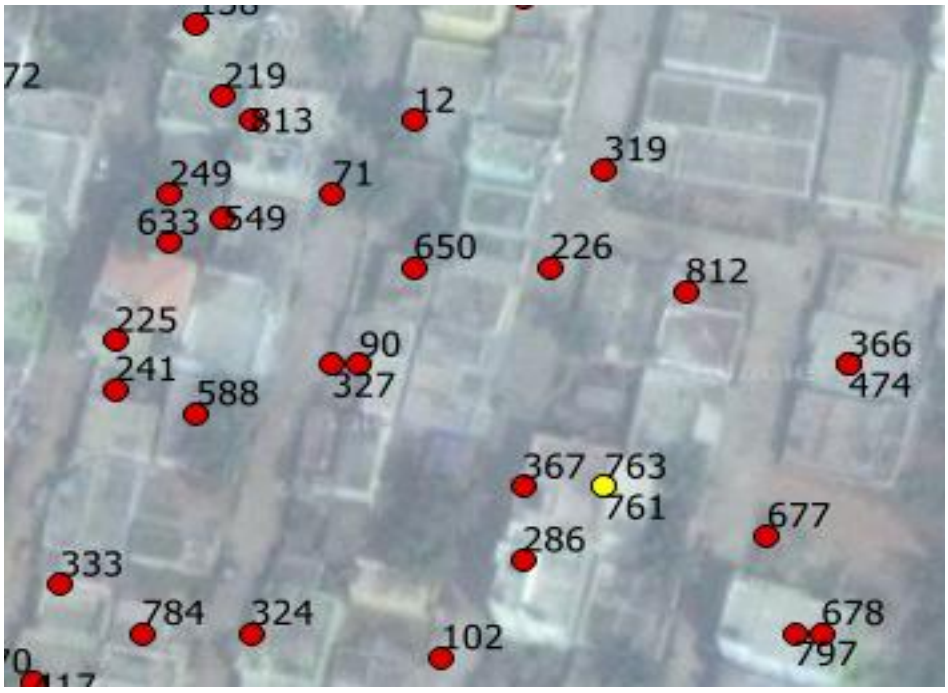
Petitioner No. 761 and 763	
Residential House

Remarks: During the ground truth verification it was found that two cases have been filed from the members of the same family and G+2 building has been constructed and further it was found that the building was having four houses. During the interaction with the petitioner it was found that the building was constructed in the year 1995 (Figure-12.110) in the site allotted by the Government under the Ashraya Yojane Scheme and presently twelve members are living in these houses.

Figure-12.110: GPS location of the petitioner house (Yellow colour) on Google Earth Image (2014) in the Adakimaranahalli Village

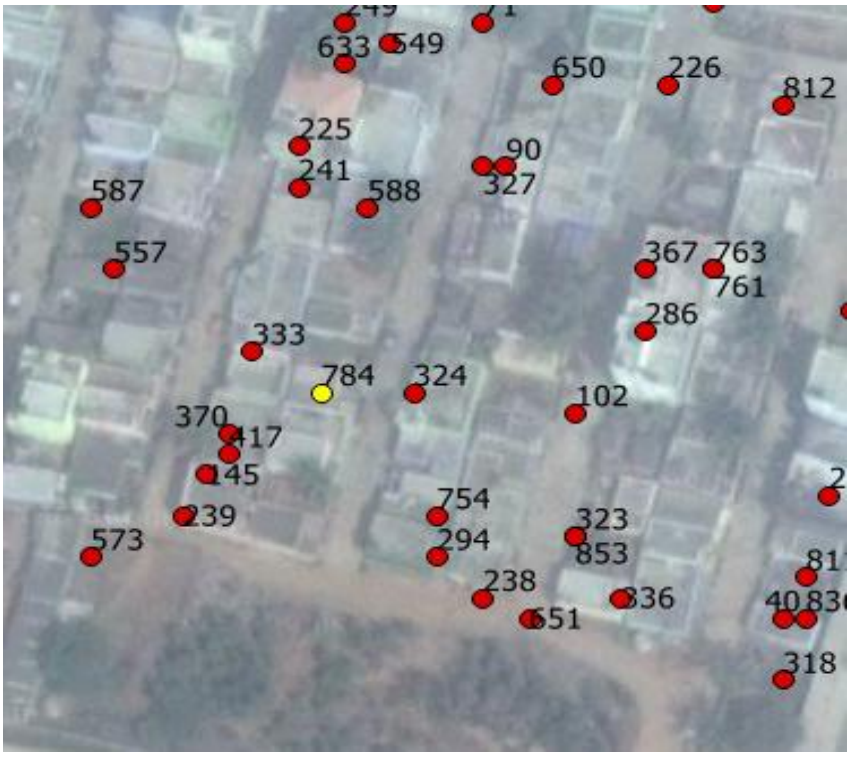
Petitioner No. 784	
Residential House

Remarks: During the ground truth verification it was found that three houses have been constructed in the ground floor. During the interaction with the petitioner it was found that the old house has been renovated in the year 2008 (Figure-12.111). Further it was found that the houses have been constructed in the site allotted by the Government under the Ashraya Yojane Scheme and presently three families with a total of nine members are living in these houses.

Figure-12.111: GPS location of the petitioner house (Yellow colour) on Google Earth Image (2014) in the Adakimaranahalli Village

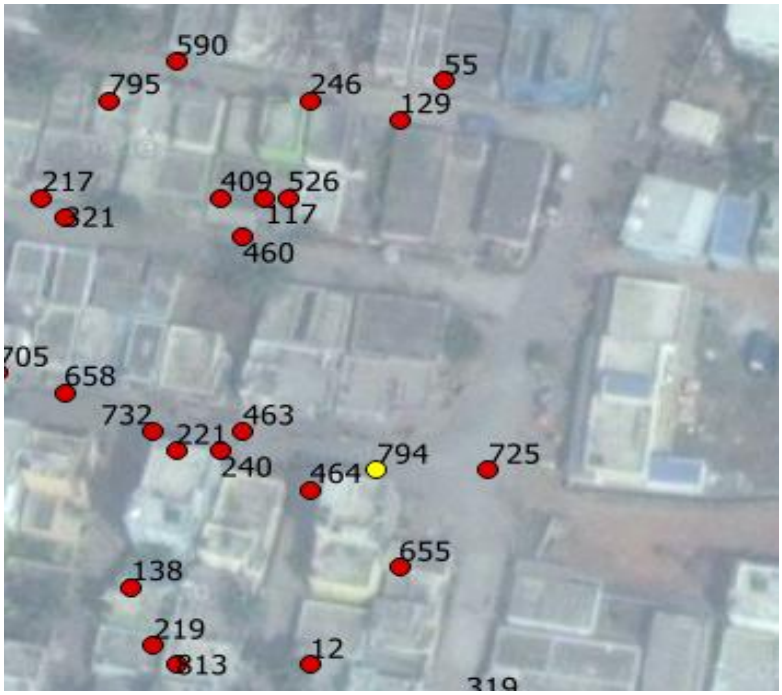
Petitioner No. 794	
Residential Building along with shop

Remarks: During the ground truth verification it was found that G+1 building along with one shop has been constructed and it was also found that the first floor was having one room. During the interaction with the petitioner it was found that the old house was constructed in the year 1990 (Figure-12.113) which has been renovated in the year 2004. Further it was found that the house has been constructed in the site allotted by the Government under the Ashraya Yojane Scheme and presently five members are living in the house.

Figure-12.113: GPS location of the petitioner house (Yellow colour) on Google Earth Image (2014) in the Adakimaranahalli Village

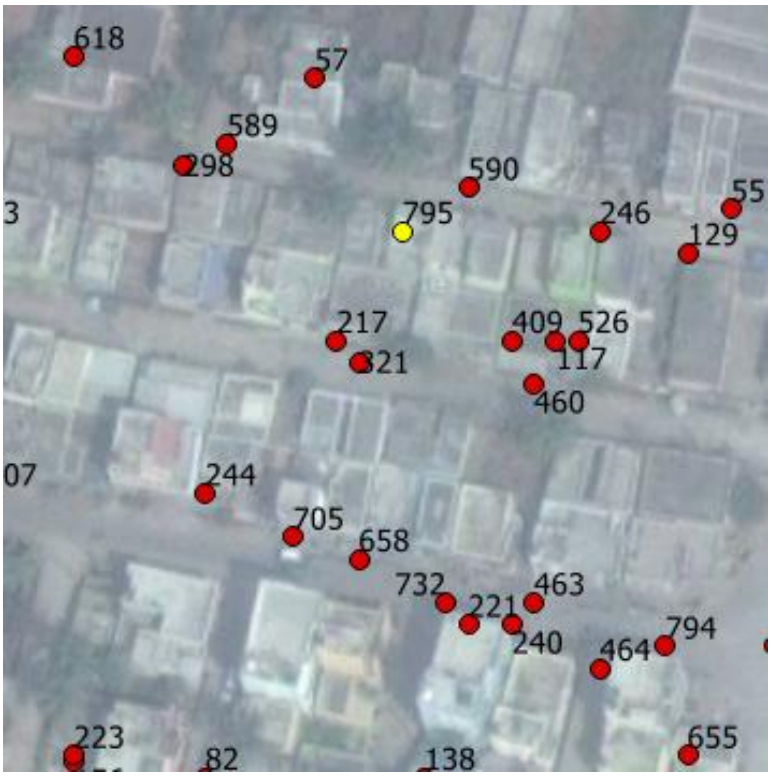
Petitioner No. 795	
Residential House

Remarks: During the ground truth verification it was found that two houses have been constructed in the ground floor. During the interaction with the petitioner it was found that the house was constructed in the year 1997 (Figure-12.114) in the site allotted by the Government under the Ashraya Yojane Scheme and presently a total of seven members are living in these houses.

Figure-12.114: GPS location of the petitioner house (Yellow colour) on Google Earth Image (2014) in the Adakimaranahalli Village

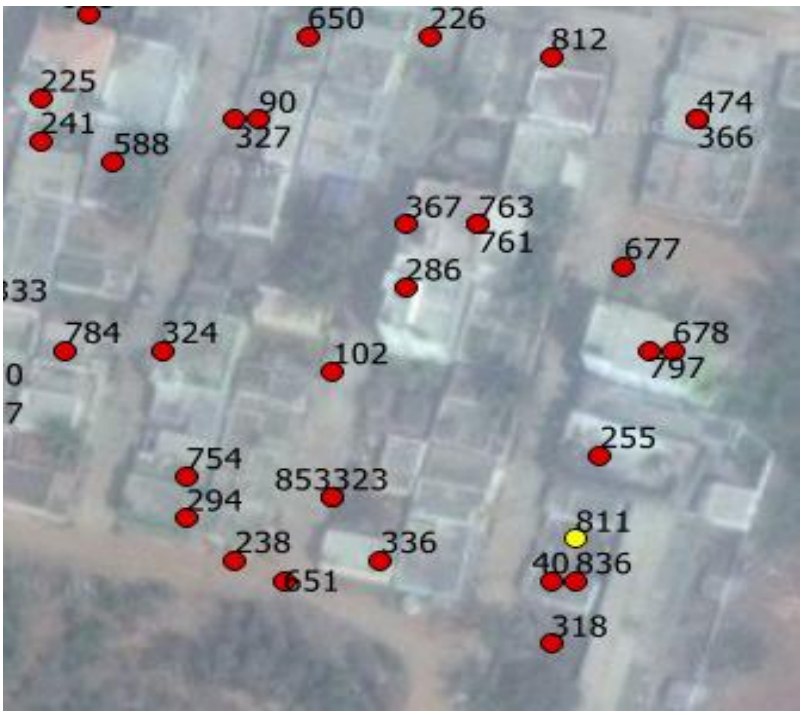
Petitioner No. 811	
Residential House

Remarks: During the ground truth verification it was found that single house has been constructed in the ground floor. During the interaction with the petitioner it was found that the house has been constructed in the year 2013 (Figure-12.115) in the site allotted by the Government under the Ashraya Yojane Scheme and presently four members are living in the house.

Figure-12.115: GPS location of the petitioner house (Yellow colour) on Google Earth Image (2014) in the Adakimaranahalli Village

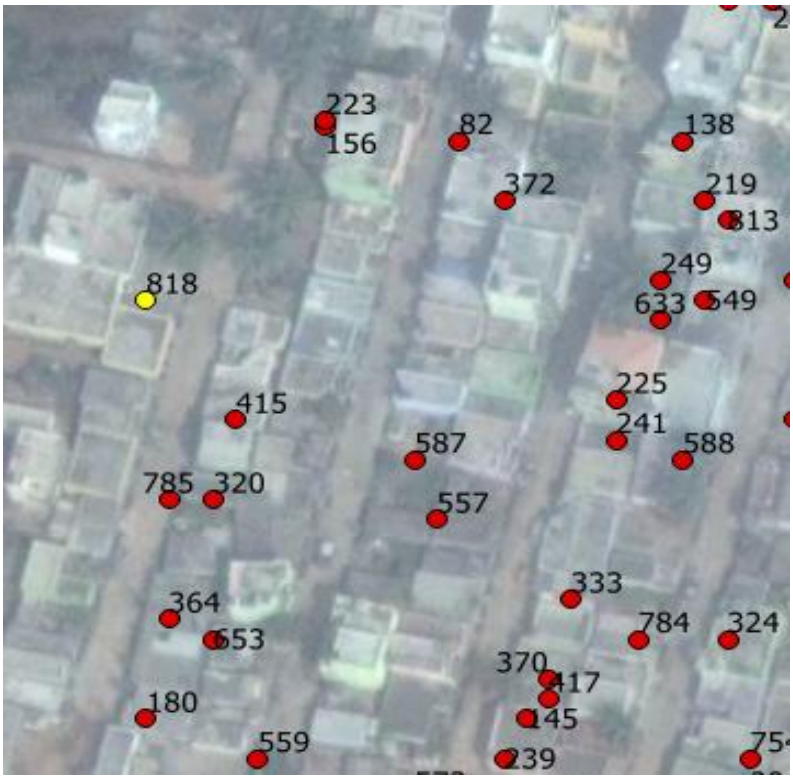
Petitioner No. 818	
Residential House

Remarks: During the ground truth verification it was found that single house has been constructed in the ground floor. During the interaction with the petitioner, it was found that the house has been constructed in the year 1987 (Figure-12.117) in the site allotted by the Government under the Ashraya Yojane Scheme and presently four members are living in the house.

Figure-12.117: GPS location of the petitioner house (Yellow colour) on Google Earth Image (2014) in the Adakimaranahalli Village

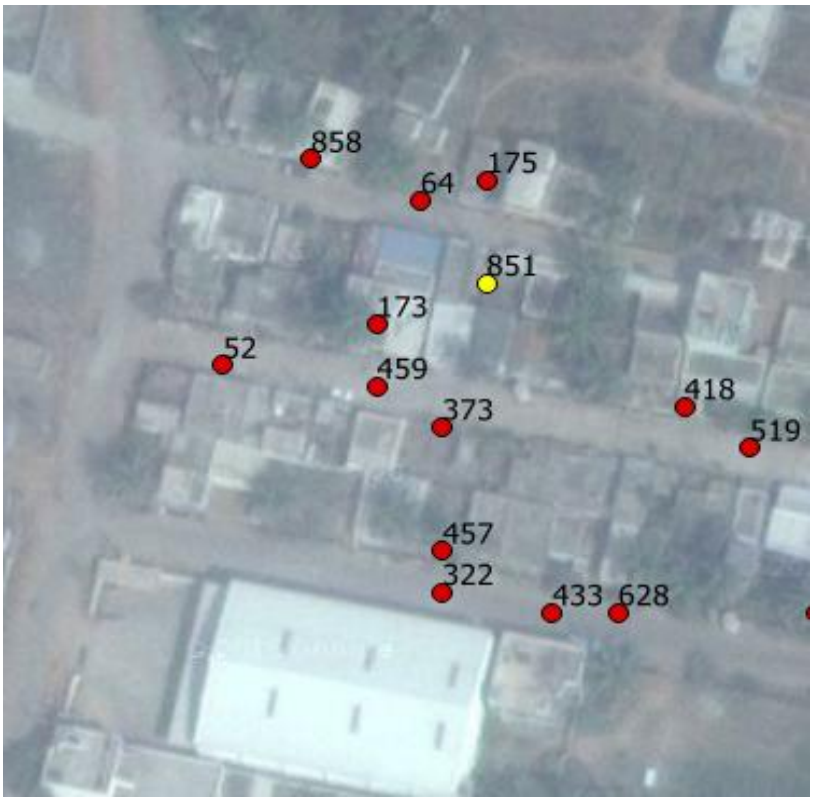
Petitioner No. 851	
Residential House

Remarks: During the ground truth verification it was found that single house has been constructed in the ground floor (Figure-12.119). While carrying out the ground truth verification the petitioners house was locked and as per the information collected from the neighbours the house has been constructed in the site allotted by the Government under the Ashraya Yojane Scheme and presently three members are living in the house.

Figure-12.119: GPS location of the petitioner house (Yellow colour) on Google Earth Image (2014) in the Adakimaranahalli Village

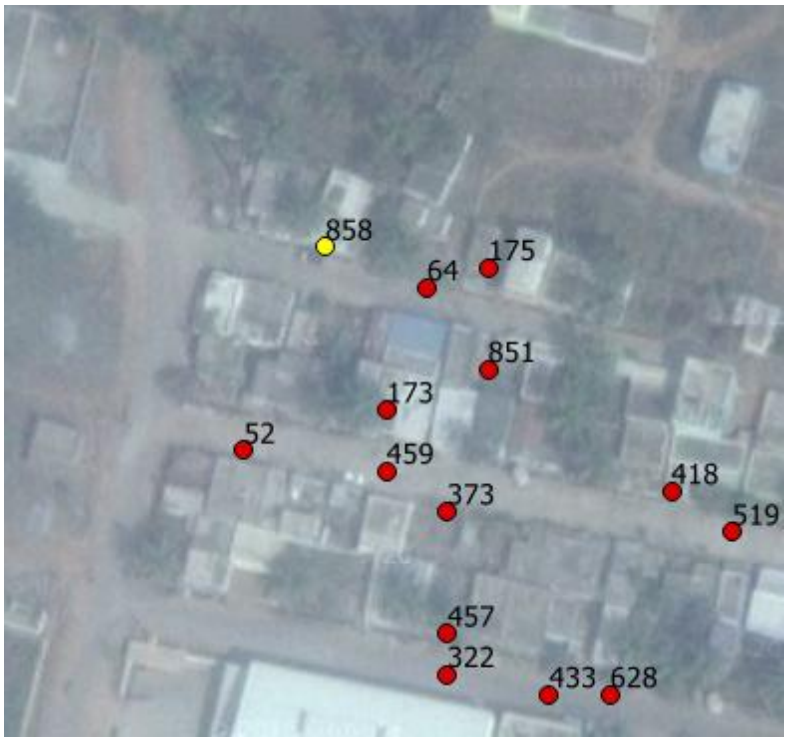
Petitioner No. 858	
Residential House

Remarks: During the ground truth verification it was found that single house has been constructed in the ground floor. During the interaction with the petitioner it was found that the house has been constructed in the year 1995 (Figure-12.120) in the site allotted by the Government under the Ashraya Yojane Scheme and presently four members are living in the house.

Figure-12.120: GPS location of the petitioner house (Yellow colour) on Google Earth Image (2014) in the Adakimaranahalli Village

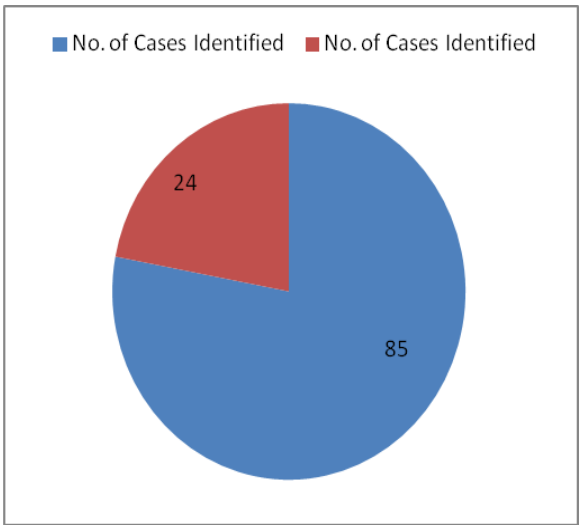
During the ground truth verification, out of 109 cases 85 residential houses cases were identified and remaining 24 houses could not be identified (Figure-12.124). The local people and the persons accompanying the ground truth exercise expressed inability to locate these addresses. Further, a written statement (PANCHANAMA) was written in the presence of all the members of the committee i.e. EMPRI staff, two representatives of the petitioners and local

Figure-12.124: Field verification status in the Siddanahosahalli village

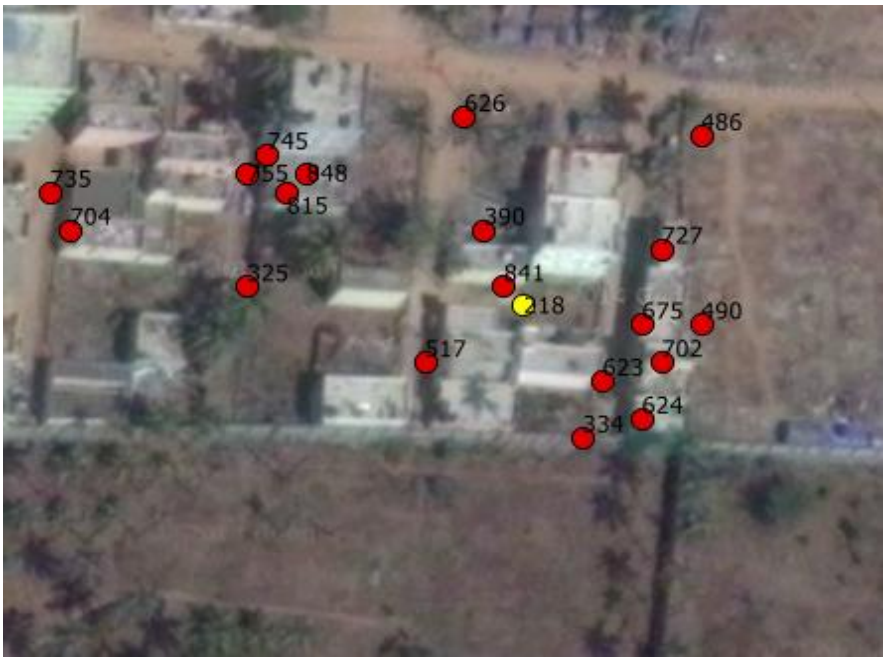
Petitioner No. 218 and 841	
Residential House

Remarks: During the ground truth verification it was found two petitions have been filed by the members of the same family and further it was found that single house has been constructed in the ground floor in an area of 15′x40′. During the interaction with the petitioner it was found that the house has been constructed in the year 2005 (Figure-12.145) and presently three members are living in the house.

Figure-12.145: GPS location of the petitioner house (Yellow colour) on Google Earth Image (2014) in the Siddanahosahalli Village

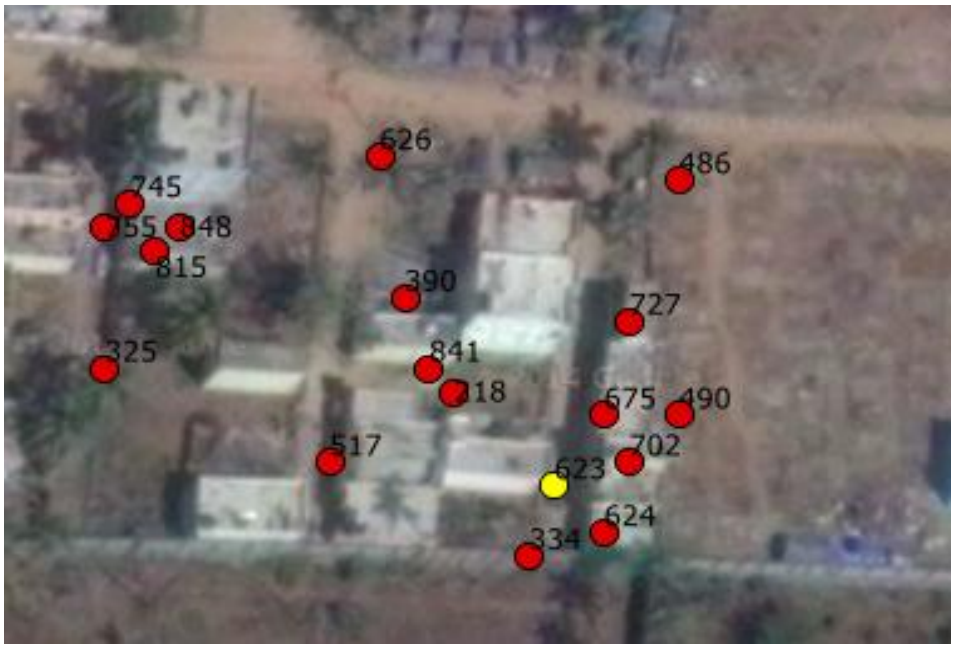
Petitioner No. 623	
Residential House

Remarks: During the ground truth verification it was found that two houses have been constructed in the ground floor in an area of 16'x27'. During the interaction with the petitioner it was found that the house was constructed in the year 2006 (Figure-12.173) in Narayanappa layout and presently a total of thirteen members are living in these houses.

Figure-12.173: GPS location of the petitioner house (Yellow colour) on Google Earth Image (2014) in the Siddanahosahalli Village

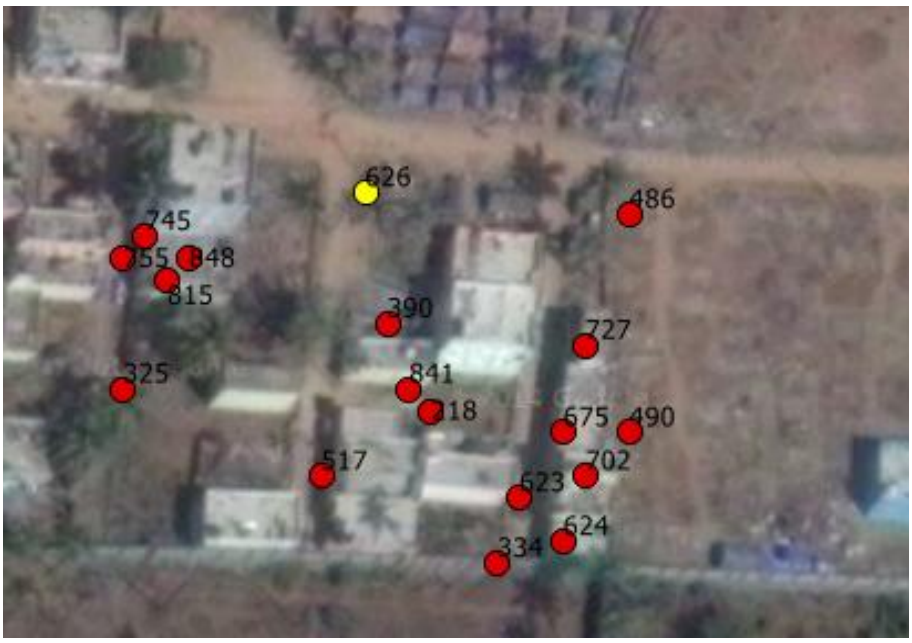
Petitioner No. 626	
Vacant Site

Remarks: During the ground truth verification it was found that the site area of 35'x40' was vacant and it is located in the Poojarappa layout (Figure-12.175).

Figure-12.175: GPS location of the petitioner site (Yellow colour) on Google Earth Image (2014) in the Siddanahosahalli Village

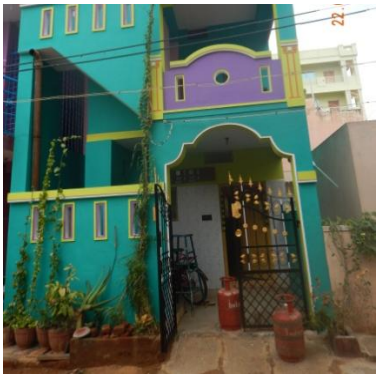
Petitioner No. 755

Remarks: During the ground truth verification it was found that G+1 building has been constructed in an area of 15'x40'. During the interaction with the petitioner it was found that the building has been constructed in the year 2004 (Figure-12.192) and presently four members are living in the house.

Figure-12.192: GPS location of the petitioner house (Yellow colour) on Google Earth Image (2014) in the Siddanahosahalli Village

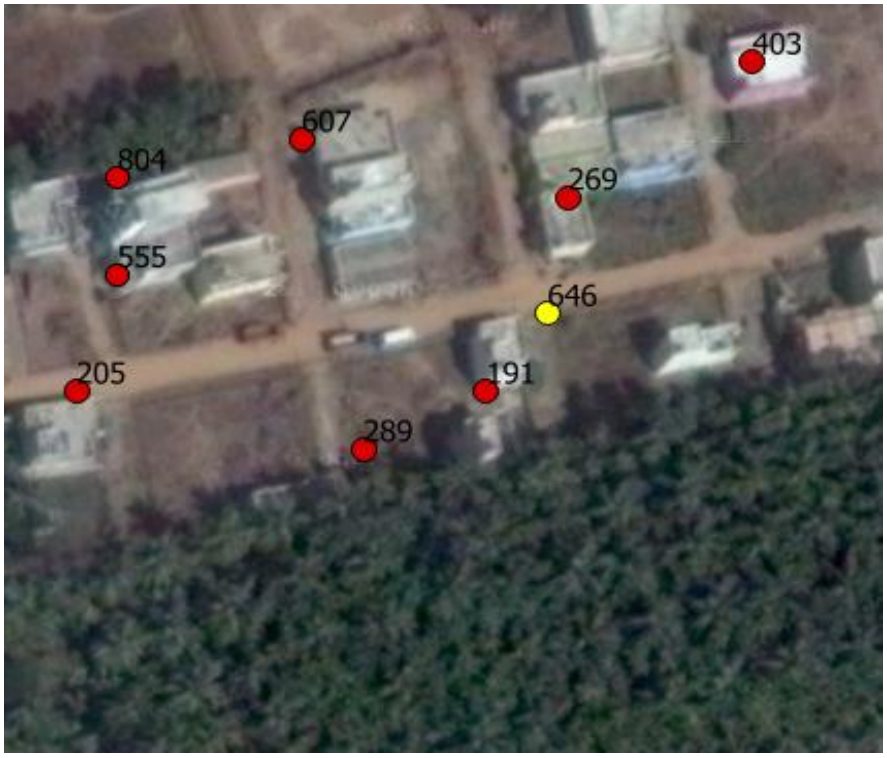
Petitioner No. 646	
Residential house along with the shop

Remarks: During the ground truth verification it was found that G+1 building along with shop has been constructed and further it was found that first floor was having single room. While carrying out the ground truth verification, the petitioners house was locked and as per the information collected from the neighbours the house was constructed in the year 2010 (Figure-12.258) in the Byraveshwara layout.

Figure-12.258: GPS location of the petitioner house (Yellow colour) on Google Earth Image (2014) in the Dombarahalli Village

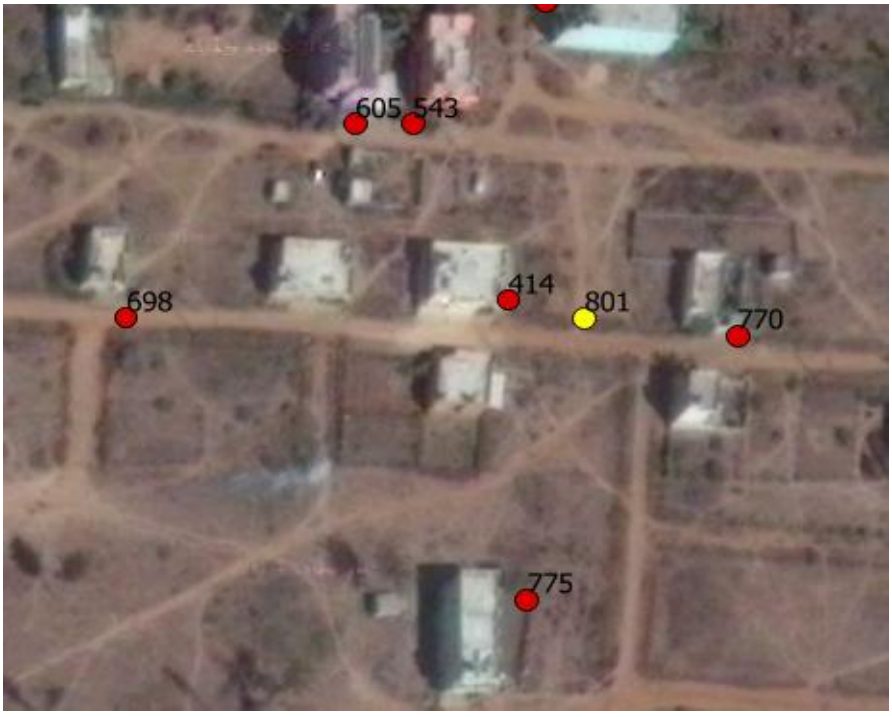
Petitioner No. 801	
Residential House along with a shop

Remarks: During the ground truth verification it was found that single house along with one shop has been constructed in the ground floor in Tippaiah layout. During the interaction with the petitioner it was found that the house was constructed in the year 2012 (Figure-12.273) and presently five members are living in the house.

Figure-12.273: GPS location of the petitioner house (Yellow colour) on Google Earth Image (2014) in the Dombarahalli Village

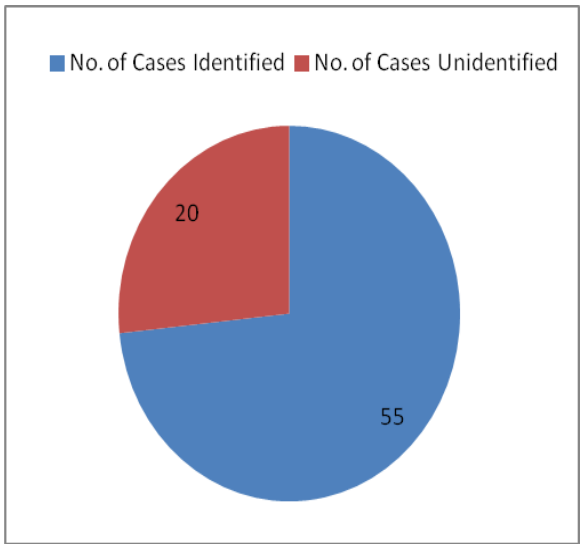
During the ground truth verification, out of 75 cases 55 residential houses cases could be identified and remaining 20 cases could not be identified (Figure-12.286). Pertaining to the addresses involving unidentified residential houses, the local people and the persons accompanying the ground truth exercise expressed inability to locate these addresses. Further, a written statement (PANCHANAMA) was written in the presence of all the members of the committee i.e. EMPRI staff, two representatives of the petitioners and local people of the village along with their signatures. Panchanama of the ground verification of the residential

Figure-12.286: Field verification status

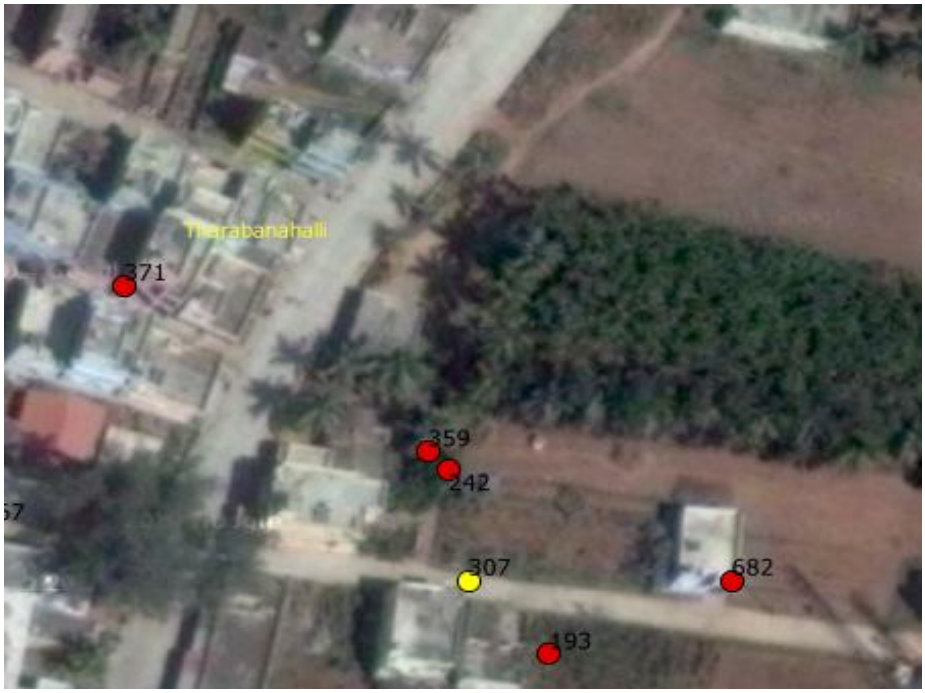
Petitioner No. 307	
Residential Building

Remarks: During the ground truth verification it was found that G+1 building has been constructed in the inherited property. During the interaction with the petitioner it was found that the old house that was constructed in the year 1987 (Figure-12.303) which has been renovated in the year 2001 and presently fifteen members are living in these houses.

Figure-12.303: GPS location of the petitioner house (Yellow colour) on Google Earth Image (2014) in the Tarabanahalli Village

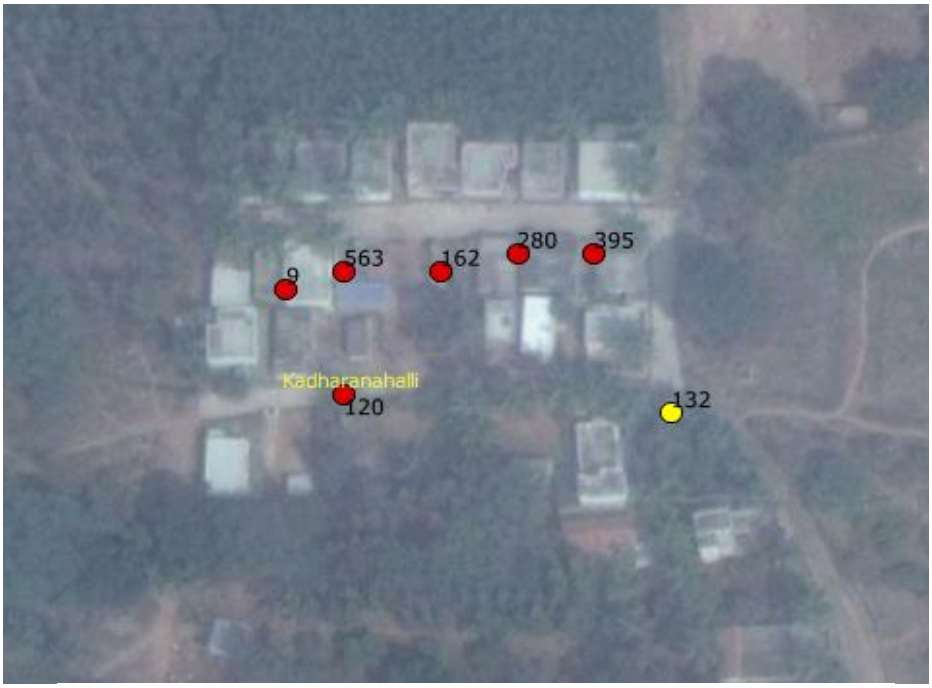
Petitioner No. 132	
Residential Building

Remarks: During the ground truth verification it was found that G+1 building has been constructed. During the interaction with the petitioner it was found that the house was constructed in the year 1975 (Figure-12.562) and presently, five members are living in the house.

Figure-12.562: GPS location of the petitioner house (Yellow colour) on Google Earth Image (2014) in the Kadaranahalli Village

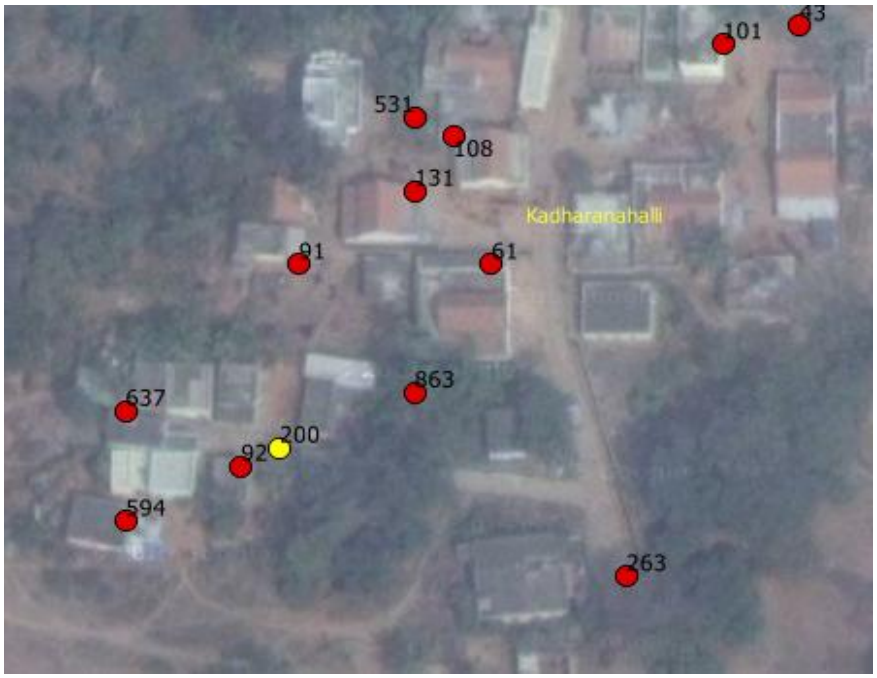
Petitioner No. 200	
Residential House

Remarks: During the ground truth verification it was found that single house has been constructed in the ground floor. During the interaction with the petitioner it was found that the house was constructed in the year 1985 (Figure-12.566) and presently, four members are living in the house.

Figure-12.566: GPS location of the petitioner house (Yellow colour) on Google Earth Image (2014) in the Kadaranahalli Village

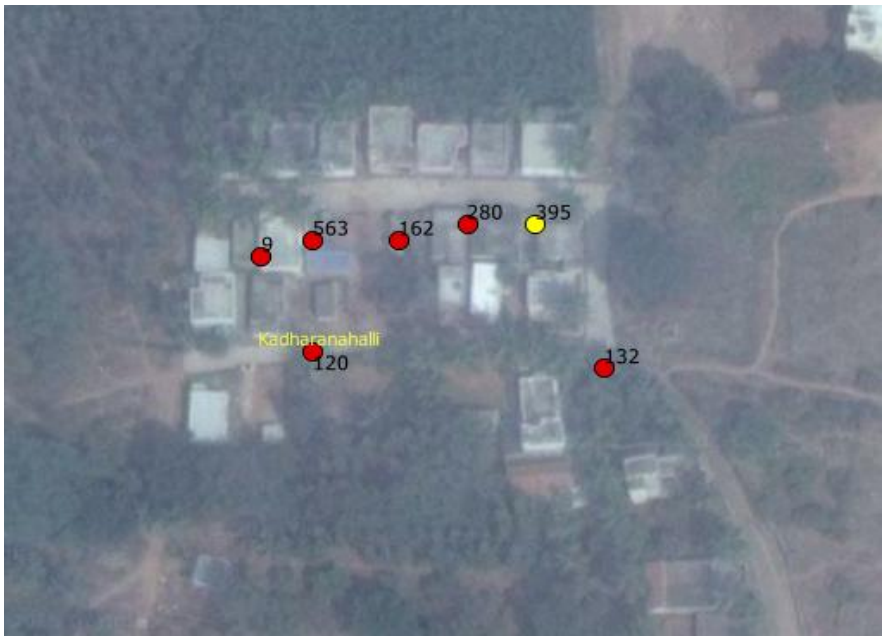
Petitioner No. 395	
Residential House

Remarks: During the ground truth verification it was found that single house has been constructed in the ground floor. During the interaction with the petitioner it was found that the house has been constructed in the year 1994 (Figure-12.569) in the site allotted by Government under Rajiv Gandhi Housing Scheme and presently, nine members are living in the house.

Figure-12.569: GPS location of the petitioner house (Yellow colour) on Google Earth Image (2014) in the Kadaranahalli Village

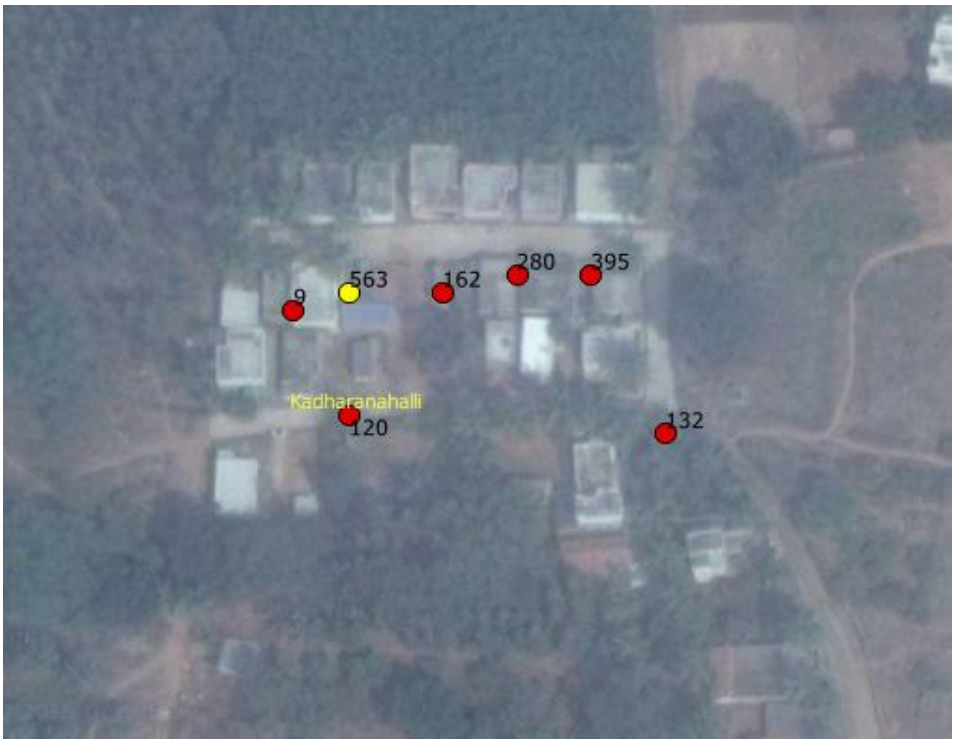
Petitioner No. 563	
Residential House

Remarks: During the ground truth verification it was found that single house has been constructed in the ground floor in an area of (30'x40'). During the interaction with the petitioner it was found that the old house which was constructed in the year 1965 (Figure-12.572) has been renovated in the year 2014 and presently three members are living in the house.

Figure-12.572: GPS location of the petitioner house (Yellow colour) on Google Earth Image (2014) in the Kadaranahalli Village

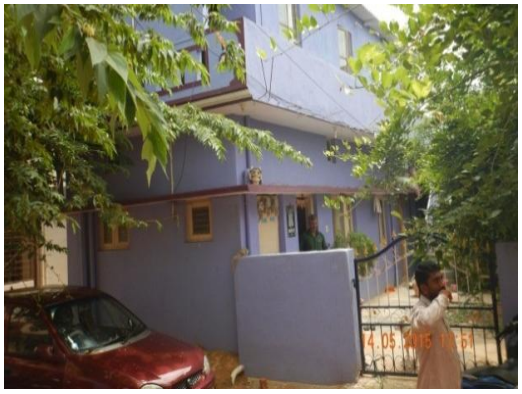
Petitioner No. 545

Remarks: During the ground truth verification it was found that G+1 building has been constructed and further it was found first floor was used for godown purpose. During the interaction with the petitioner it was found that the house was constructed in the year 2007 (Figure-12.591).

Figure-12.591: GPS location of the petitioner house (Yellow colour) on Google Earth Image (2014) in the Lakshmipura Village

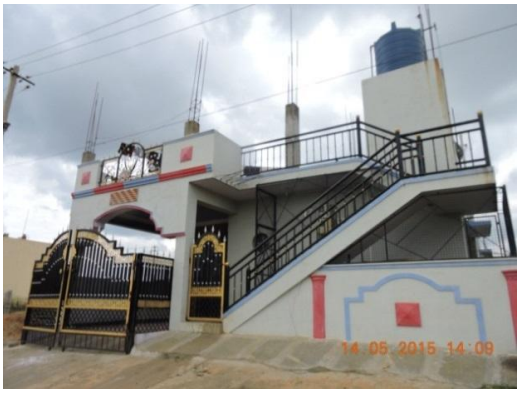
Petitioner No. 867

Remarks: During the ground truth verification it was found that single house has been constructed in the ground floor. While carrying out the ground truth verification, the petitioner house was locked and the house is constructed in the Rajarajeshwari layout (Figure-12.600).

Figure-12.600: GPS location of the petitioner house (Yellow colour) on Google Earth Image (2014) in the Lakshmipura Village

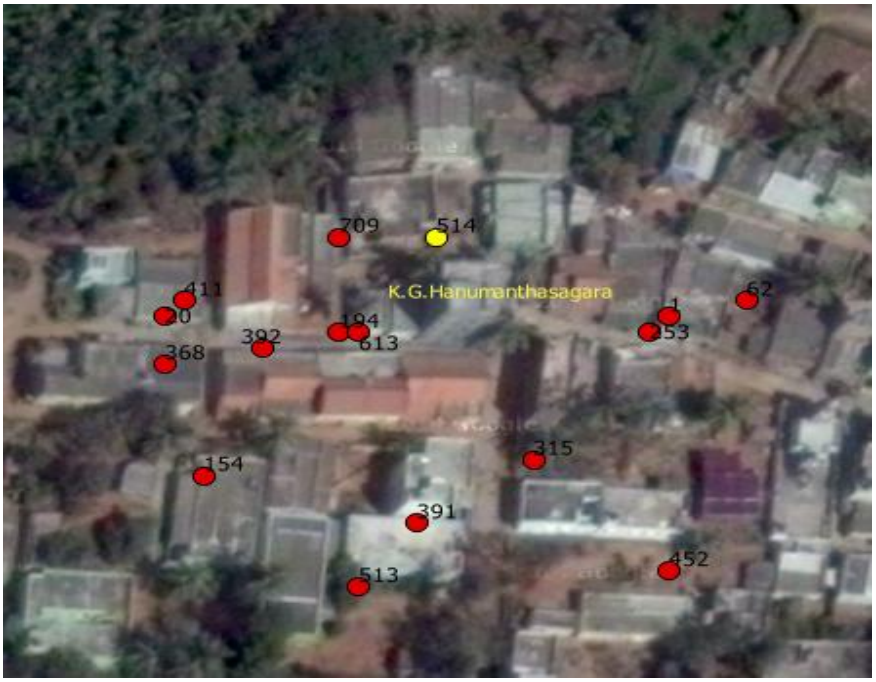
Petitioner No. 514	
Residential House

Remarks: During the ground truth verification it was found that two houses have been constructed in the ground floor. During the interaction with the petitioner it was found that the house has been constructed in the year 1996 (Figure-12.618) and presently two families with a total of eight members are living in these houses.

Figure-12.618: GPS location of the petitioner house (Yellow colour) on Google Earth Image (2014) in the Hanumathasagara Village

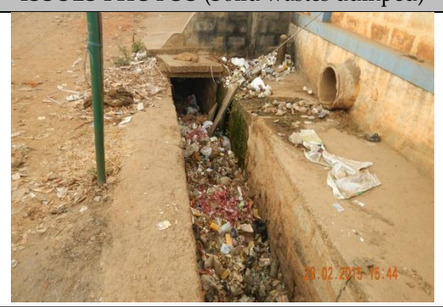
ISSUES PHOTOS (Solid wastes dumped)

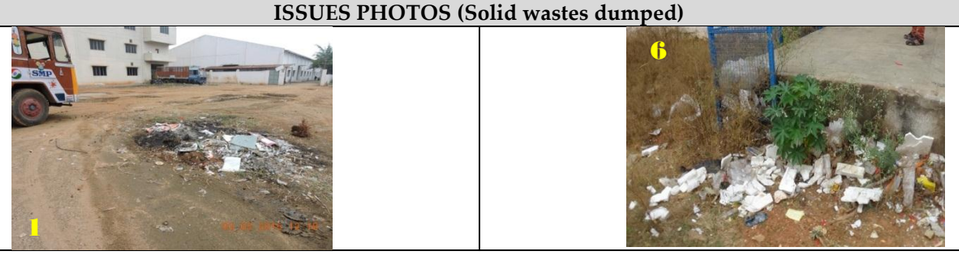
ISSUES PHOTOS (Solid wastes dumped)

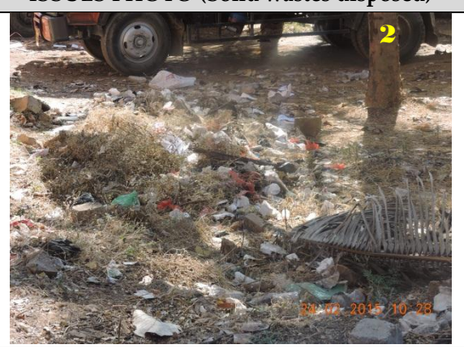
ISSUES PHOTO (Solid wastes disposed)

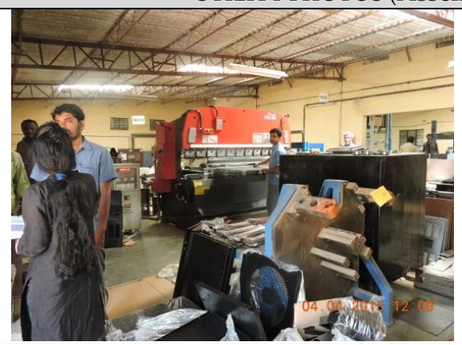
ISSUES PHOTOS (Scrap stored in the premises)

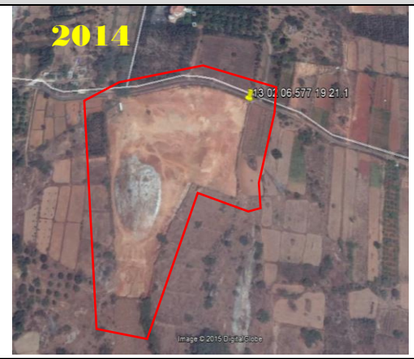
ISSUES PHOTO (Stone removal)
