Sub: Fire Accident in High Rise Commercial Carlton Towers,  
Airport Road, Bangalore on 23-02-2010 – constitution  
of a technical committee to investigate the cause of fire,  
work done and lapses.

**FIRE ACCIDENT IN HIGH RISE COMMERCIAL BUILDING  
(Carlton Tower)  
ON 23-02-2010**

**INVESTIGATION REPORT OF THE COMMITTEE, CONSTITUTED BY  
THE DGP, FIRE & EMERGENCY SERVICES, IN OFFICE ORDER  
NO.GBC(3)37/2010 DATED 02-03-2010**

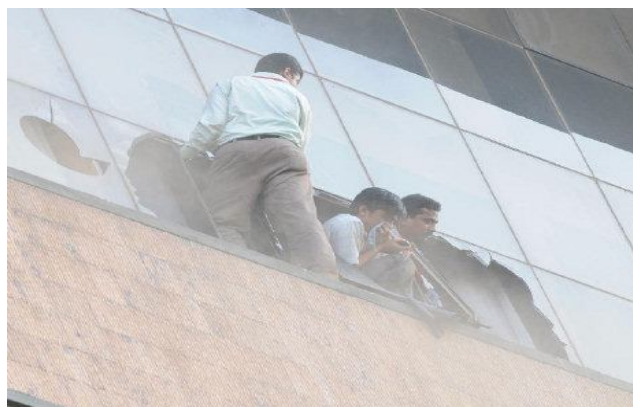
- 7 out of the 9 occupants have jumped from the building before the reaching of Fire & Emergency Services. 2 have died, probably due to inhalation of carbon monoxide and suffocation. About 68 occupants injured and were treated as in and out patients in the near by Manipal Hospital. The response from Police & 108 Ambulance Service was excellent.
